Project No. E14145.000
9 July 2014

Subject: **LATROBE ROAD REMEDIATION**
El Dorado County, California

Youngdahl Consulting Group, Inc. is pleased to present this report presenting the results of our forensic assessment for a portion of Latrobe Road where slope instability and retaining wall movement was identified. The purpose of this study was to evaluate the probable causes of the instability observed and prepare recommendations for mitigation. The scope of our study included a review of the existing gabion wall design prepared by the County of El Dorado, review of photos and documentation prepared during the wall construction operations, provide an opinion as to potential causes of the instability, and provide recommendations for slope and retaining wall repair.

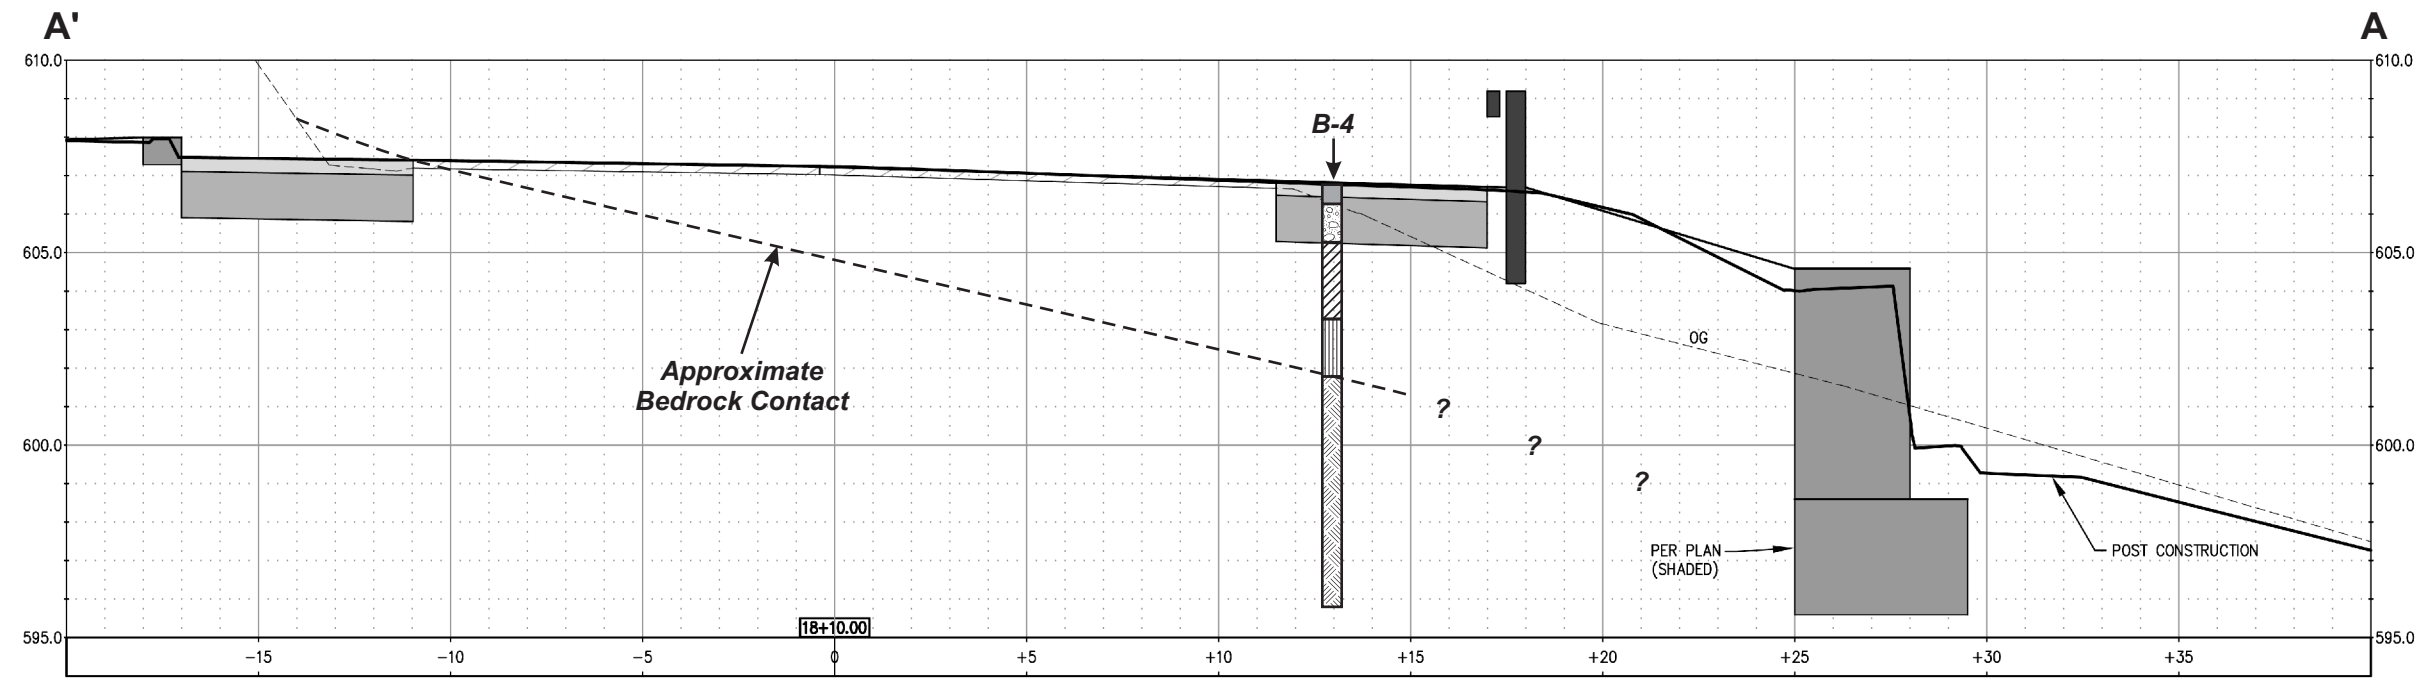
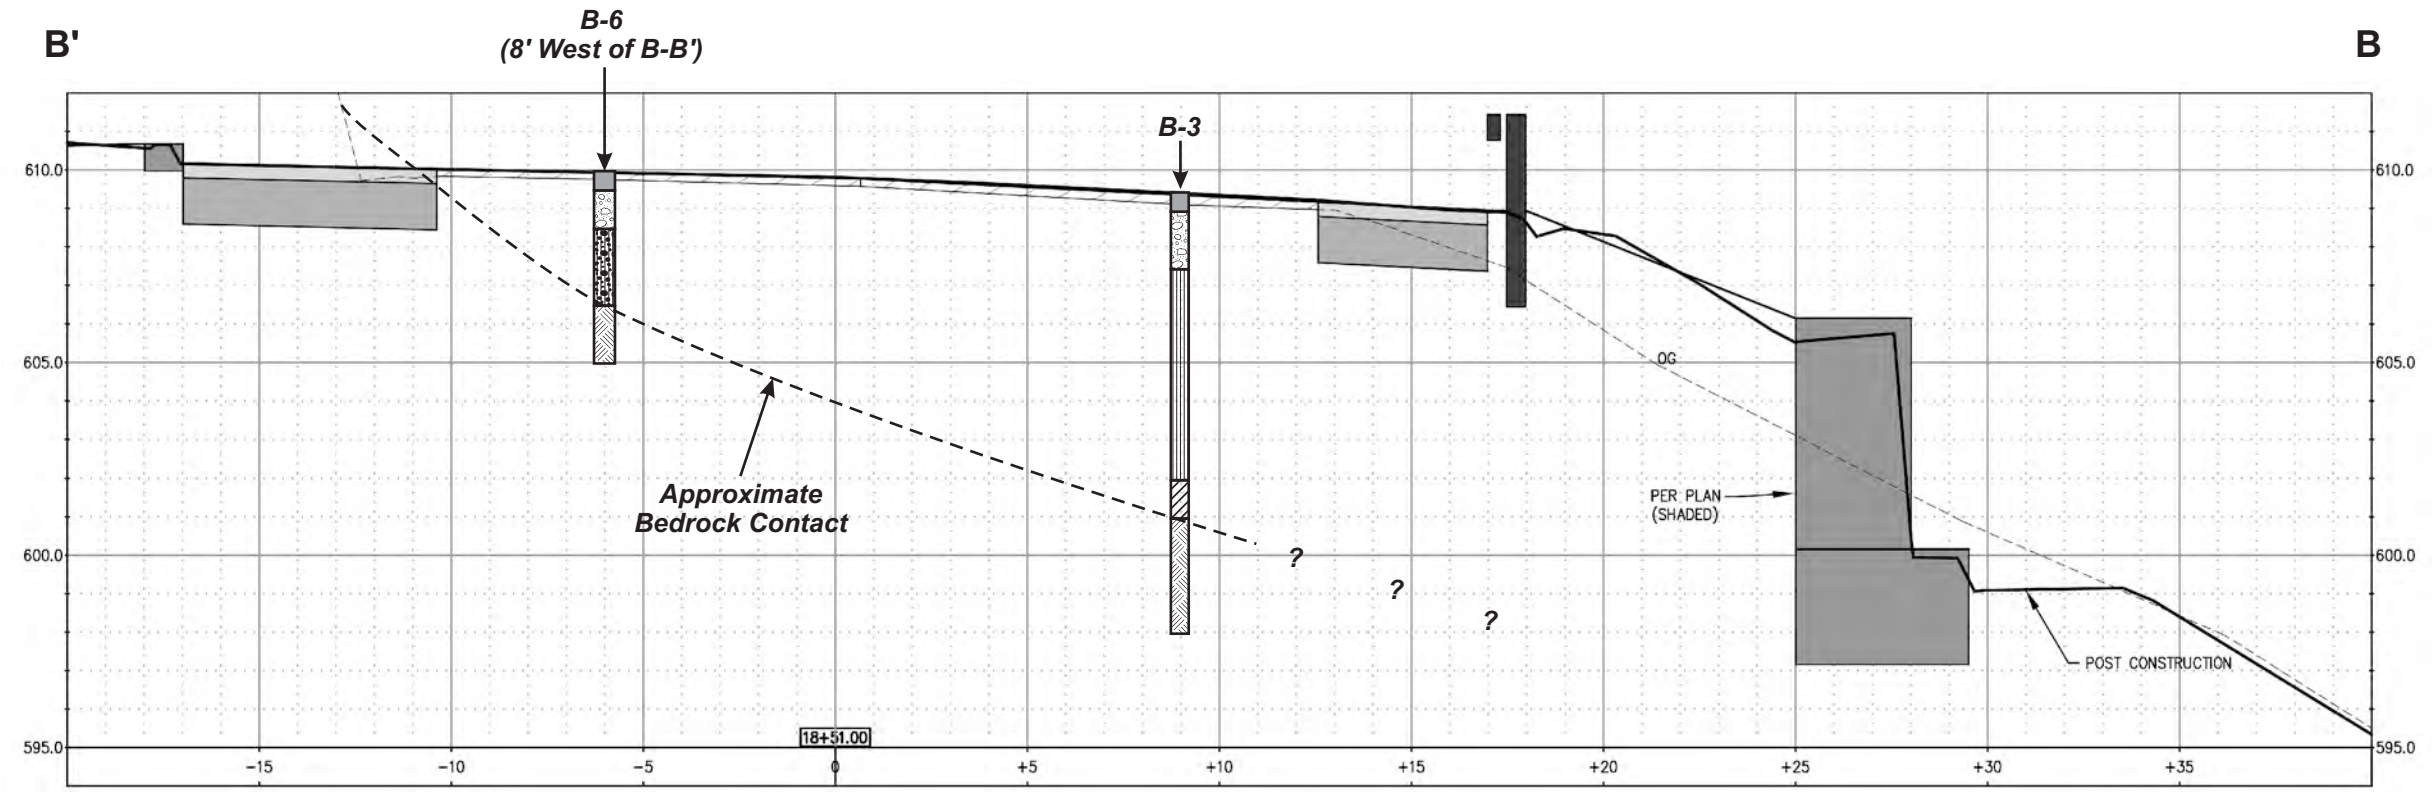
GEOTECHNICAL • ENVIRONMENTAL • MATERIALS TESTING	Project No.: E14145.000	CROSS-SECTIONS A-A' & B-B' Latrobe Road Remediation El Dorado Hills, California	FIGURE A-10
	June 2014

A more detailed description of the subsurface conditions encountered during our subsurface exploration is presented graphically on the "Exploratory Test Boring Logs", Figures A-2 through A-8, Appendix A. These logs show a graphic interpretation of the subsurface profile, and the location and depths at which samples were collected. Cross-sections of the subsurface soils encountered and the adjacent wall conditions are depicted on Figures A-10 and A-11.
