MATERIALS REPORT

US 50, Silva Valley Parkway Interchange, Phase 1

03-ED-50
PM 1.07/R2.40
EA 03-1E2901

March 2012

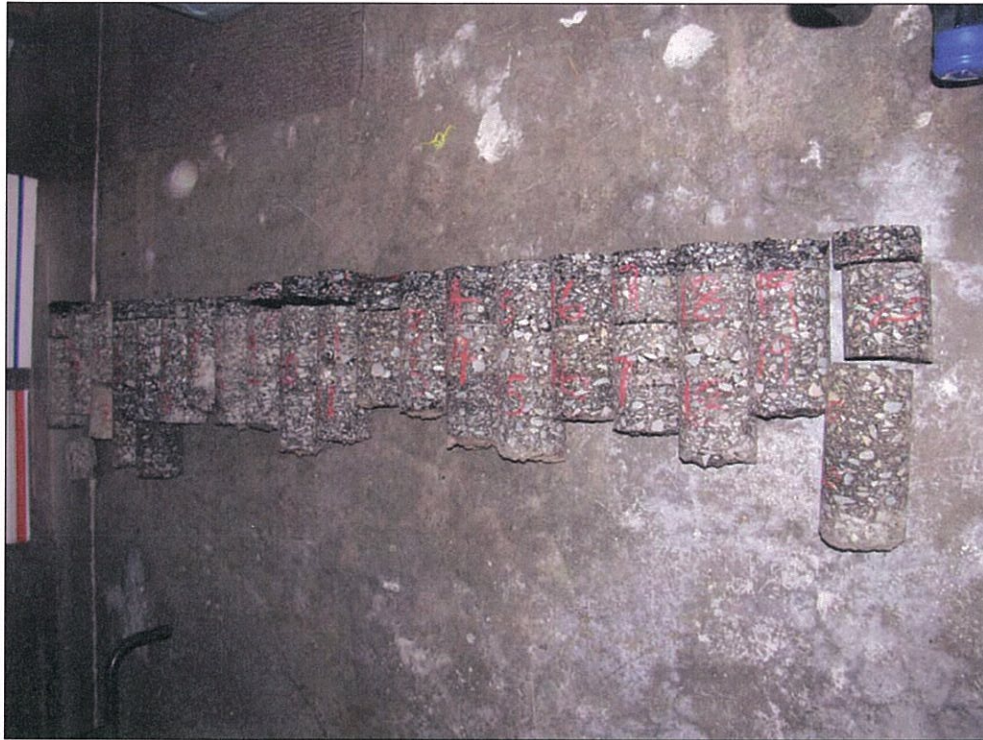
PHOTO 3

A total of 20 cores were extracted. All cores had an open gap graded AC for the top lift. Said lift was recently placed. Cores were taken at approximately 500 foot intervals.

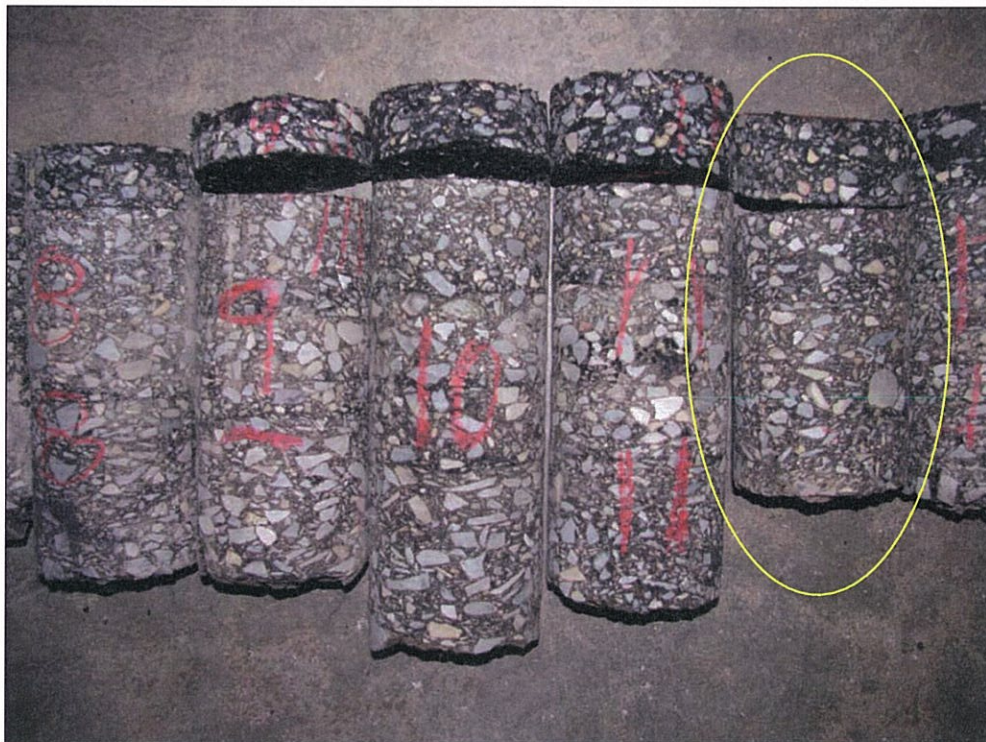
PHOTO 4

Core 12 (circled above) had the thinnest AC section. See core log for more details.

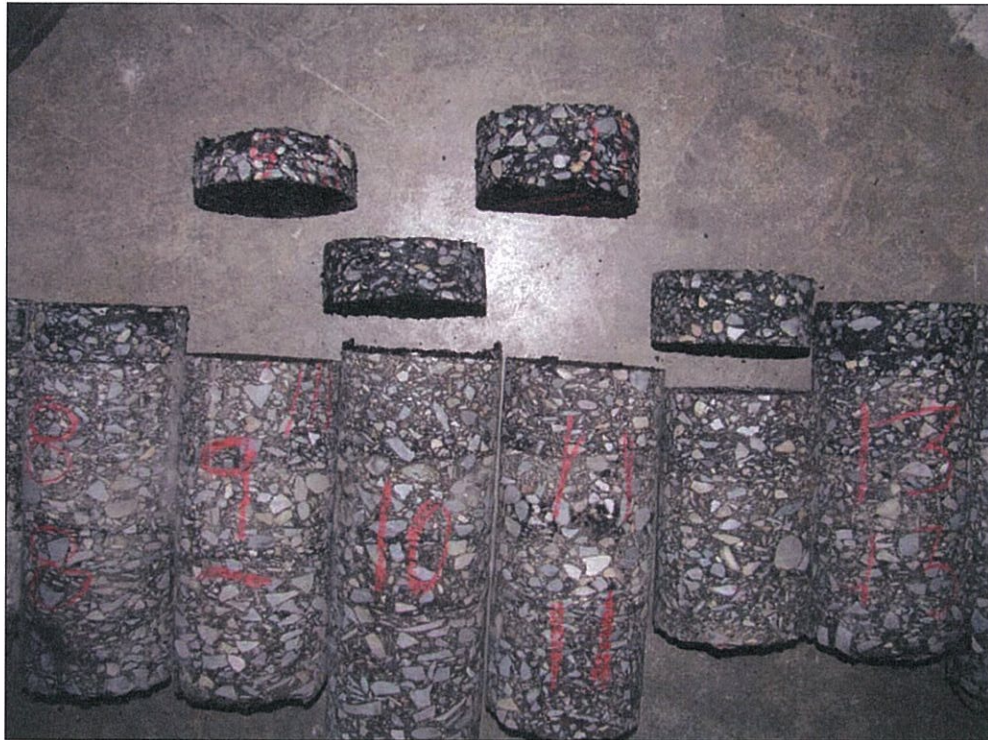
PHOTO 5

Due to its recent placement, the top lift of AC materials had a tendency to separate from the lower lifts during coring activities.

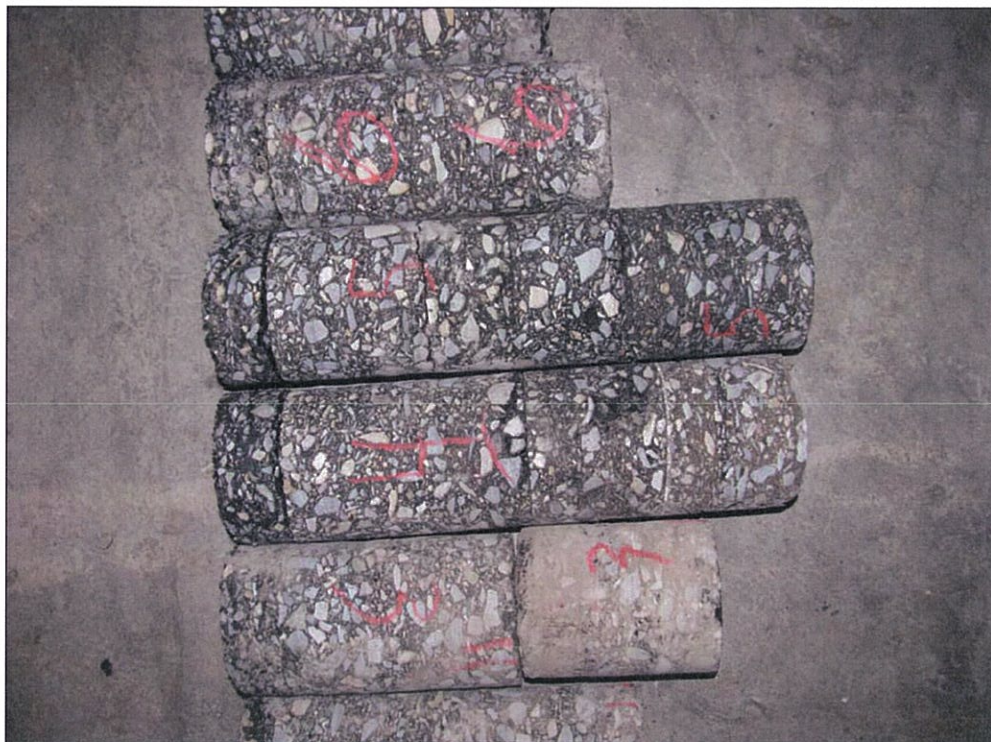
PHOTO 6

Extracted cores revealed up to seven distinct lifts of AC pavements.

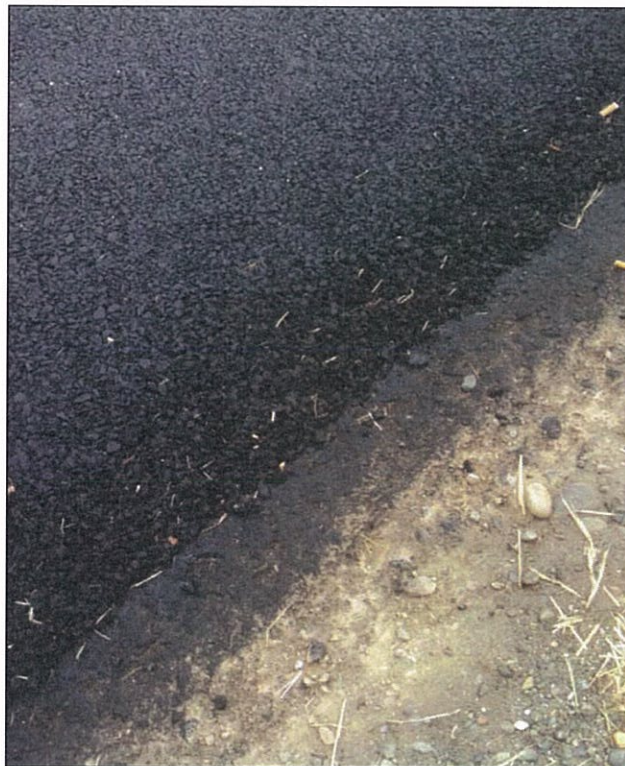
PHOTO 8

An up close shot reveals the nature of the open gap graded material.

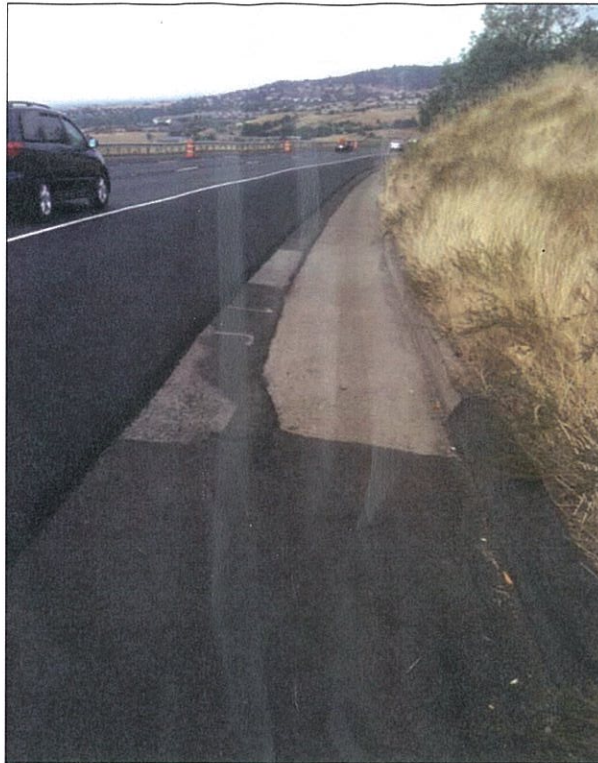
PHOTO 9

Facing westward, the tapered of a prior overlay are visible.

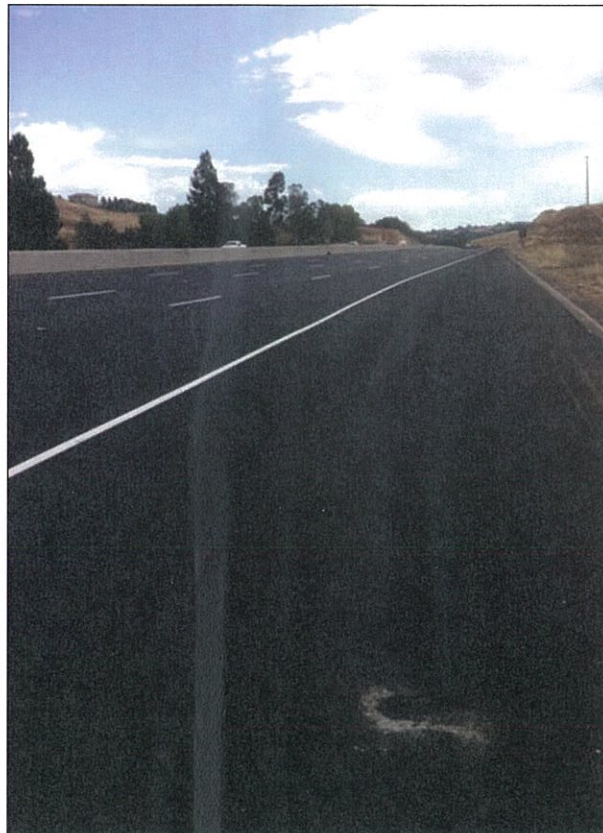
PHOTO 10

Note the core in the foreground. Coring was general done along the centerline of the existing shoulders.
