**Aerially Deposited Lead,
Naturally Occurring Asbestos
and Lead Containing Paint
Site Investigation
and Bridge Survey Report**

**Highway 50 Site Investigation
Post Mile 0.16 to 2.90
El Dorado County, California**

**GEOCON PROJECT NO. S9300-06-22
TASK ORDER NO. 22, CONTRACT NO. 03A1368**

MARCH 2008

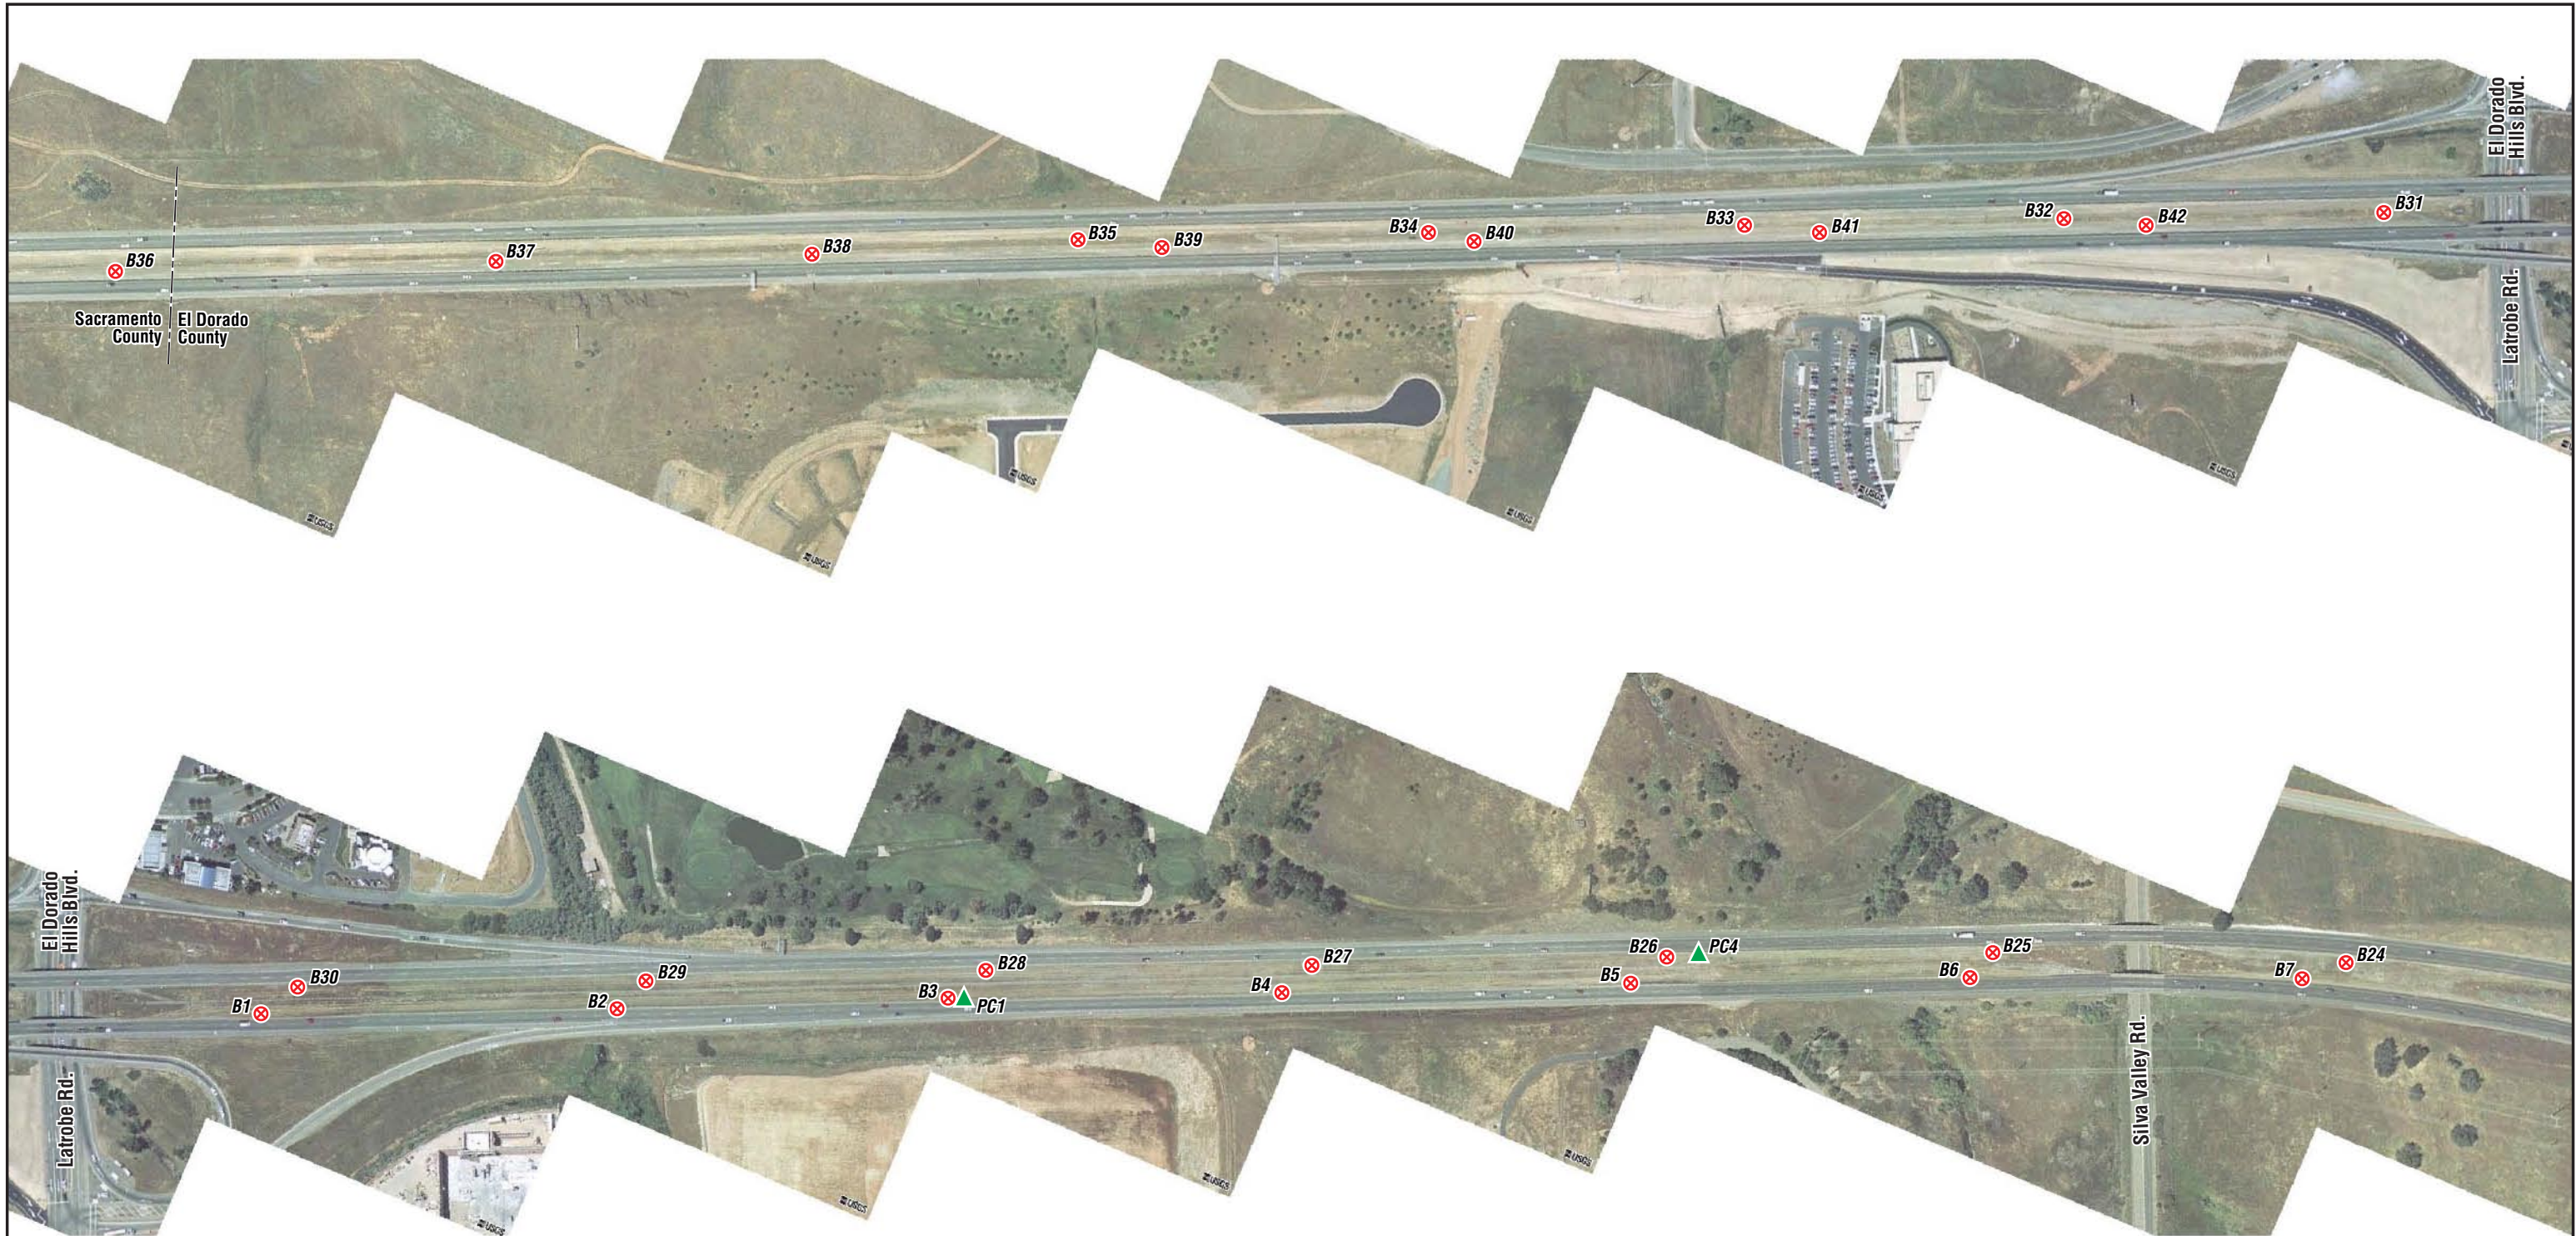
Figure 2-1

B1 ⊗ Approximate Naturally Occurring Asbestos & Aerially Deposited Lead Sample Location (Direct-Push)

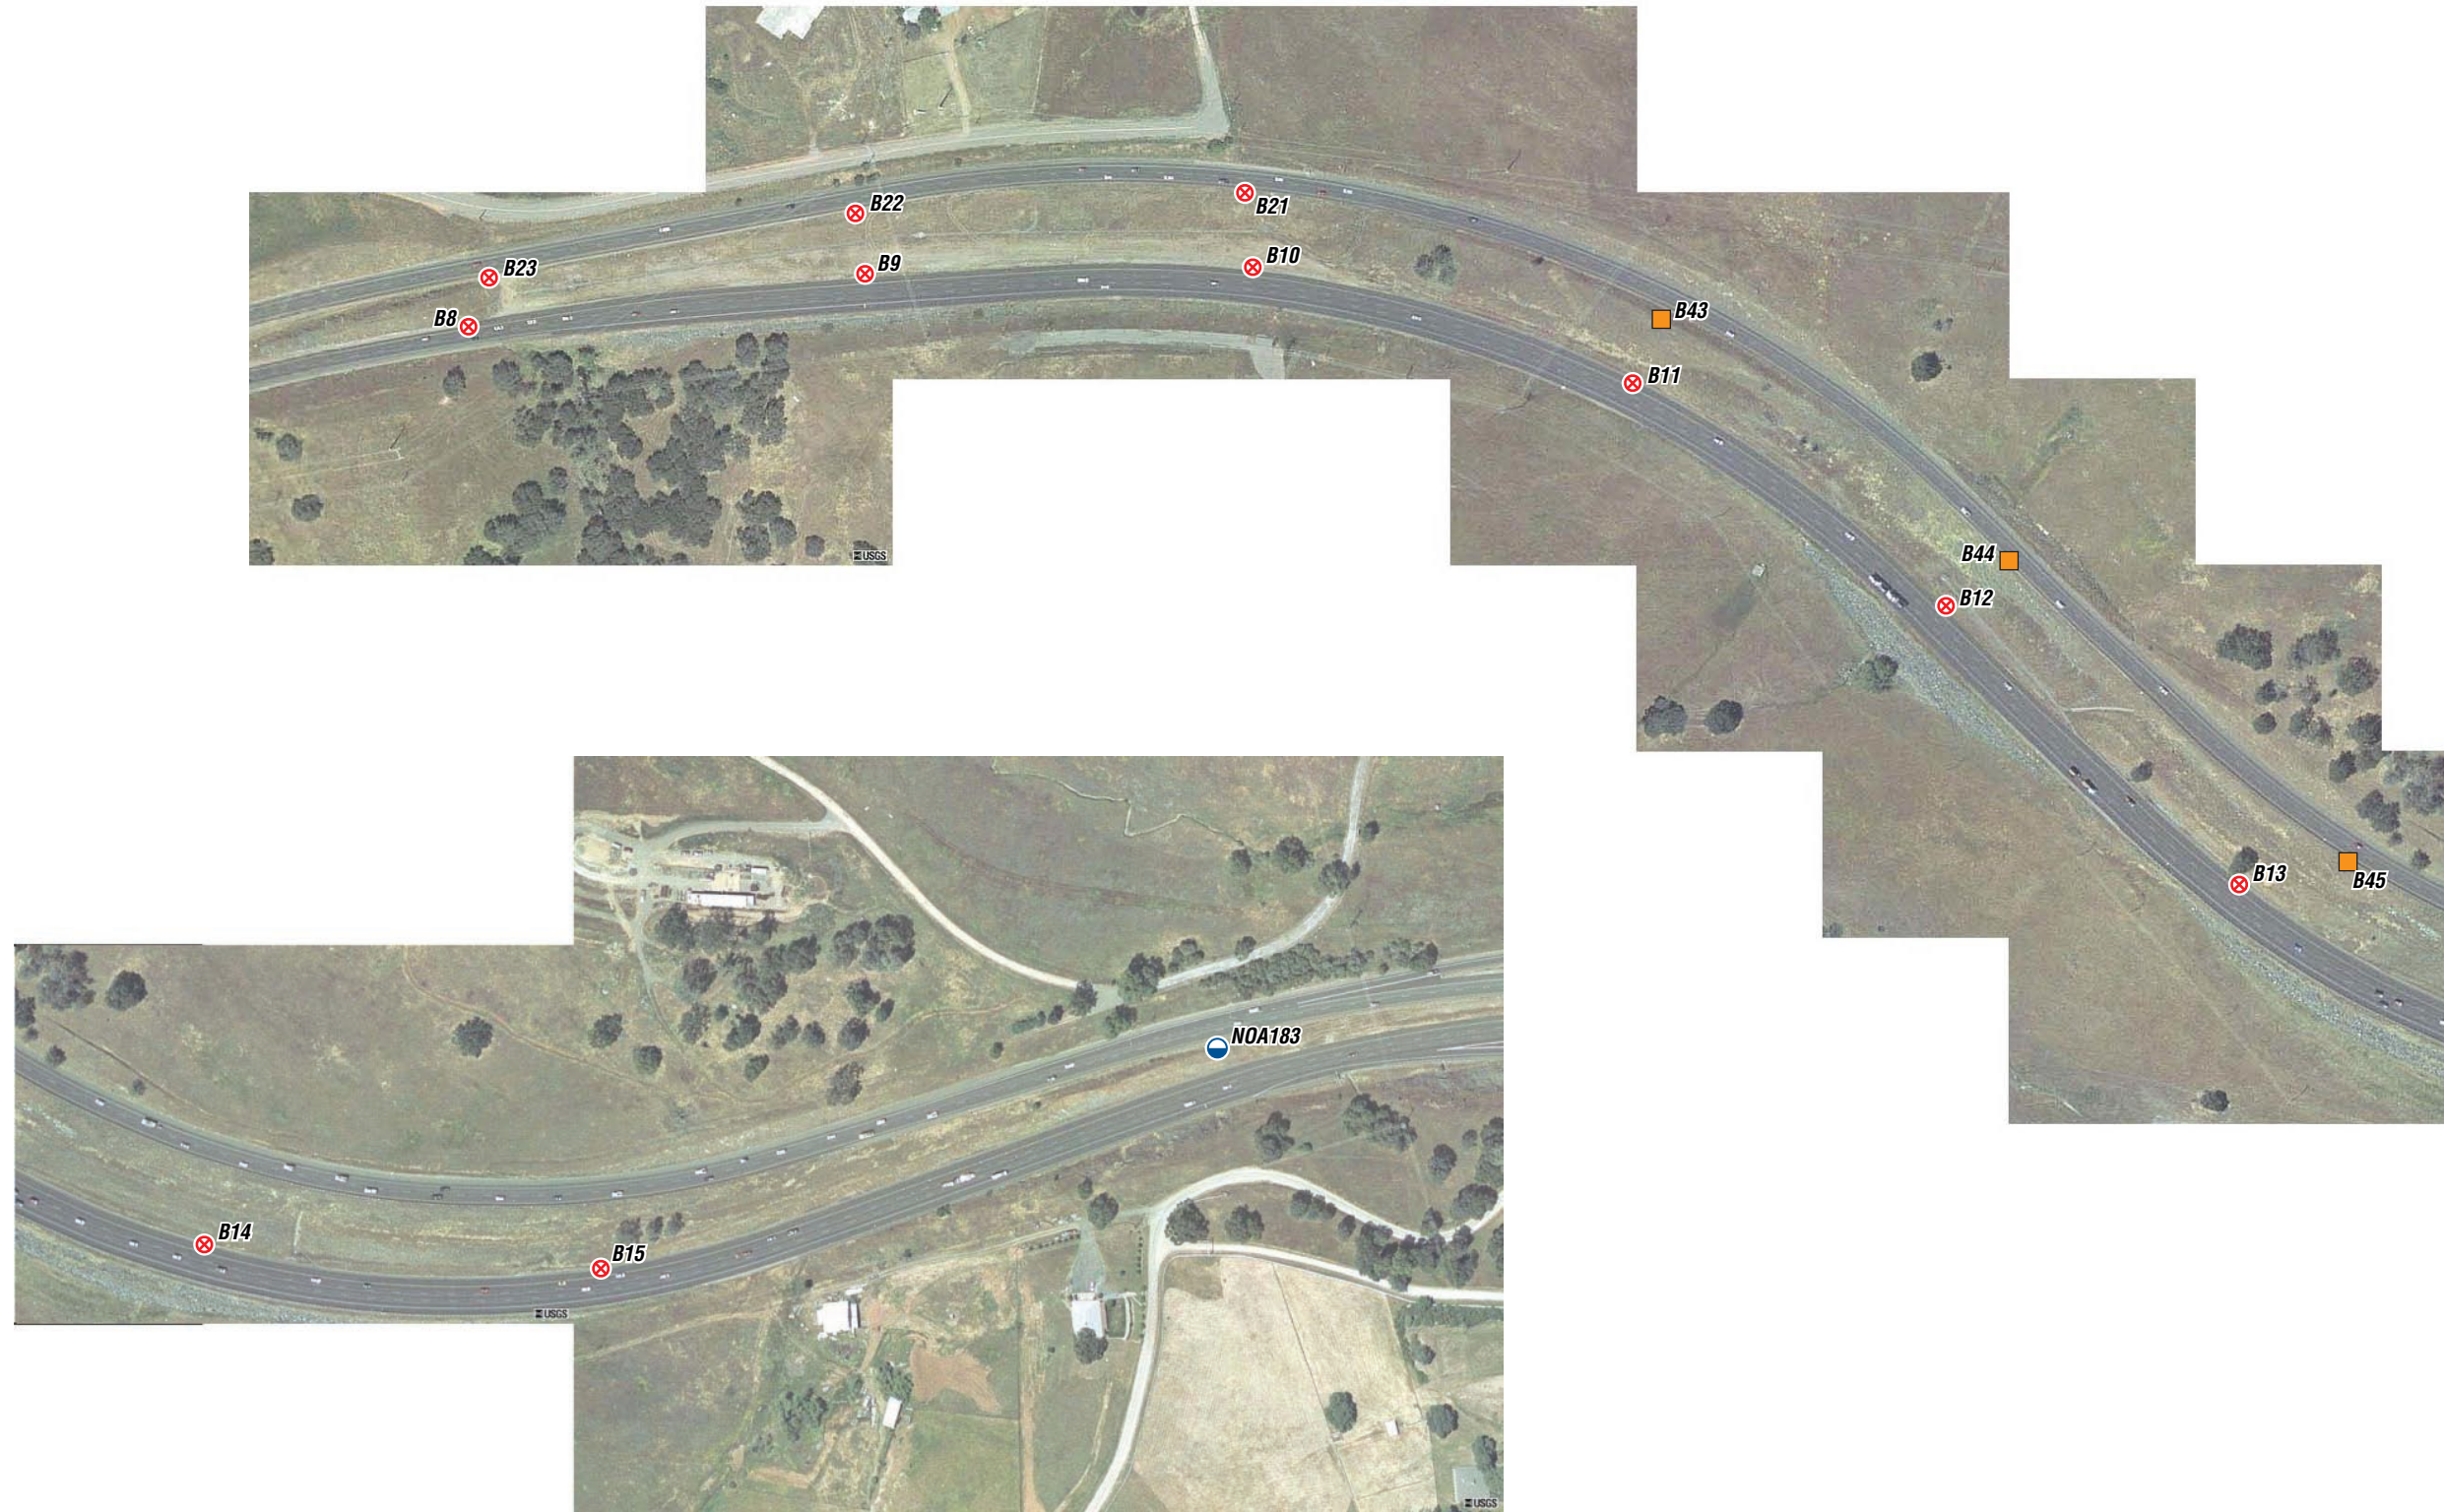
- B1** ⊗ Approximate Naturally Occurring Asbestos & Aerially Deposited Lead Sample Location (Direct-Push)
- B43** ◻ Approximate Naturally Occurring Asbestos & Aerially Deposited Lead Sample Location (Hand-Auger)
- PC4** ▲ Approximate Paint Chip Sample Location
- NOA183** ● Approximate Naturally Occurring Asbestos Rock Chip Sample Location

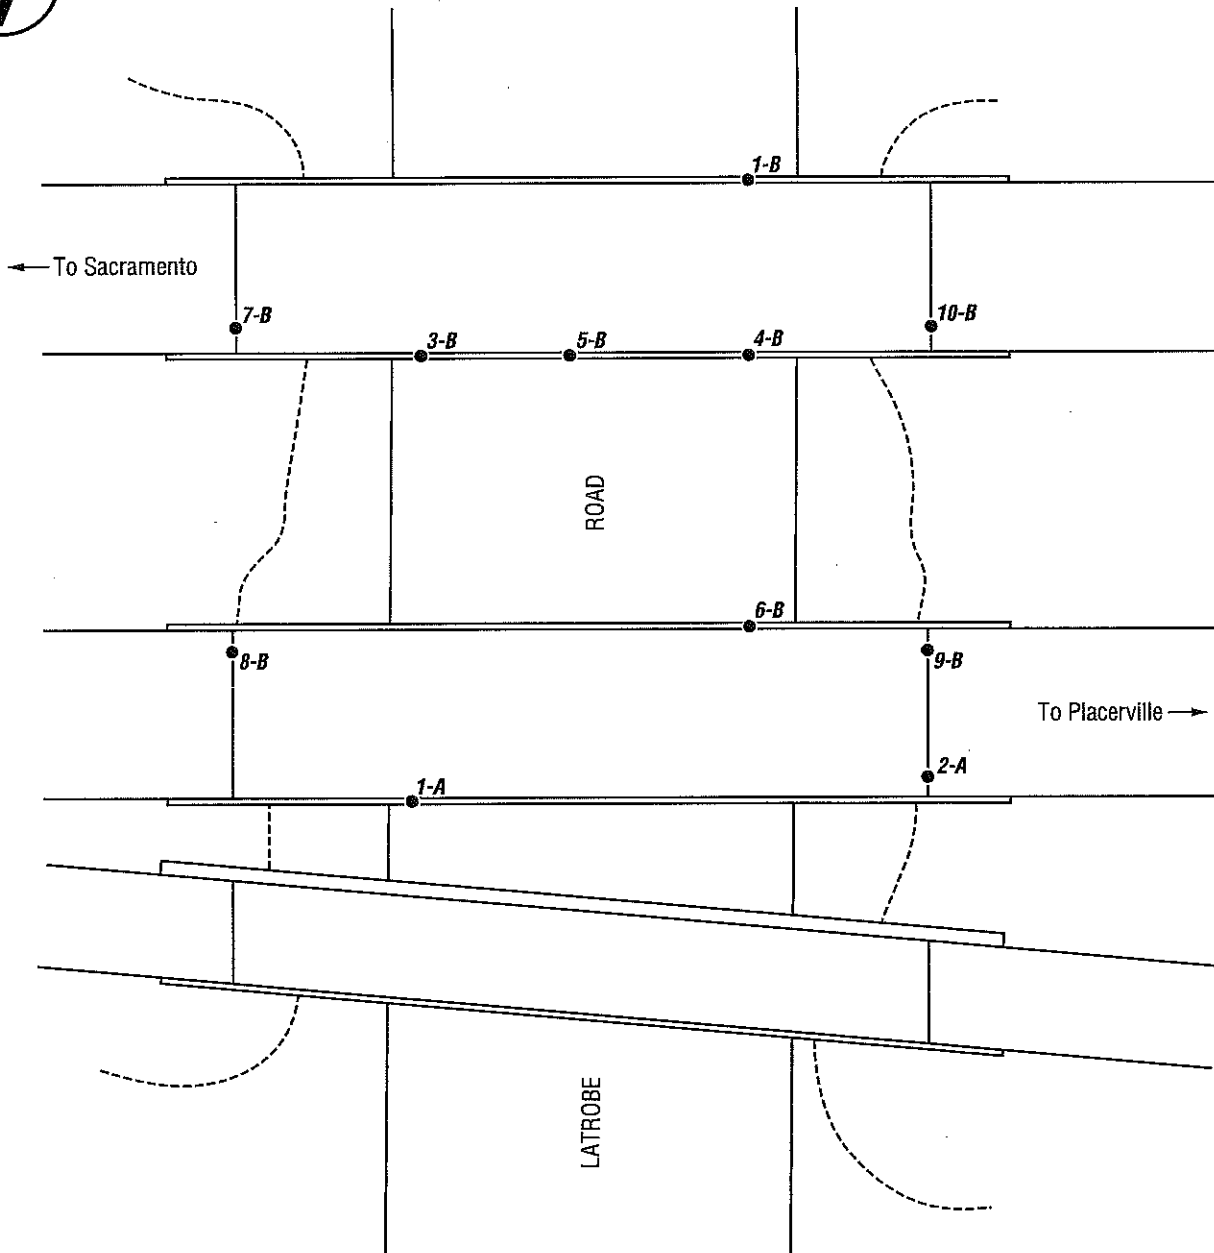
Figure 2

Forty-one (at least 10 from each bridge) material samples were obtained from the bridge structures on December 3, 6 and 7, 1999. The samples were obtained from the joint seals, joint filler material and guardrail bearing-pad shims using a core drill. Painted bridge components were not observed during the bridge surveys and therefore paint chip samples were not obtained. QA/QC procedures were provided during the asbestos survey activities including providing chain-of-custody documentation for each sample transferred to the laboratory. The approximate sample locations are depicted on the attached Site Plans, Figures 2 through 5.

1-B ● Approximate Sample Location

The existing guardrail bearing-pad shims at the Latrobe Road UC, Clarksville Road UC, Bass Lake Road UC and Cameron Park UC, will require removal and disposal by a licensed and certified asbestos abatement contractor in conjunction with the planned bridge renovation work. In addition, sheet packing observed at the Cameron Park UC will also require abatement. For preliminary planning purposes only, the asbestos content, ACM present condition, estimated quantity and approximate abatement costs for each bridge are shown below.

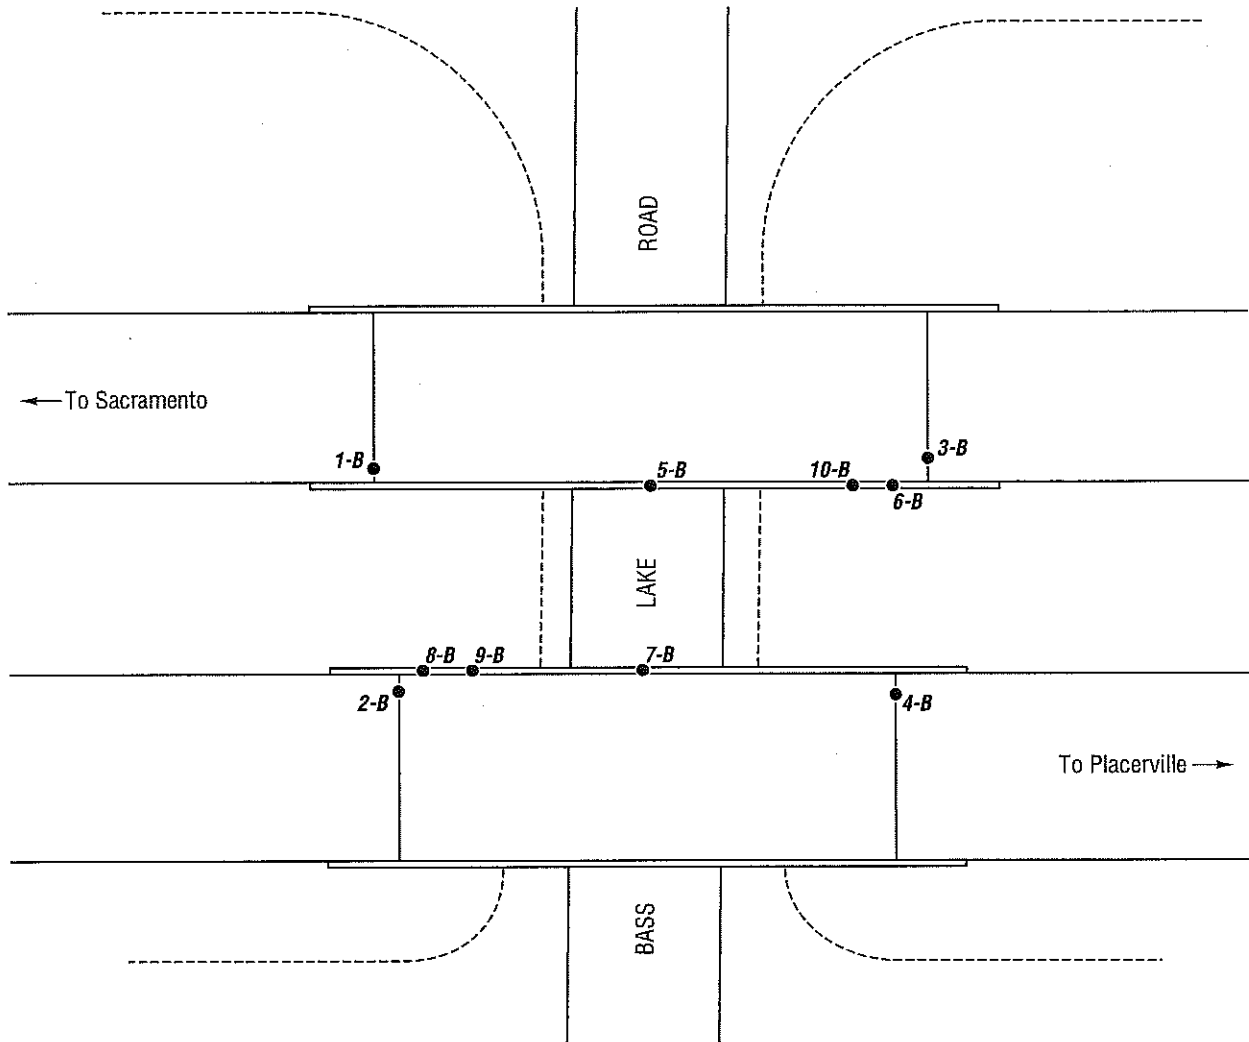
Figure 4

5-B ● Approximate Sample Location

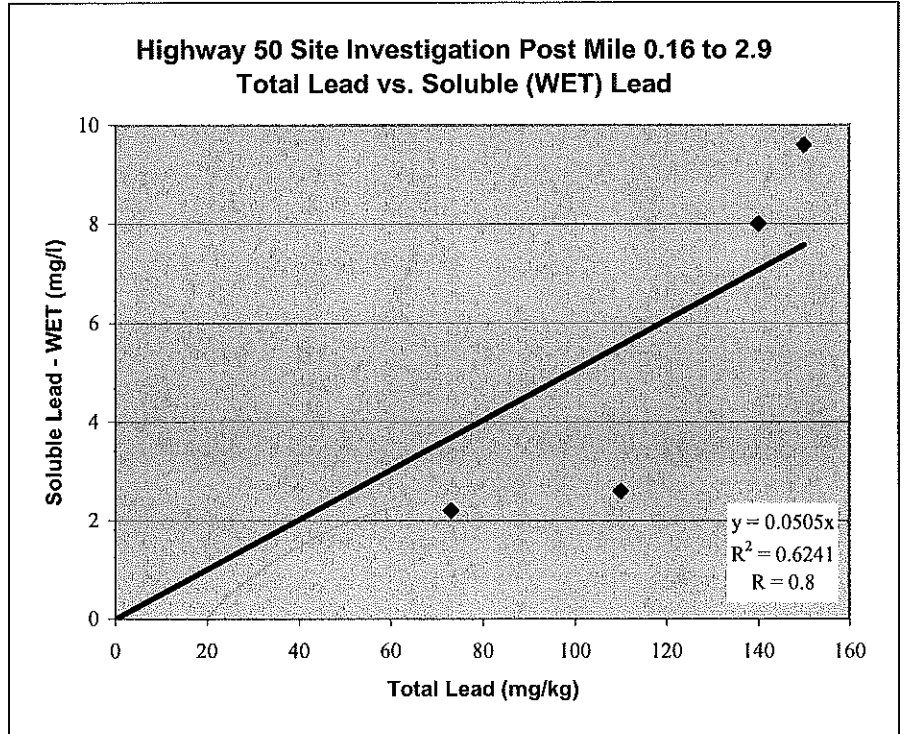
Sample ID	Total Lead	WET Lead
B10,12,14-0	73	2.2
B1,3,5,7-0	110	2.6
B43,44,45-0	140	8.0
B12,14-2	150	9.6

**Highway 50 Site Investigation Post Mile 0.16 to 2.9
Total Lead vs. Soluble (WET) Lead**
