FOUNDATION REPORT

US 50, Silva Valley Parkway Overcrossing

Bridge No. 25-0127

April 2012

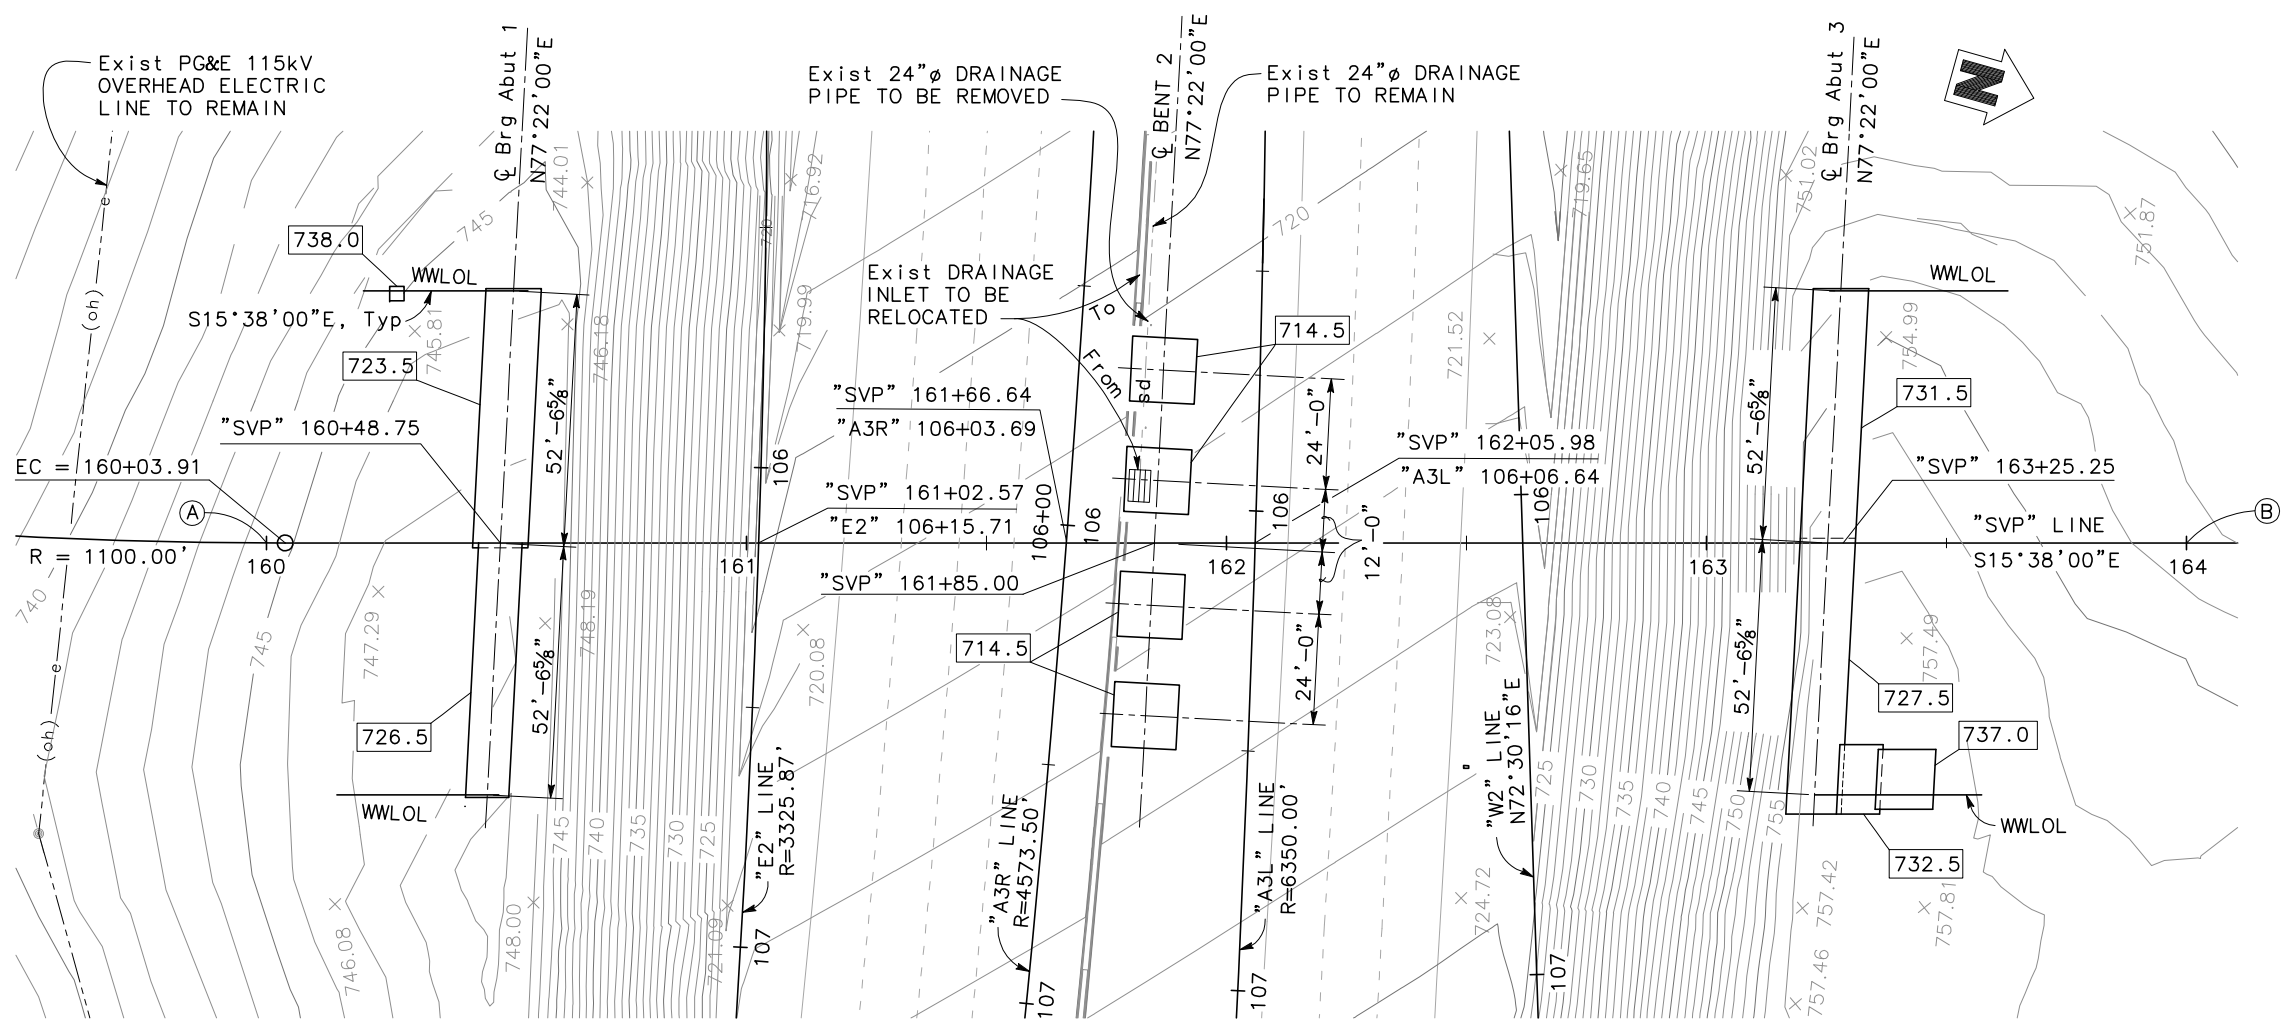
PLAN
1" = 20'

The General Plan and Foundation Plan prepared by MTCO (see Appendix B) shows the overcrossing structure supported with a four-column bent at mid-span. Foundations will consist of spread footings, 9 to 11.5 feet wide, at Abutments 1 and 3, and four, 13.5x13.5 feet, spread footings at Bent 2 that are spaced at 24 feet center-to-center.

The General Plan and Foundation Plan for the project is in Appendix B. The following summarizes the proposed foundation design, as provided by MTCO:

- The foundation for Abutments 1 and 3 consist of spread footings. The footings are 9 to 11.5 feet wide, 106 feet long at Abutment 1, 109 feet long at Abutment 3, and 2.5 feet thick. The design requires a maximum contact pressure of approximately 4 kips per square foot (ksf).
- At Bent 2, MTCO proposes four columns, each with an individual spread footing. The footings are 13.5 feet square, 3.5 feet thick, with edges approximately 10.5 feet apart (24 feet on-center). The design requires a maximum contact pressure of approximately 21 ksf.
