Photo Monitoring:

Rubicon Trail El Dorado County Site Assessment April 9, 2014

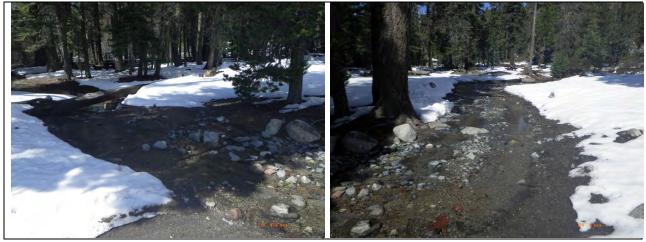
Wentworth Springs Campground RT Station 33+65.67

Water Depths: 0.1', 0.2', 0.2' (Average: 0.17')

Notes: The Rock Ditch Crossing (RDX) was exposed with snow melt run-off flowing across the RDX.

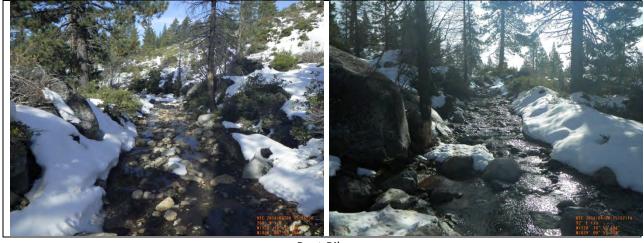
Post Pile RT Station 75+00

Water Depths: 0.3', 0.3', 0.5' (Average: 0.37')

Notes: The Rock Ditch Crossing (RDX) was observed and was functioning as designed. Snow melt run-off was observed flowing down the hardened surface of the Trail.

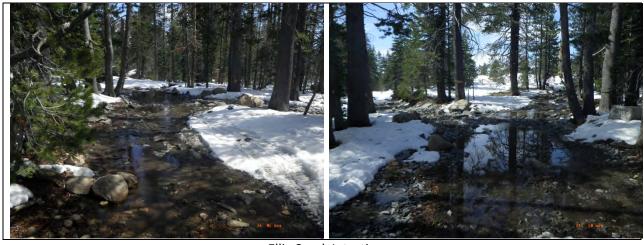
Ellis Creek Intertie RT Station 99+86.95

Water Depths: 0.2', 0.2', 0.4' (Average: 0.27')

Notes: The Rock Lined Channel (RLC) was exposed with snow melt run-off flowing in the RLC. The water was properly draining towards the Rock Energy Dissipator (RED) which was not covered with snow and functioning as designed.

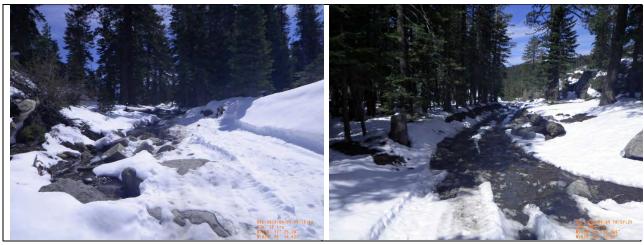
Walker Hill RT Station 170+80

Water Depths: 0.2', 0.3', 0.4' (Average: 0.30')

Notes: The Rock Slope Protection (RSP) was not fully exposed on both sides of the Trail. There was snow melt run-off flowing down the hardened surface of the Trail, which discharges into a Rock Energy Dissipator.

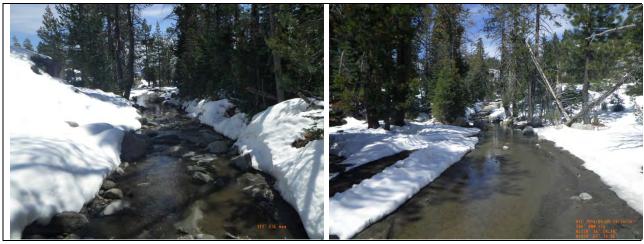
Soup Bowl RT Station 198+40.84

Water Depth: 0.3', 0.6', 0.6' (Average: 0.5')

Notes: The Rock Ditch Crossing (RDX) was exposed through the snow with snow melt run-off flowing through it.
