# Rubicon Trail Site Assessment

## March 27, 2024

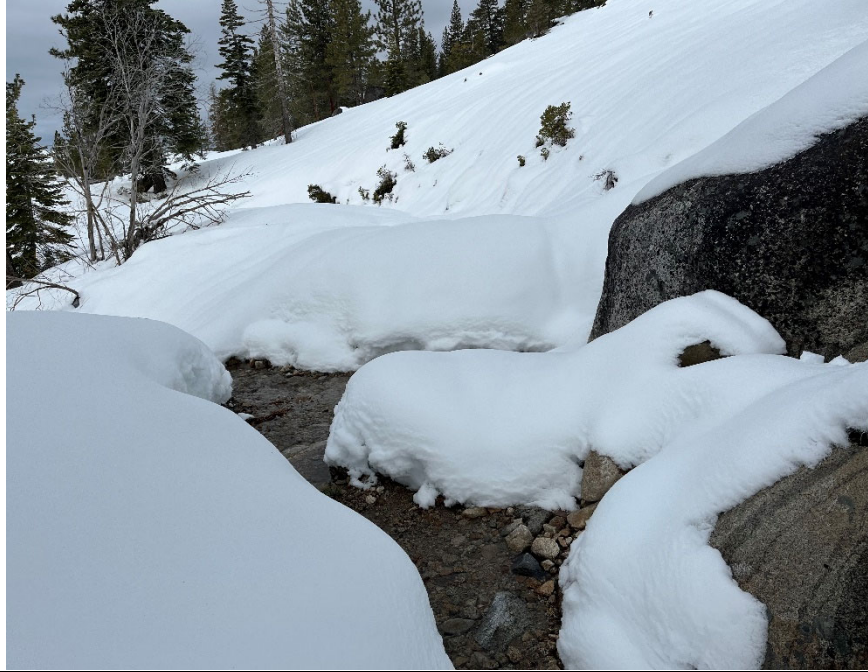
**Post Pile**

RT Station 68+00

Water Depths:	<b>1</b>	<b>2</b>	<b>2</b>
---------------	----------	----------	----------

Notes:	<b>Trail features starting to show</b>
--------	--

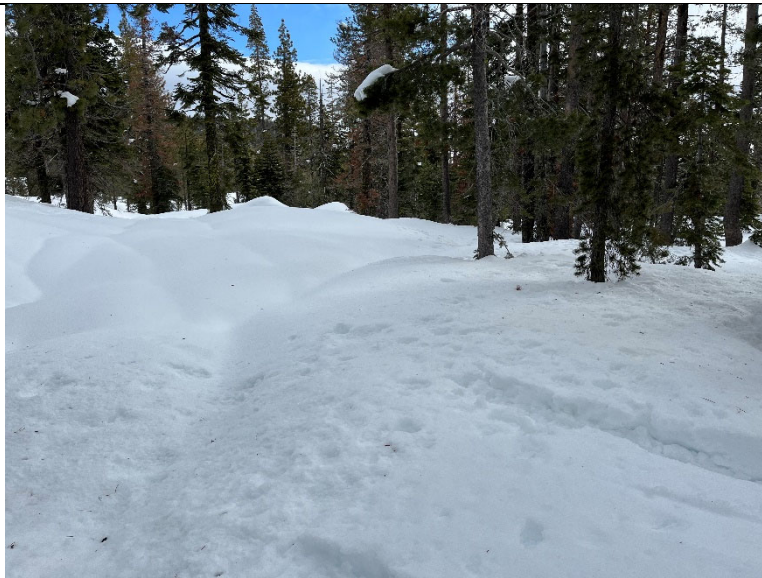
**Intertie**

RT Station 115+00

Water Depths:	<b>0</b>	<b>0</b>	<b>0</b>
---------------	----------	----------	----------

Notes:	<b>Intertie covered in snow.</b>
--------	----------------------------------
