County of El Dorado

NPDES Trash Report - Tahoe Basin

2024 Trash Report

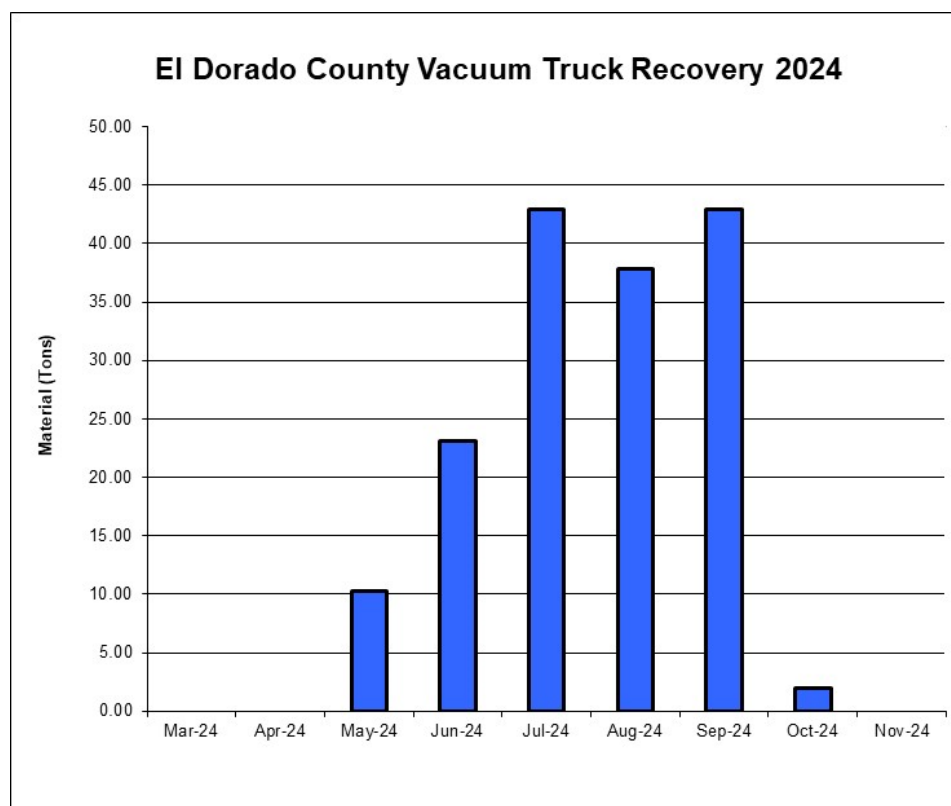
The vacuum truck is a critical piece of equipment for removing material in storm drain systems including trash. In 2024, the County inspected thousands of structures, pipes, conveyances, treatment systems. The County maintained approximately **129** structures, **30** conveyances, **62** pipes and 5 treatment systems, recovering an estimated **123 yards** or **158 tons** of sediment and material from structures, pipes and conveyances (Appendix D). This included all vector work and maintenance of BMPs, but did not include sweeping. The types of BMPs inspected/maintained included sand/sediment traps, vaults, drop inlets, conveyance swales, sediment basins, rock lined channels, conveyance pipes and flow lines.

Date	\$ / lb	lbs / hour	Total Material (yards)	Total Material (tons)	Total Hours (Vactor)	Date	Operator Cost (Vactor)	Vactor Cost	Refuse Fees	Total Monthly Vactor Cost
Mar-24	\$ -	0	0	0.00	0	Mar-24	\$ -	\$ -	\$ -	\$ -
Apr-24	\$ -	0	0	0.00	0	Apr-24	\$ -	\$ -	\$ -	\$ -
May-24	\$ 0.27	1140	8	10.26	18	May-24	\$ 1,778	\$ 1,278	\$ 2,544	\$ 5,600
Jun-24	\$ 0.30	1026	18	23.09	45	Jun-24	\$ 4,445	\$ 3,195	\$ 6,265	\$ 13,905
Jul-24	\$ 0.32	953	33	41.68	88	Jul-24	\$ 8,643	\$ 6,213	\$ 12,065	\$ 26,921
Aug-24	\$ 0.23	1376	30	37.83	55	Aug-24	\$ 5,433	\$ 3,905	\$ 8,011	\$ 17,349
Sep-24	\$ 0.20	1591	34	42.96	54	Sep-24	\$ 5,334	\$ 3,834	\$ 8,079	\$ 17,247
Oct-24	\$ 0.55	550	2	1.92	7	Oct-24	\$ 691	\$ 497	\$ 913	\$ 2,102
Nov-24	\$ -	\$ -	0	0.00	0	Nov-24	\$ -	\$ -	\$ -	\$ -
	\$ / lb	lbs / hour		Total Material (tons)						
Average Annual	\$ 0.21	737								
Total Annual			123	158	267	Total Annual	\$ 26,325	\$ 18,922	\$ 37,877	\$ 83,124

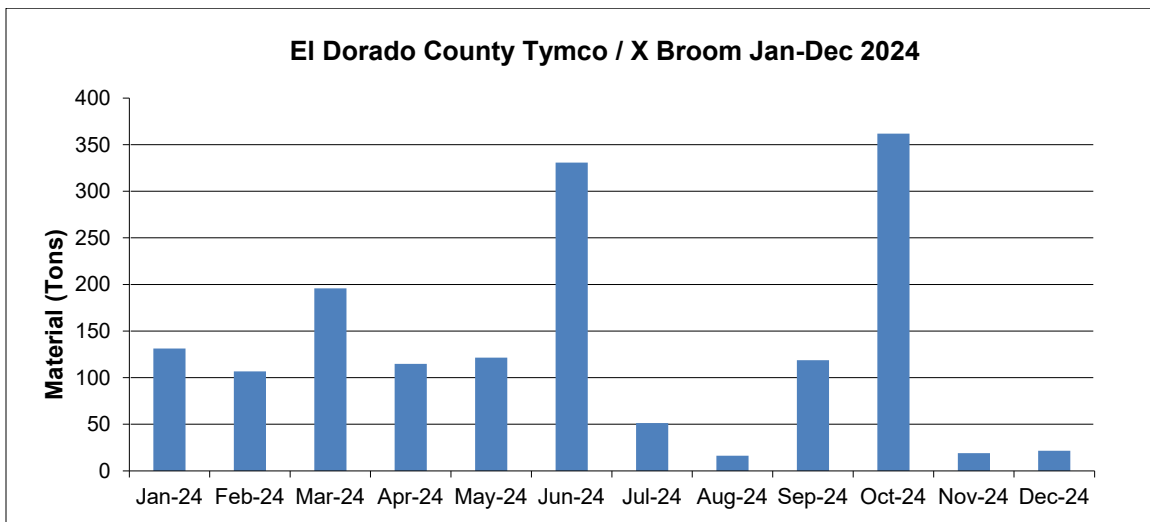
Monthly Sweeper Data

times. The County also dedicates significant resources to road repairs during late summer months, which can also hinder sweeping efforts. Nonetheless, in 2024 the County recovered 1589 tons of material with its sweeping program, recovering approximately 4421 lbs/hour with an operational efficiency of \$0.06/lb. These are some of the largest recovery amounts on record indicating the County's commitment to ensuing targeted and efficient sweeper operations and skilled equipment maintenance. The operational and efficiency data from the sweepers for calendar year 2024 are included below.

Tymco / X Broom					Tymco / X Broom					
Date	\$ / lb	lbs / hour	Total Material (tons)	Total Man Hours (Sweeper)	Date	Operator Cost (Sweeper)	Sweeper Cost	South Tahoe Refuse	Total Monthly Sweeper Cost	Miles Swept
Jan-24	\$0.03	6106	131	43	Jan-24	\$3,767.23	\$3,053.00	\$2,025.30	\$8,845.53	359
Feb-24	\$0.03	7618	107	28	Feb-24	\$2,453.08	\$1,988.00	\$1,318.80	\$5,759.88	248
Mar-24	\$0.03	6525	196	60	Mar-24	\$5,256.60	\$4,260.00	\$2,826.00	\$12,342.60	445
Apr-24	\$0.03	6652	115	35	Apr-24	\$3,022.55	\$2,449.50	\$1,624.95	\$7,097.00	198
May-24	\$0.07	2859	122	85	May-24	\$7,446.85	\$6,035.00	\$4,003.50	\$17,485.35	581
Jun-24	\$0.04	5168	331	128	Jun-24	\$11,214.08	\$9,088.00	\$6,028.80	\$26,330.88	817
Jul-24	\$0.07	2931	51	35	Jul-24	\$3,066.35	\$2,485.00	\$1,648.50	\$7,199.85	197
Aug-24	\$0.16	1296	16	25	Aug-24	\$2,190.25	\$1,775.00	\$1,177.50	\$5,142.75	192
Sep-24	\$0.05	4168	119	57	Sep-24	\$4,993.77	\$4,047.00	\$2,684.70	\$11,725.47	386

Oct-24	\$0.04	4668	362	155	Oct-24	\$13,579.55	\$11,005.00	\$7,300.50	\$31,885.05	814
Nov-24	\$0.09	2363	19	16	Nov-24	\$1,401.76	\$1,136.00	\$753.60	\$3,291.36	129
Dec-24	\$0.08	2700	22	16	Dec-24	\$1,401.76	\$1,136.00	\$753.60	\$3,291.36	140
	\$ / lb	lbs / hour	Total Material (tons)							
Average Annual	\$0.06	4421								
Total Annual			1589	683	Total Annual	\$59,793.83	\$48,457.50	\$32,145.75	\$140,397.08	4506
Average Monthly			132	57		\$4,982.82	\$4,038.13	\$2,678.81	\$11,699.76	376
			Jan-May 2024 tot mat. Tons							
			670							
			Jun-Dec 2024 tot mat. Tons							
			919

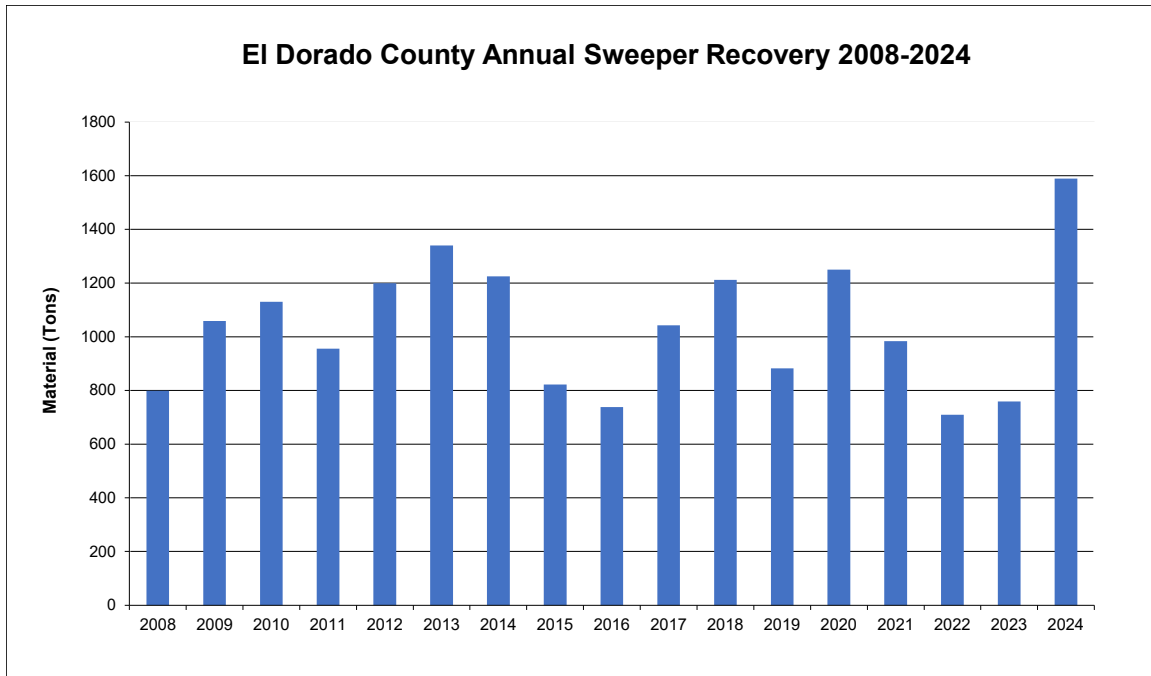
Street Sweeper Material Recovery		
	Cubic yards (yd^3)	Tons
2008	623	799
2009	826	1059
2010	882	1131
2011	745	955
2012	936	1200
2013	1045	1340
2014	955	1225
2015	641	822
2016	575	738
2017	813	1043
2018	945	1212
2019	688	882
2020	975	1250
2021	767	984
2022	554	710
2023	563	759
2024	1177	1589
