MATERIALS REPORT

US 50, Silva Valley Parkway Interchange, Phase 1

03-ED-50
PM 1.07/R2.40
EA 03-1E2901

March 2012

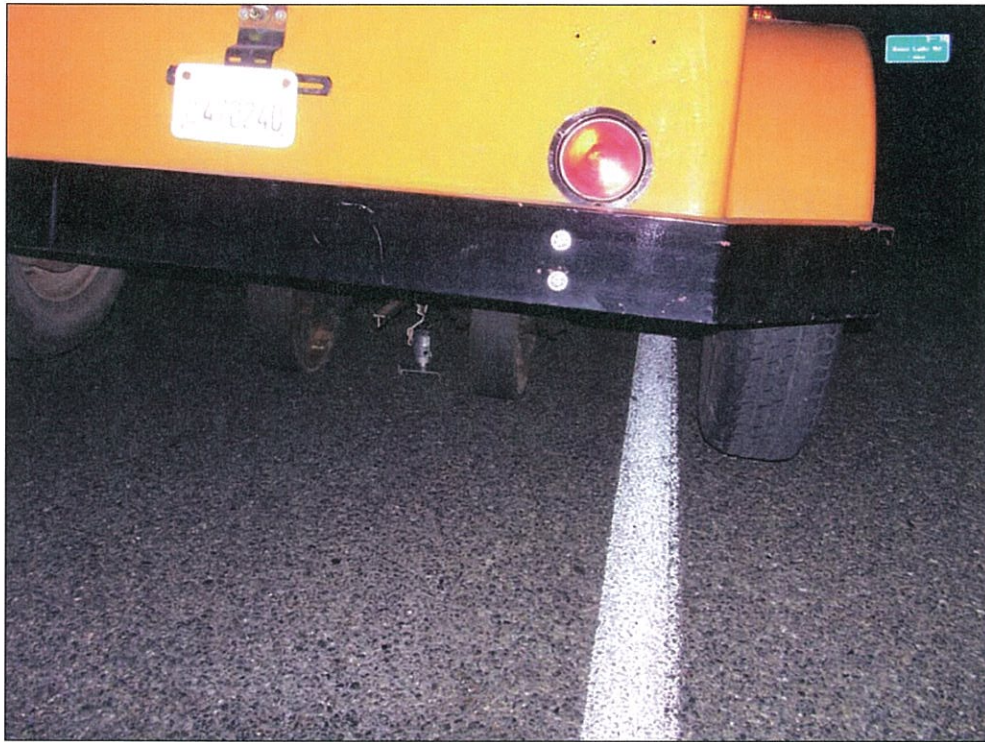
PHOTO 1

Pictured above is DYNAFLECT deflection device, in action, in the E2 lane of Highway 50. (Circa 2007.) Notice the surface is comprised of DGAC. (Included for historical reference.)

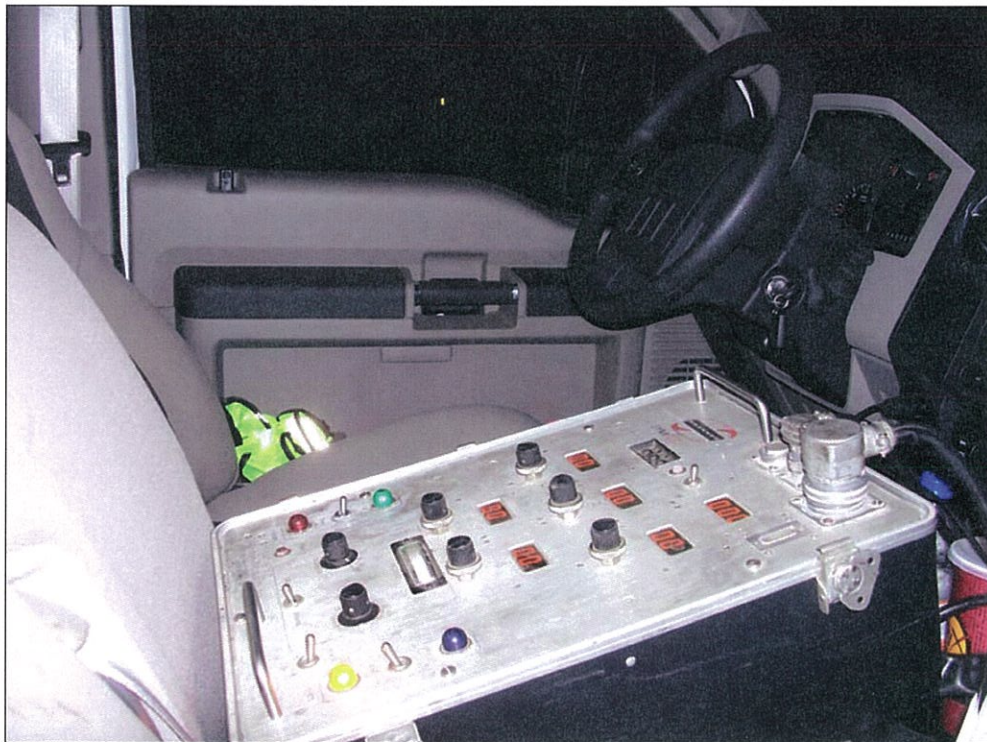
PHOTO 2

Pictured above is the "Control Box" for the DYNAFLECT deflection device as oriented in the tow vehicle. This pictures was taken along the same subject section of Highway 50 in 2007.

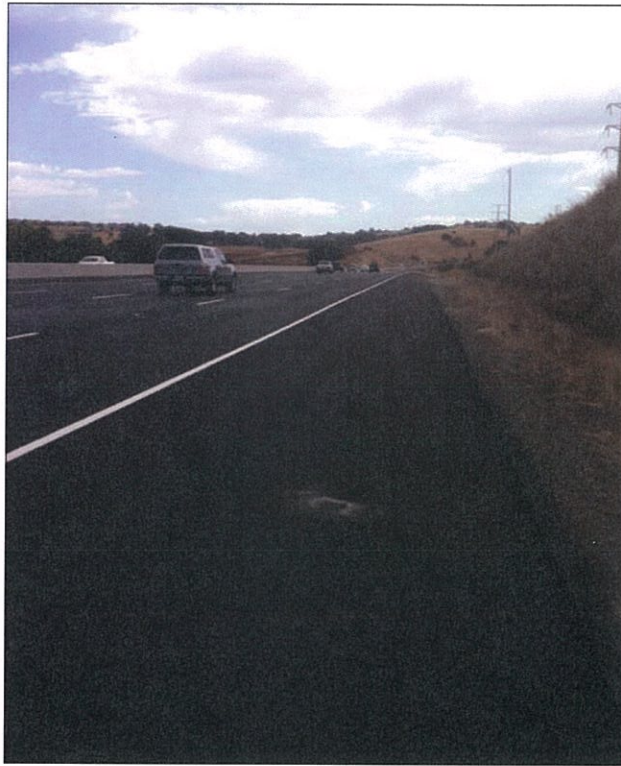
PHOTO 7

Facing eastward, the freshly rehabilitated highway makes for a good photo.
