Project No. E14145.000
9 July 2014

Subject: **LATROBE ROAD REMEDIATION**
El Dorado County, California

Youngdahl Consulting Group, Inc. is pleased to present this report presenting the results of our forensic assessment for a portion of Latrobe Road where slope instability and retaining wall movement was identified. The purpose of this study was to evaluate the probable causes of the instability observed and prepare recommendations for mitigation. The scope of our study included a review of the existing gabion wall design prepared by the County of El Dorado, review of photos and documentation prepared during the wall construction operations, provide an opinion as to potential causes of the instability, and provide recommendations for slope and retaining wall repair.

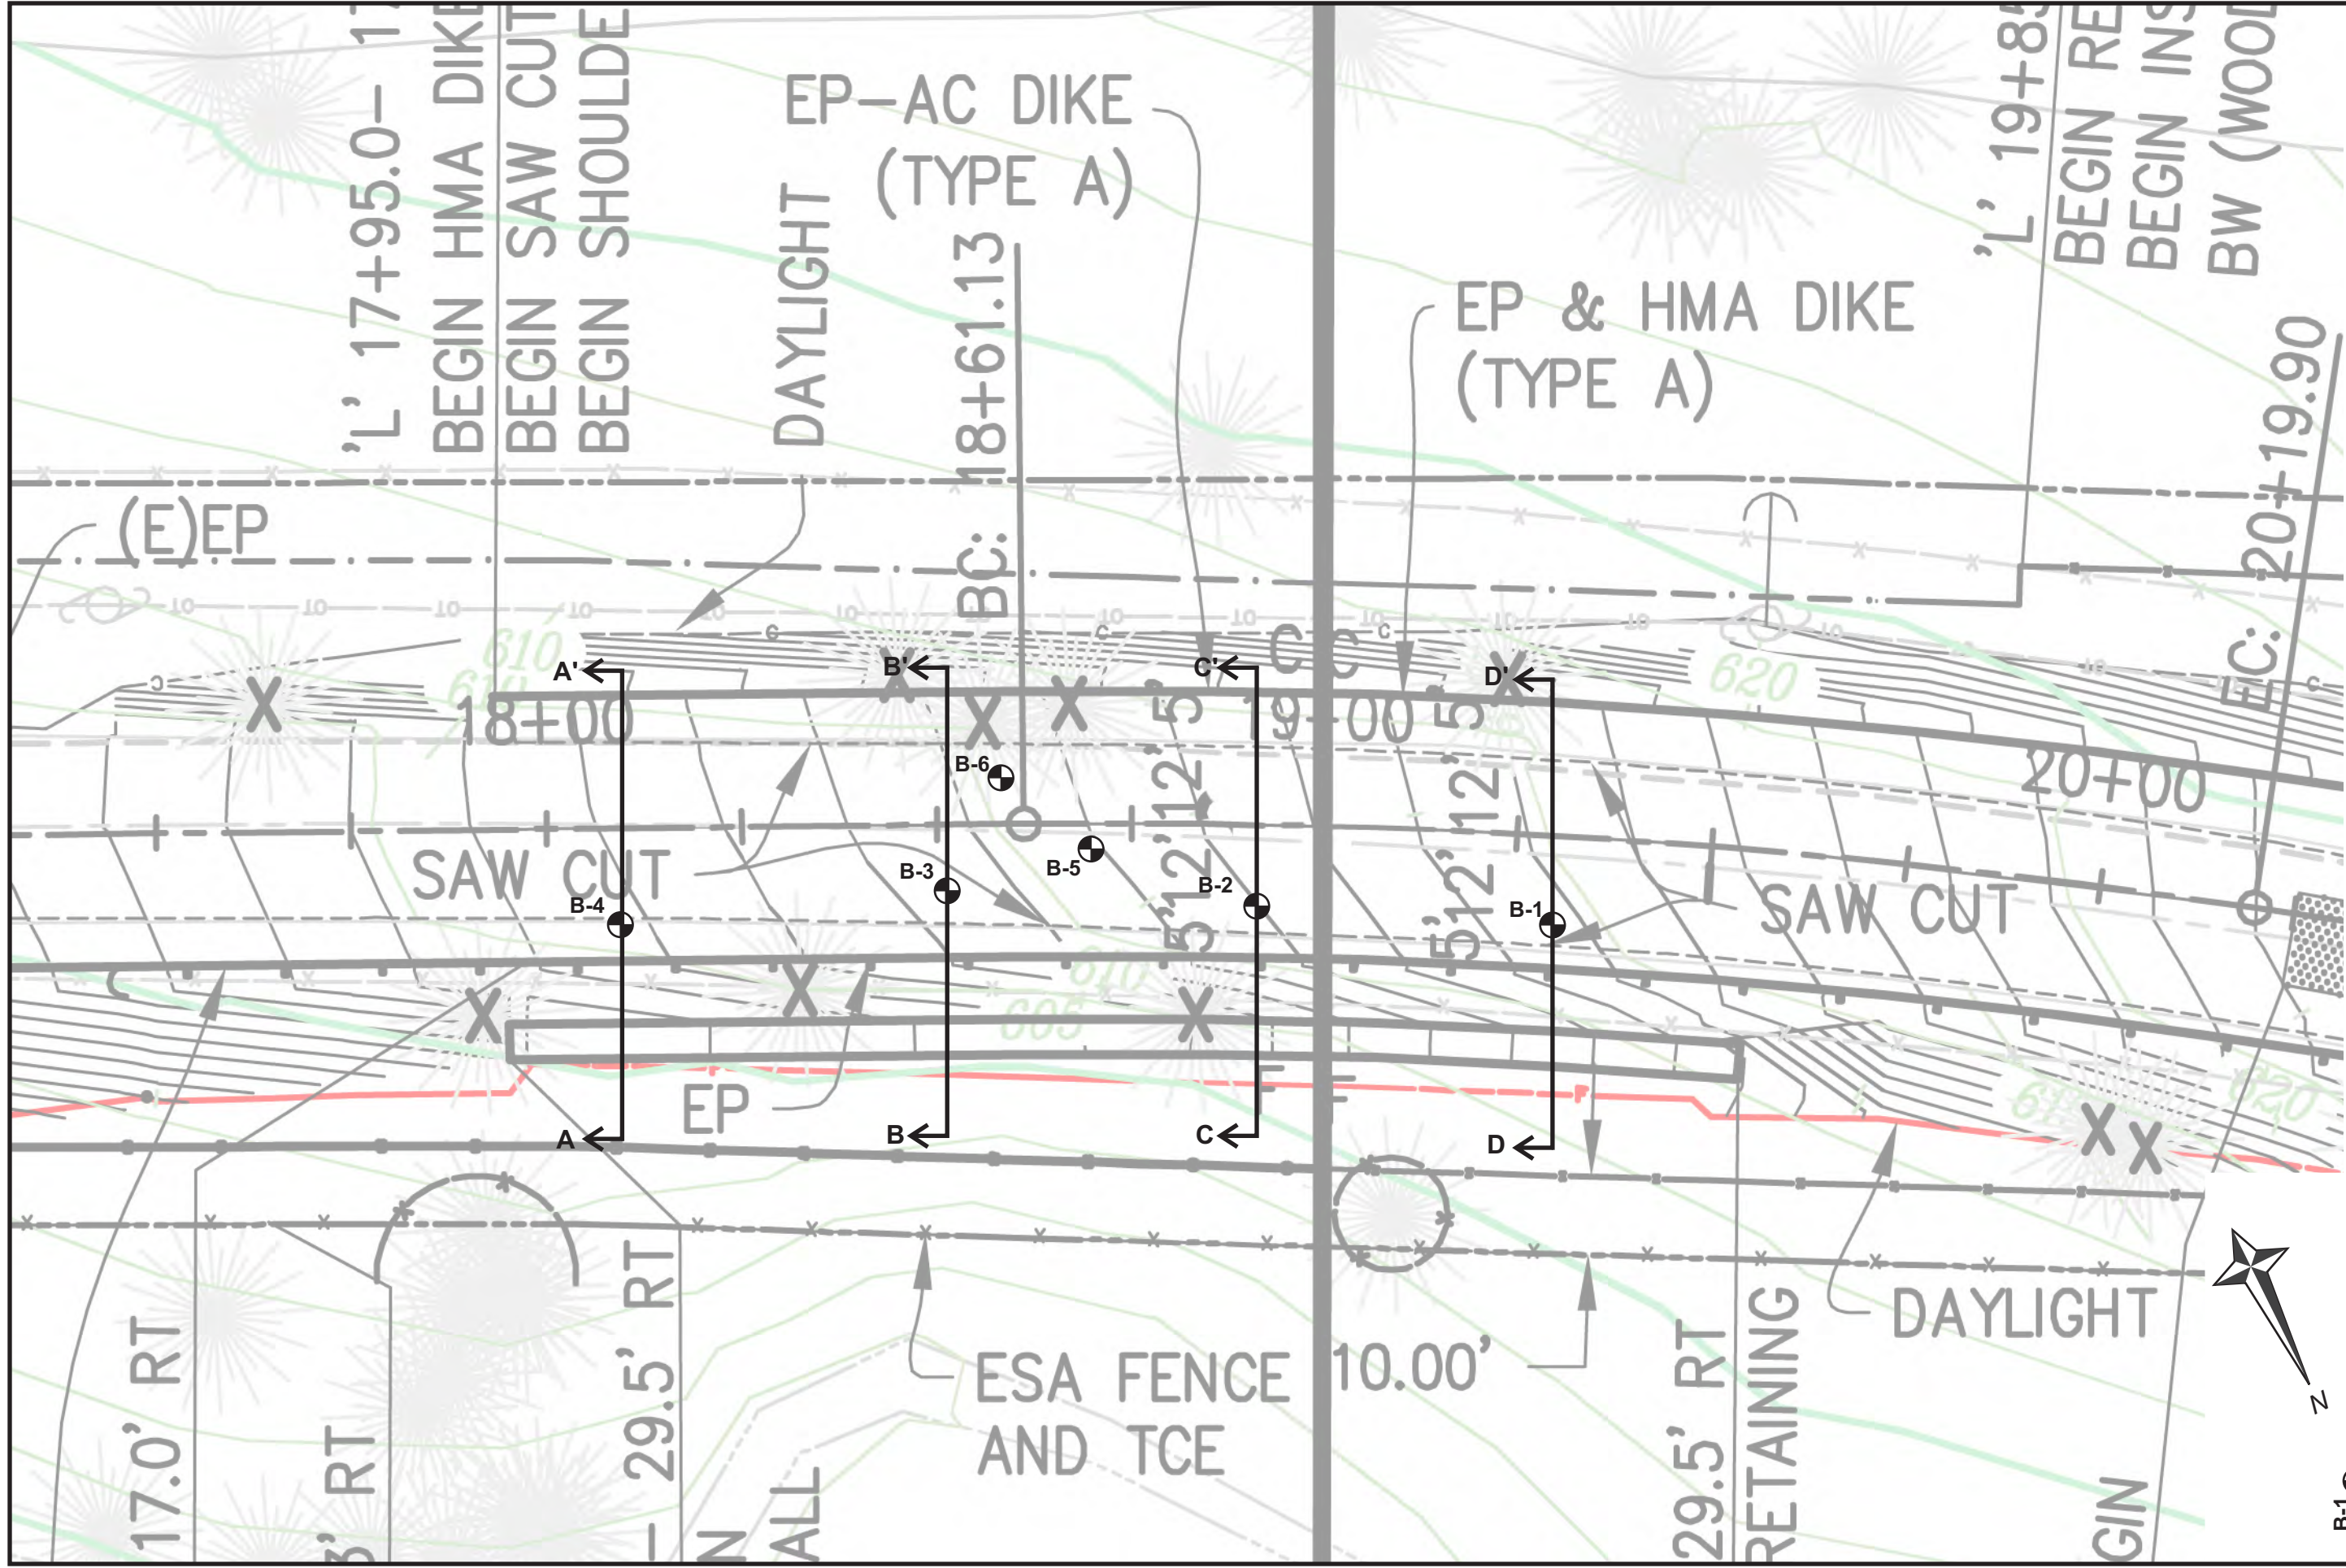
<p>YOUNGDAHL CONSULTING GROUP, INC. GEOTECHNICAL • ENVIRONMENTAL • MATERIALS TESTING</p>	Project No.: E14145.000	SITE PLAN Latrobe Road Remediation El Dorado Hills, California	FIGURE A-2
	June 2014

REFERENCE: Latrobe Road North Of Ryan Ranch Road, El Dorado County Department Of Transportation Sheet L-1, Dated 3/22/13
