FOUNDATION AND ROADWAY STUDY

New York Creek Pedestrian Bridge and
New York Creek Trail East
Tam O'Shanter Drive to Silva Valley Parkway
El Dorado County, California

2009-0071-2

April 30, 2012

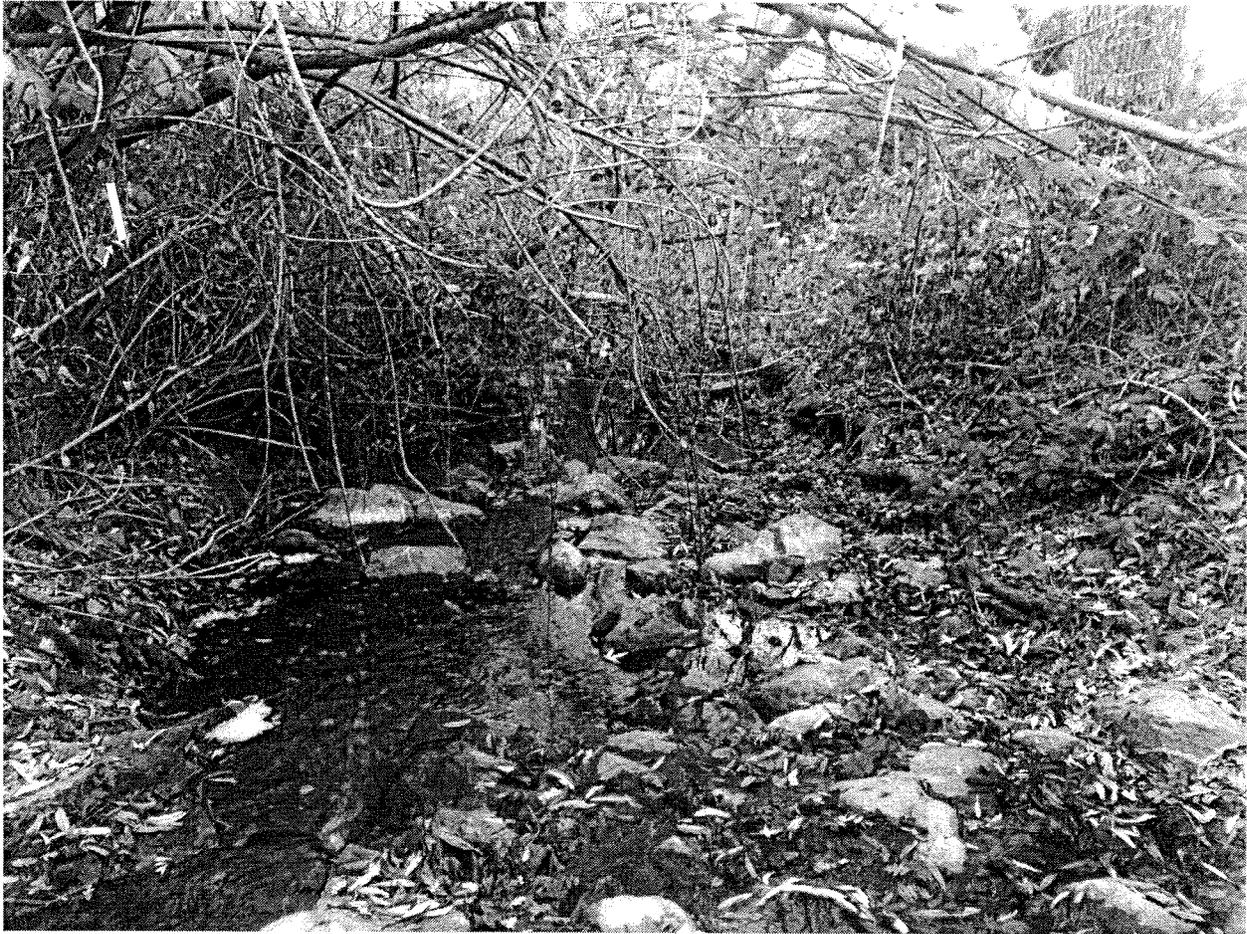
January 3, 2012: Looking North, downstream, along New York Creek near the proposed alignment.

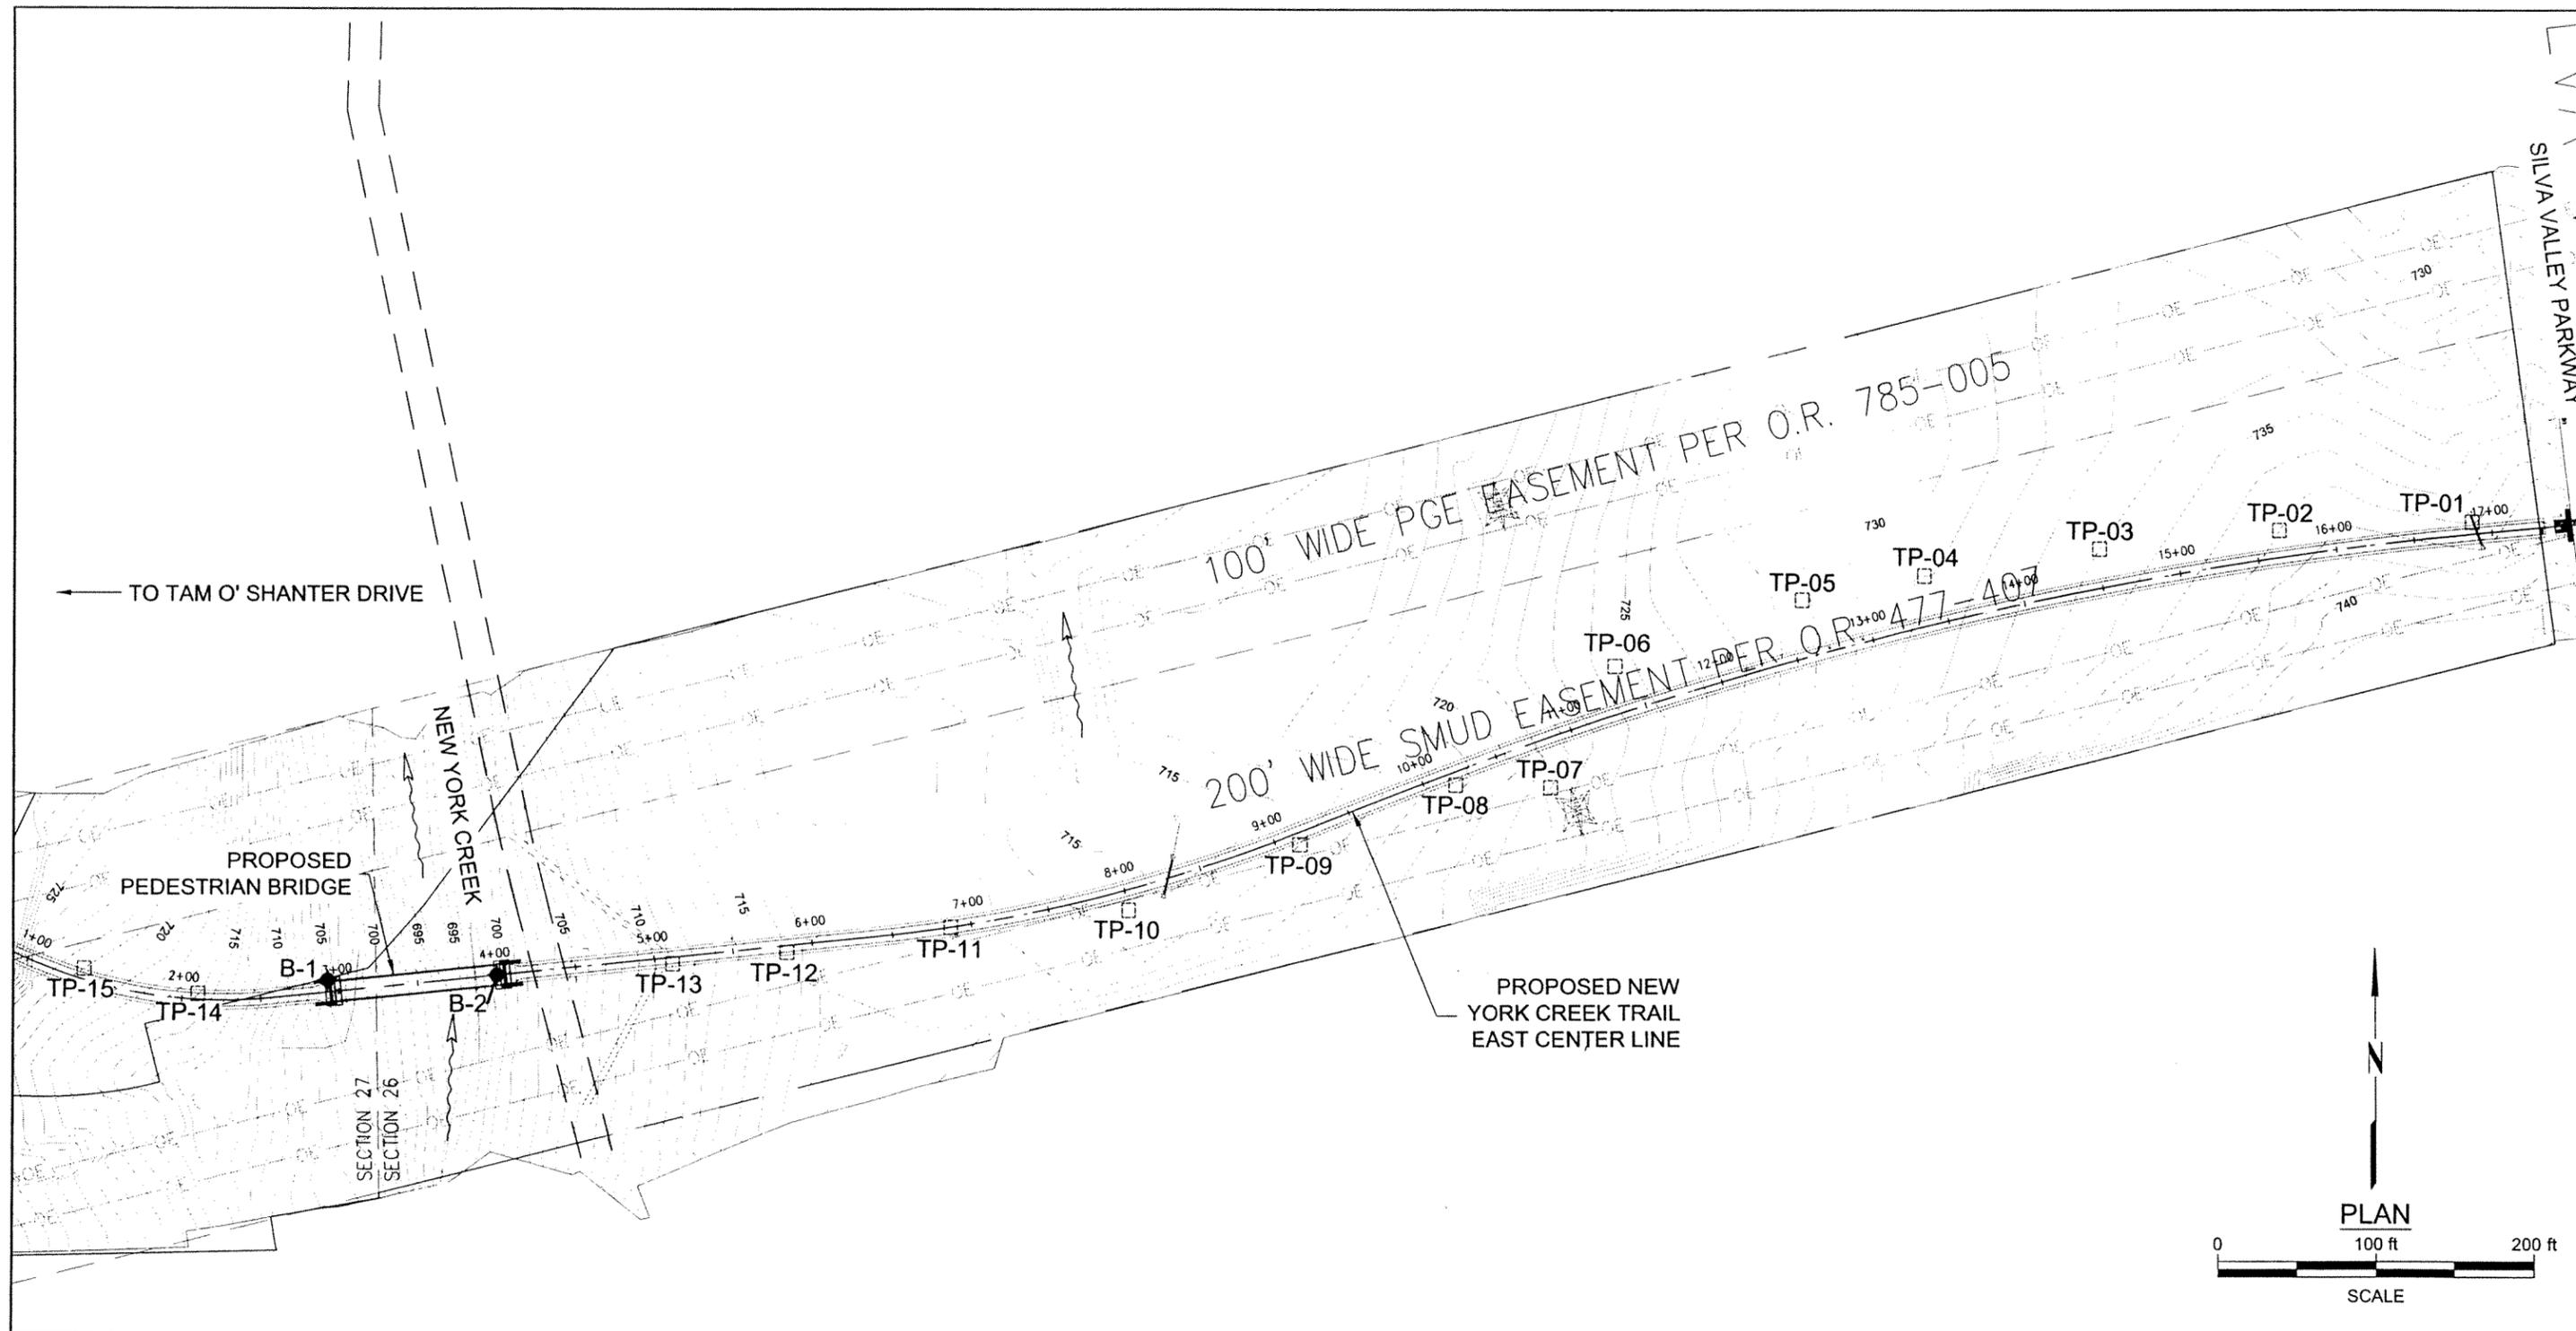
Taber Consultants Engineers and Geologists 3911 West Capitol Avenue West Sacramento, CA 95691-2116 (916) 371-1690 Fax (916) 371-7265		
El Dorado County DOT		
New York Creek Trail East El Dorado Hills, California		
Boring Location Map		
2009-0071-2	April 2012	Figure - 2

Figure-2, "Boring Location Map" shows site extents, site topography, boring and test pit locations, the proposed alignment, the proposed bridge, major utilities, and New York Creek.

with a Caterpillar 420 D backhoe. Boring and test pit locations are indicated on Figure 2.

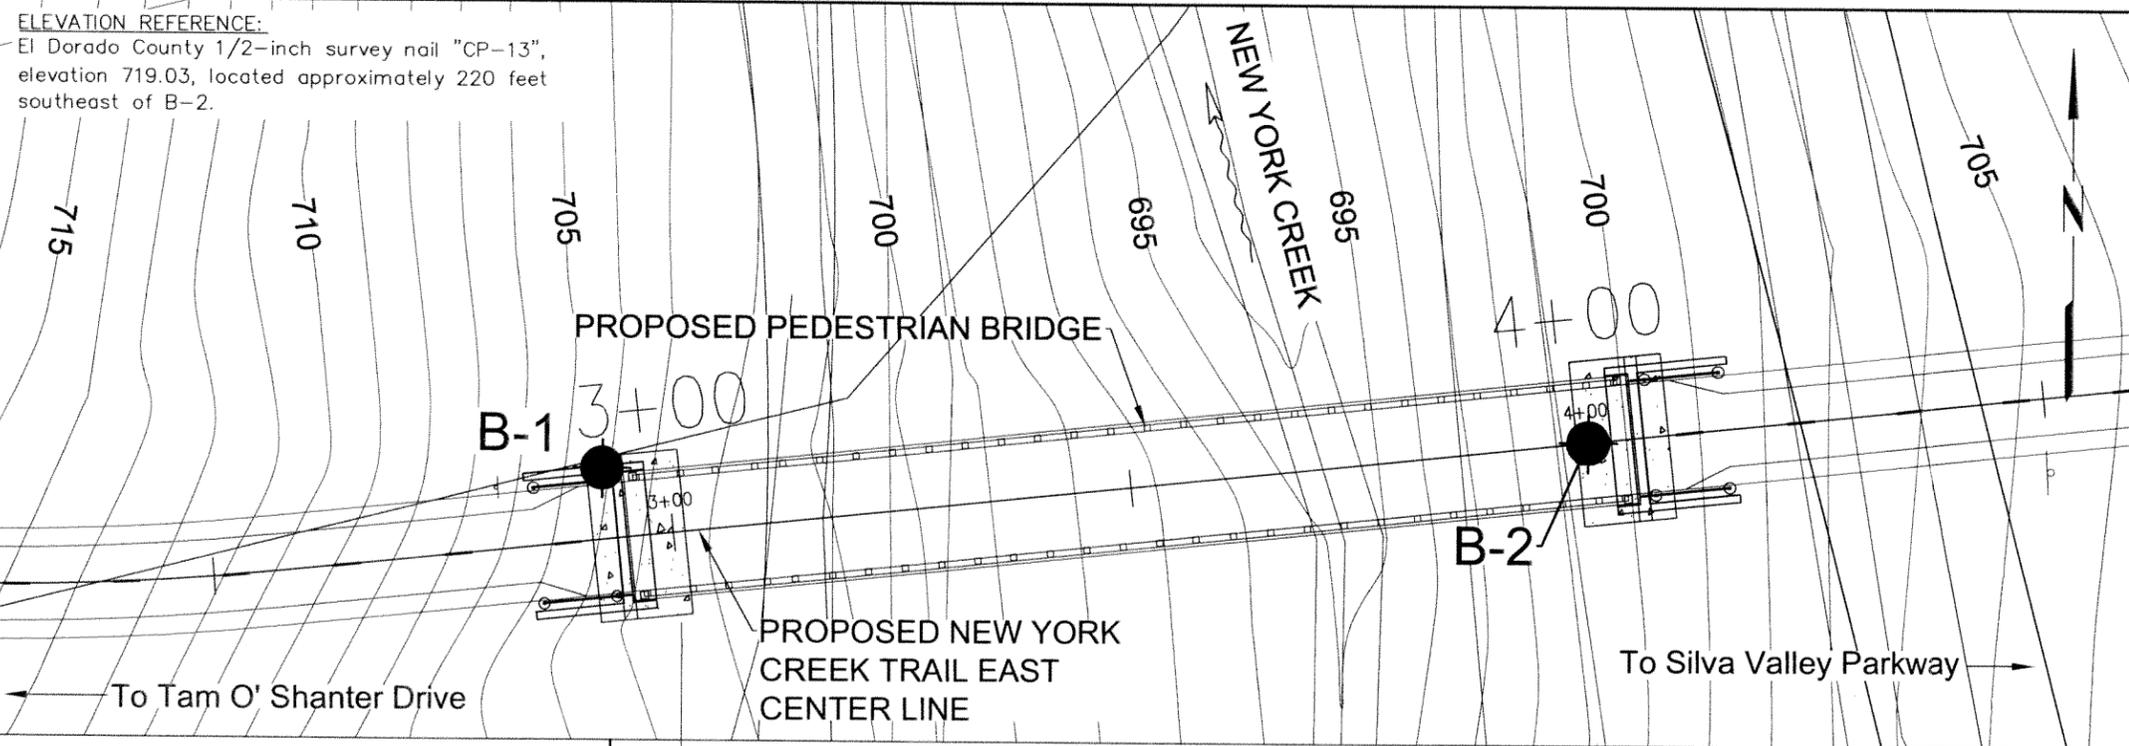
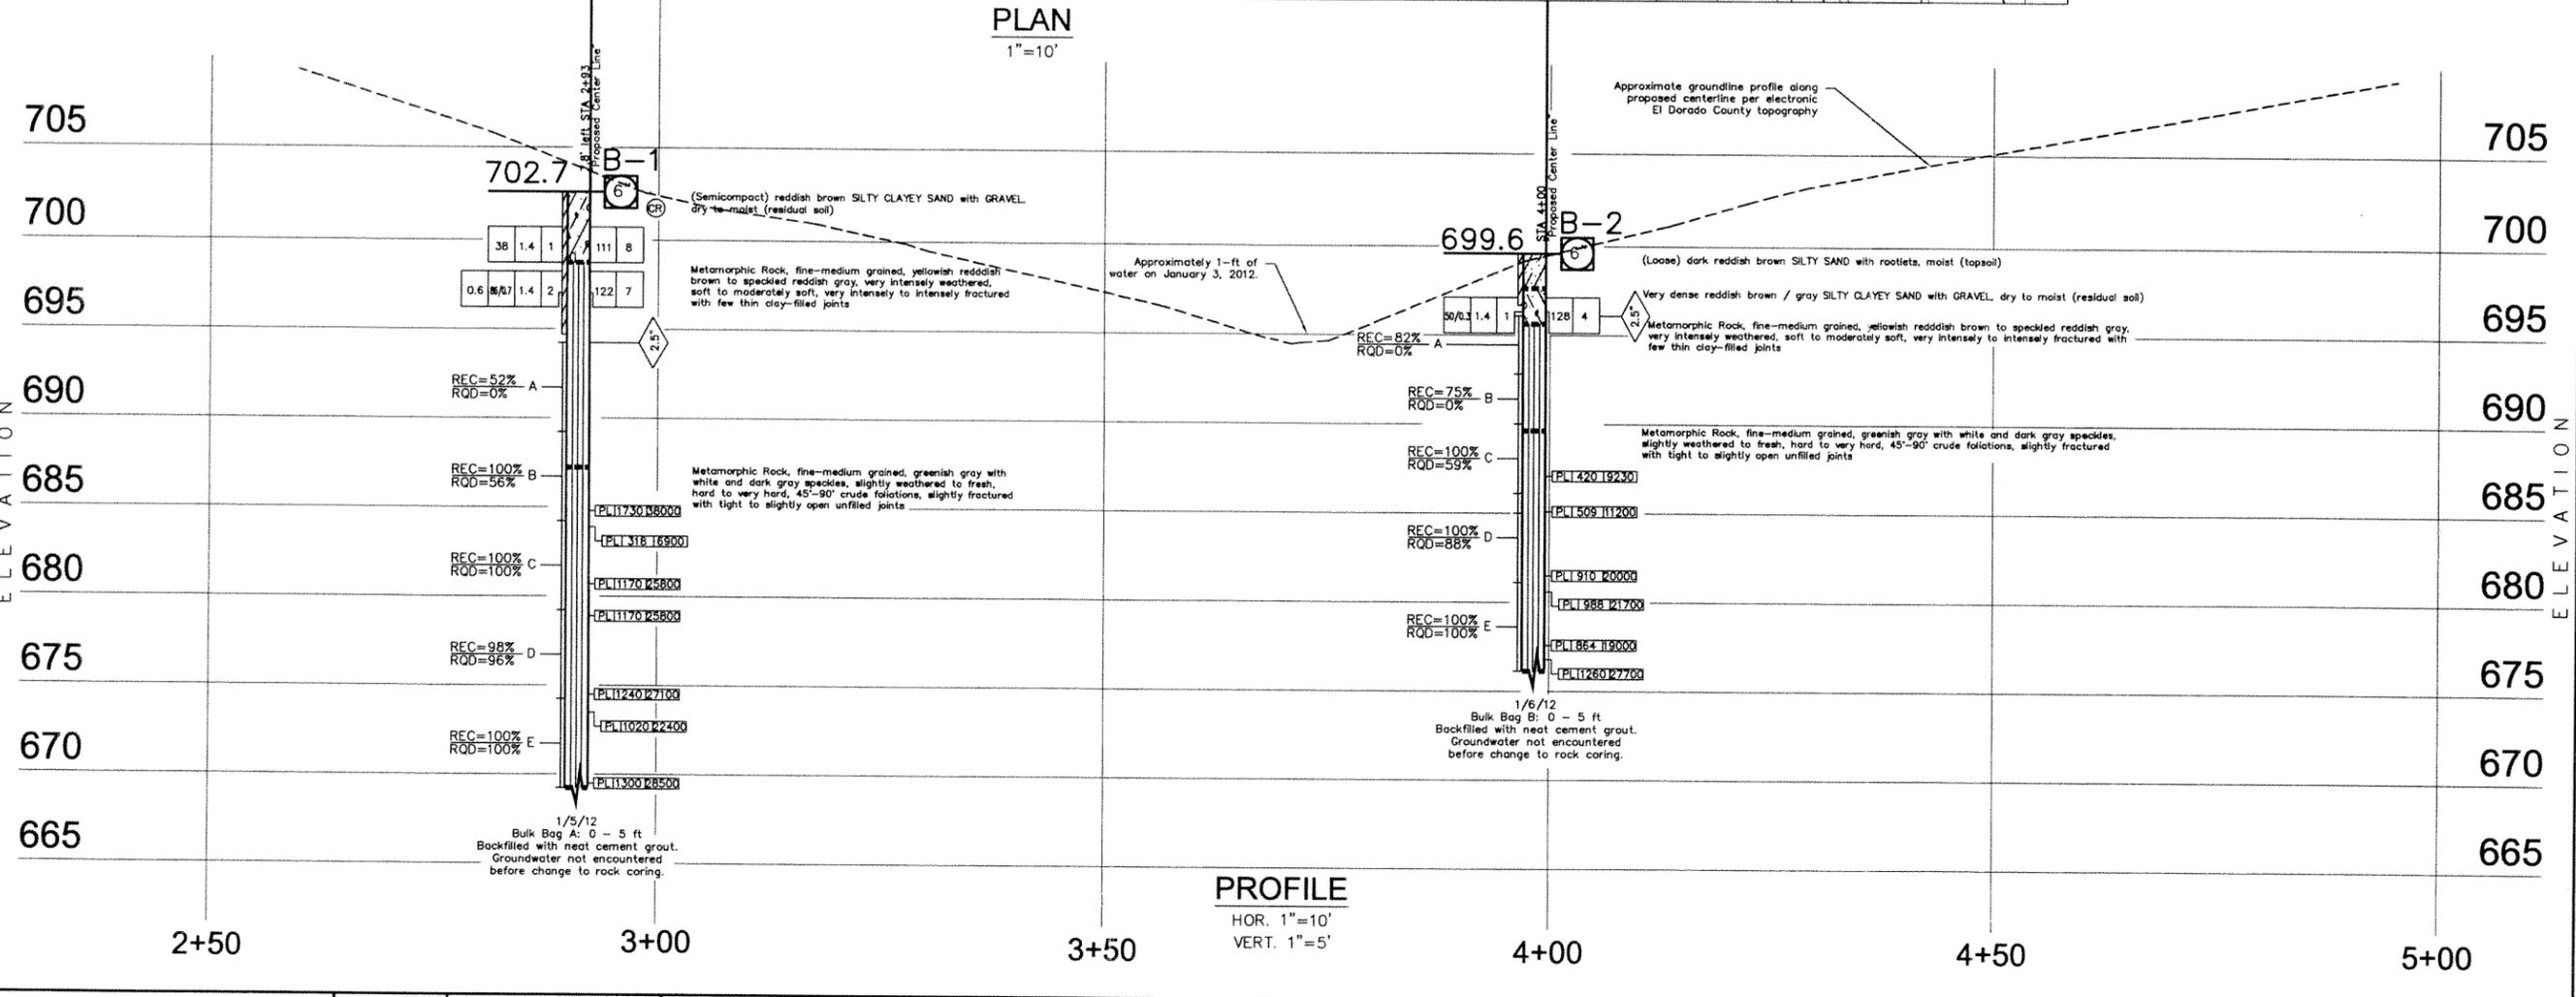
ELEVATION REFERENCE:
 El Dorado County 1/2-inch survey nail "CP-13", elevation 719.03, located approximately 220 feet southeast of B-2.

Where diamond coring was used to advance the borings (B-1 and B-2), the recovered cores were logged as to percent recovery and Rock Quality Designation (RQD). Cores were stored in core boxes for reference. Rock core samples were subjected to point load index testing (results are presented in the "Log of Test Borings" drawing and in Figure-4). Portions of drive samples were retained in sealed containers for laboratory testing and reference. Moisture content, dry density, and unconfined compressive strength tests were conducted on selected samples (drive sample test results are shown in the "Log of Test Borings" drawing).

Upper unit materials consisting of loose to very dense silty sand, clayey sand, and silty, clayey sand with gravel were encountered from the ground surface to 4±feet depth (elev. 698.7±feet and elev. 695.6±feet in B-1 and B-2, respectively). Upper unit materials are susceptible to erosion if exposed, and are not considered capable of supporting concentrated, heavy loads.

Middle unit materials were encountered below upper unit materials to 15±feet depth (elev. 687.7±feet) and 10±feet depth (elev. 689.6±feet) in B-1 and B-2, respectively. Middle unit materials consist of very intensely weathered, soft to moderately soft, very intensely to intensely fractured metamorphic rock. Middle unit materials are capable of supporting concentrated, moderate to heavy loads, but are susceptible to erosion if exposed.

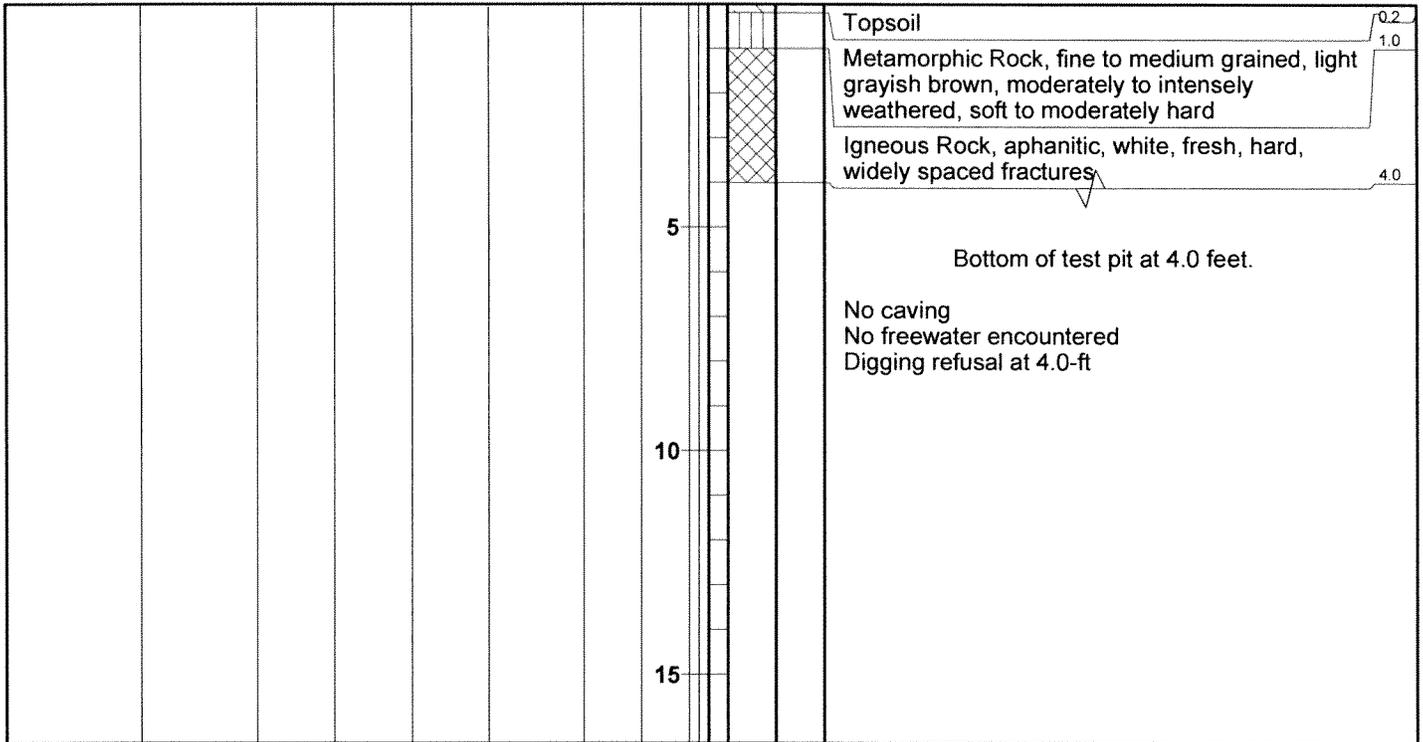
TEST PIT TP-05

TYPE: CAT 420 D Backhoe

SURFACE ELEVATION: 724.5

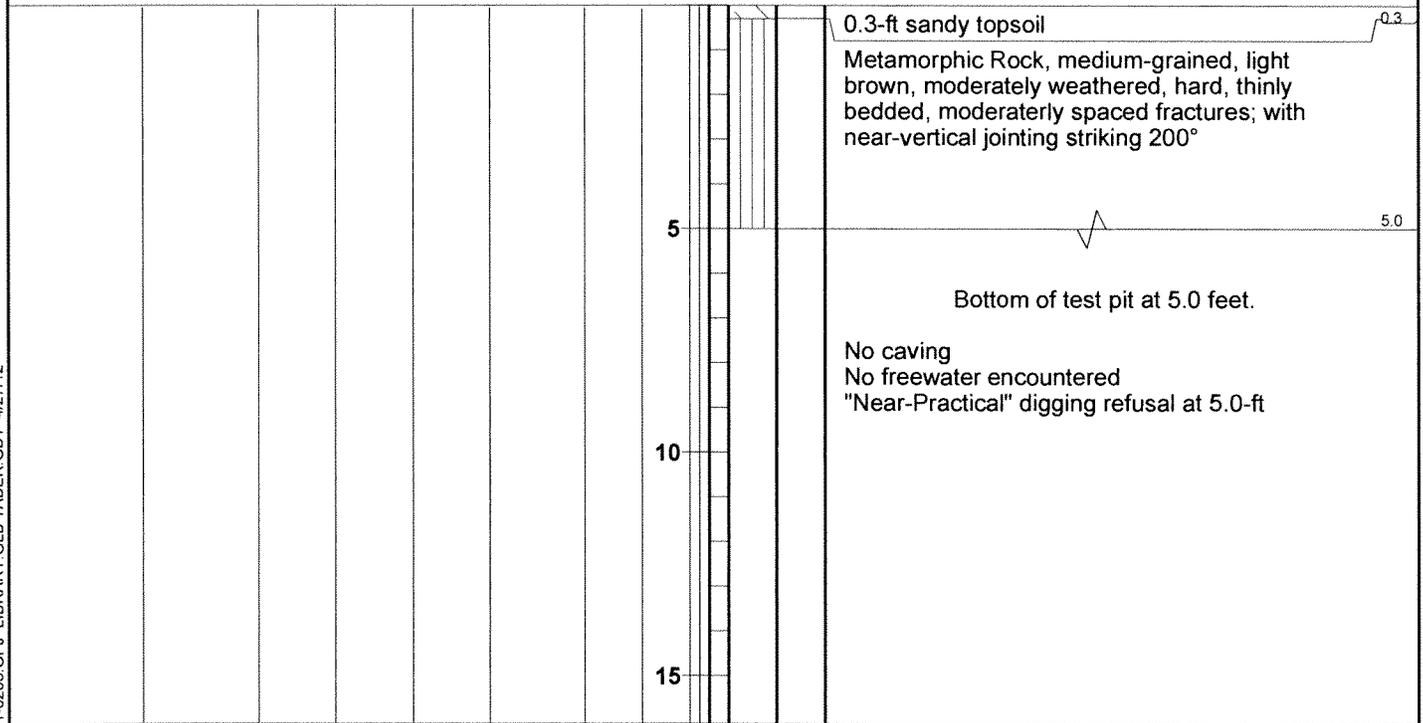
TEST PIT TP-06

POCKET PENETROMETER (tsf)	OTHER TESTS	DRY DENSITY (lbs/cu. ft.)	Moisture (%)	BLOWS/FOOT 350 ft-lb	SAMPLE SIZE (inches)	SAMPLE No.	DEPTH IN FEET	MATERIAL SYMBOL	UNIFIED SOIL CLASS
<p>THE TEST PIT LOGS SHOW SUBSURFACE CONDITIONS AT THE DATES AND LOCATIONS INDICATED AND IT IS NOT WARRANTED THAT THEY ARE REPRESENTATIVE OF SUBSURFACE CONDITIONS AT OTHER LOCATIONS AND TIMES.</p>									
LOGGED BY: BDM					DATE: 01-17-2012

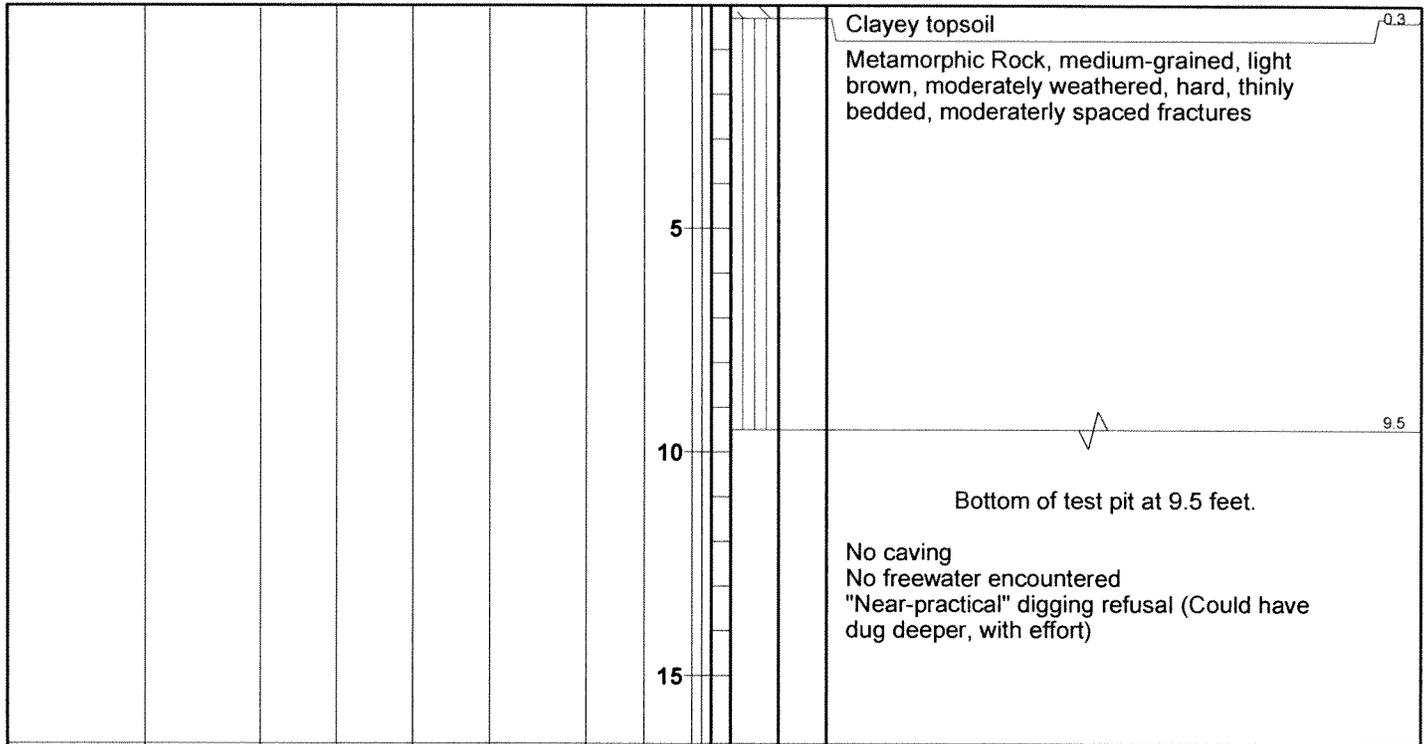
TEST PIT TP-07

TYPE: CAT 420 D Backhoe

SURFACE ELEVATION: 719.0

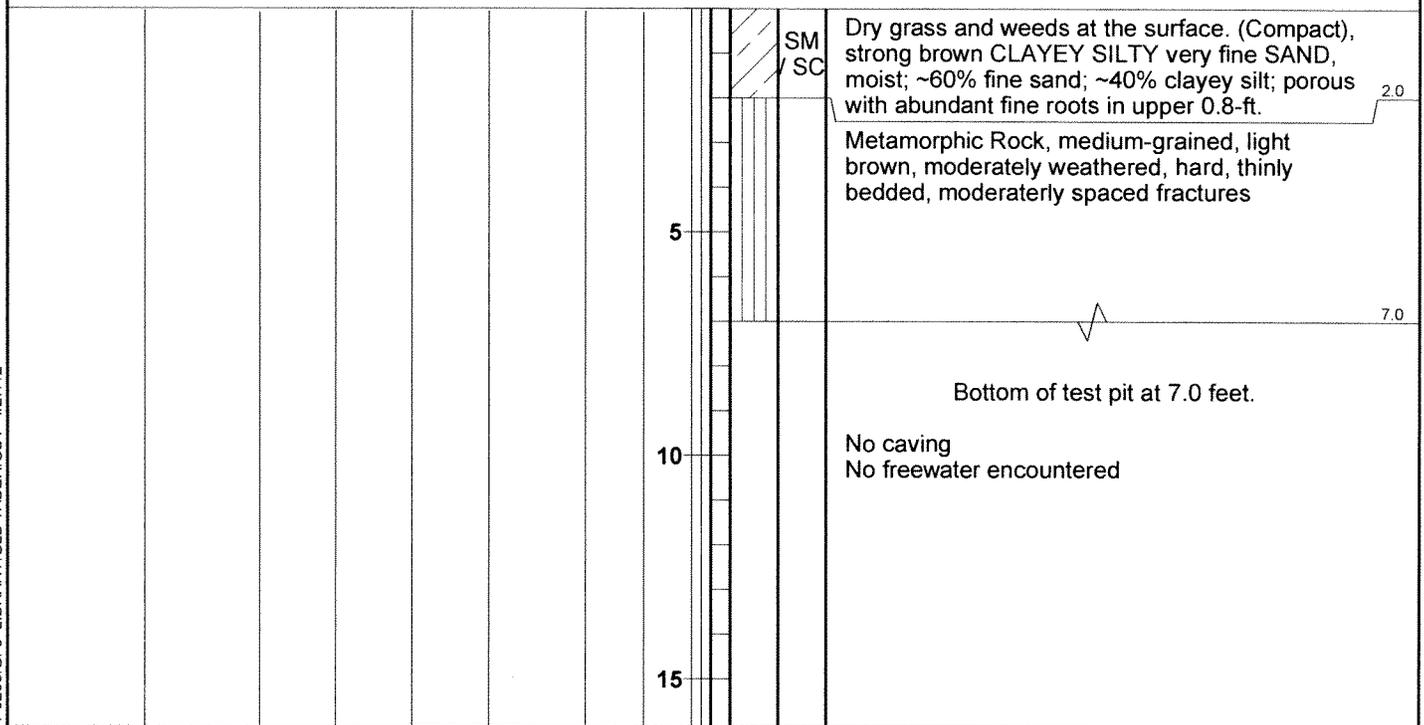
TEST PIT TP-08

POCKET PENETROMETER (tsf)	OTHER TESTS	DRY DENSITY (lbs/cu. ft.)	Moisture (%)	BLOWS/FOOT 350 ft-lb	SAMPLE SIZE (inches)	SAMPLE No.	DEPTH IN FEET	MATERIAL SYMBOL	UNIFIED SOIL CLASS	<p>THE TEST PIT LOGS SHOW SUBSURFACE CONDITIONS AT THE DATES AND LOCATIONS INDICATED AND IT IS NOT WARRANTED THAT THEY ARE REPRESENTATIVE OF SUBSURFACE CONDITIONS AT OTHER LOCATIONS AND TIMES.</p>	
										LOGGED BY: BDM	DATE: 01-17-2012

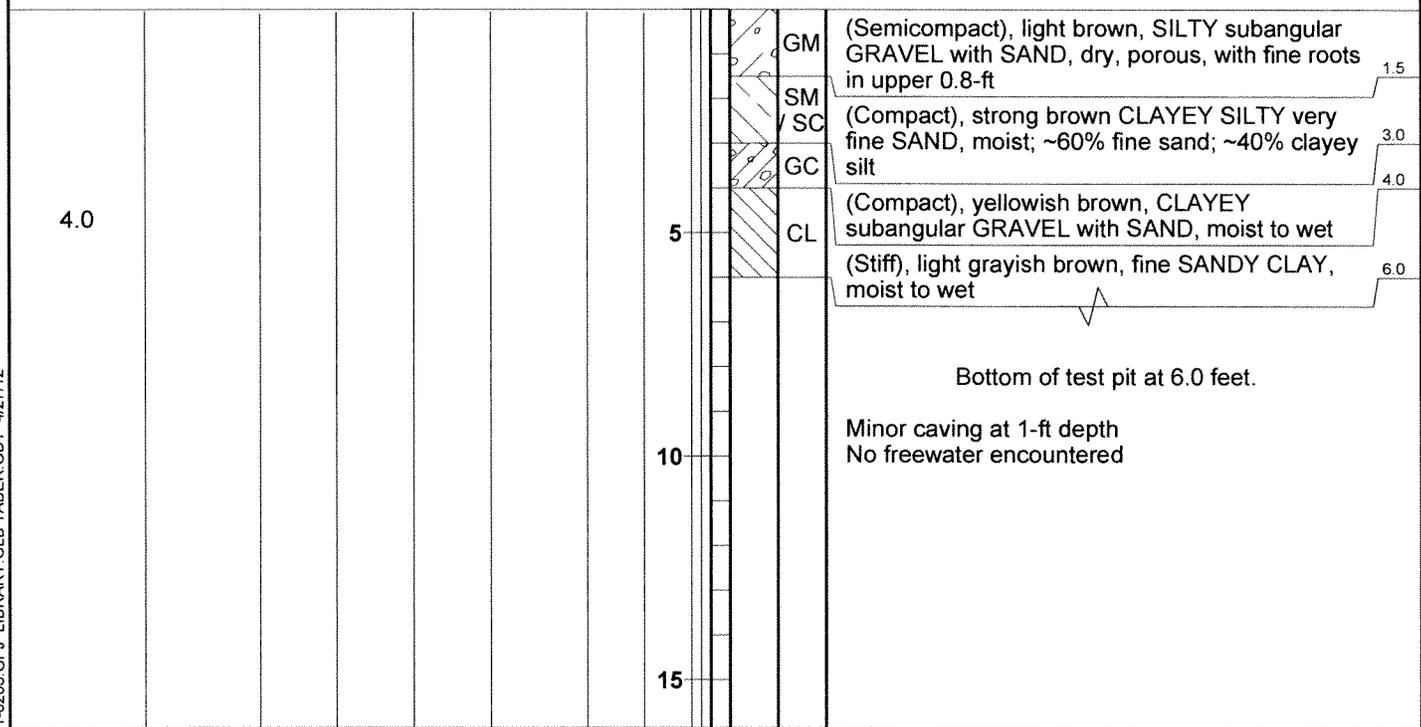
TEST PIT TP-10

POCKET PENETROMETER (tsf)	OTHER TESTS	DRY DENSITY (lbs/cu. ft.)	Moisture (%)	BLOWS/FOOT 350 ft-lb	SAMPLE SIZE (inches)	SAMPLE No.	DEPTH IN FEET	MATERIAL SYMBOL	UNIFIED SOIL CLASS	THE TEST PIT LOGS SHOW SUBSURFACE CONDITIONS AT THE DATES AND LOCATIONS INDICATED AND IT IS NOT WARRANTED THAT THEY ARE REPRESENTATIVE OF SUBSURFACE CONDITIONS AT OTHER LOCATIONS AND TIMES.	
										LOGGED BY: BDM	DATE: 01-17-2012

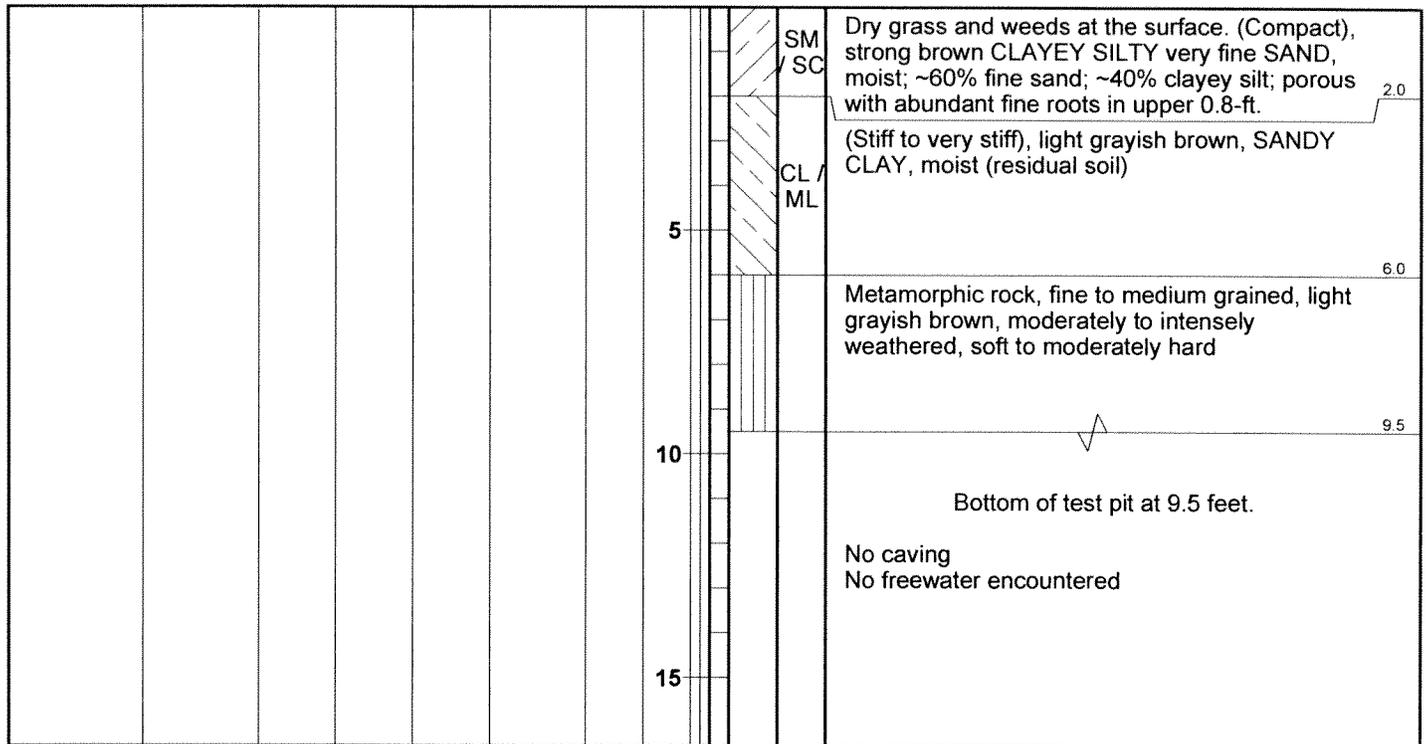
TEST PIT TP-11

TYPE: CAT 420 D Backhoe

SURFACE ELEVATION: 716.0

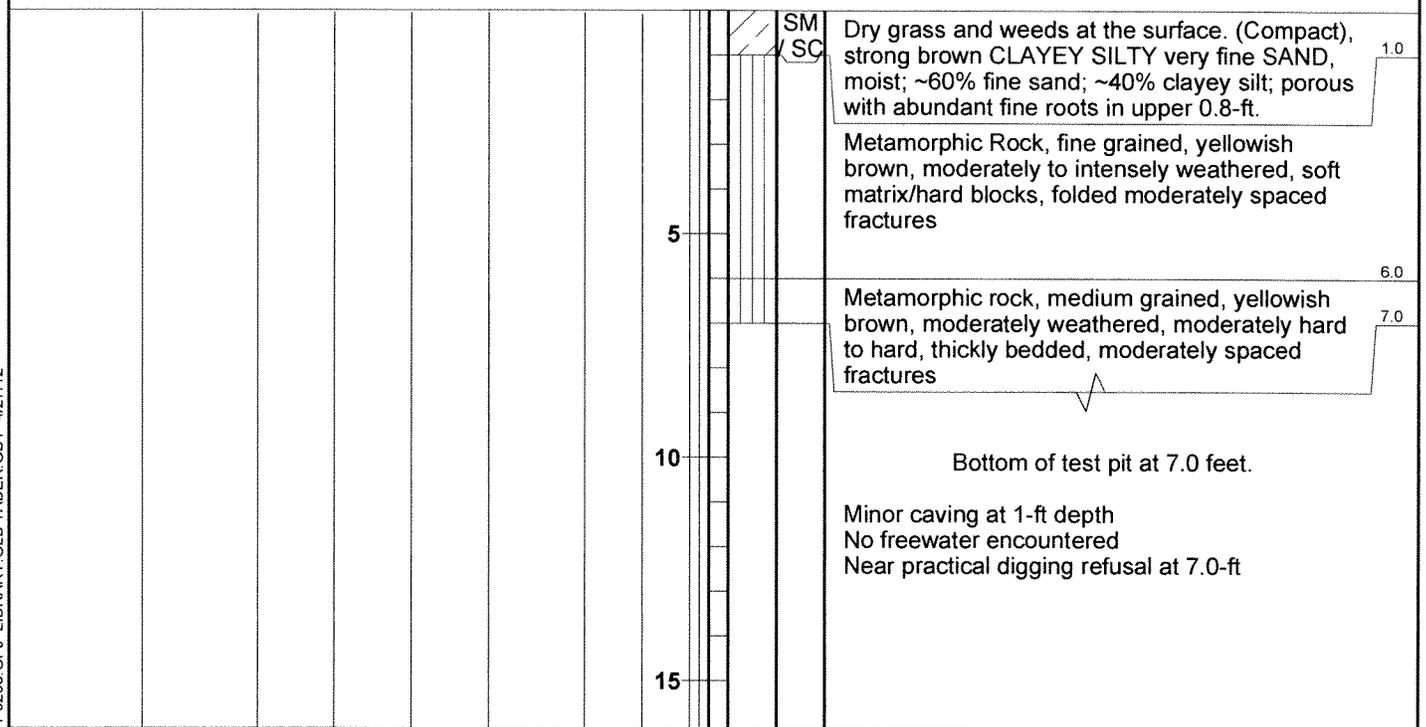
TEST PIT TP-12

POCKET PENETROMETER (tsf)	OTHER TESTS	DRY DENSITY (lbs/cu. ft.)	Moisture (%)	BLOWS/FOOT 350 ft-lb	SAMPLE SIZE (inches)	SAMPLE No.	DEPTH IN FEET	MATERIAL SYMBOL UNIFIED SOIL CLASS	THE TEST PIT LOGS SHOW SUBSURFACE CONDITIONS AT THE DATES AND LOCATIONS INDICATED AND IT IS NOT WARRANTED THAT THEY ARE REPRESENTATIVE OF SUBSURFACE CONDITIONS AT OTHER LOCATIONS AND TIMES.
									LOGGED BY: BDM
									DATE: 01-17-2012

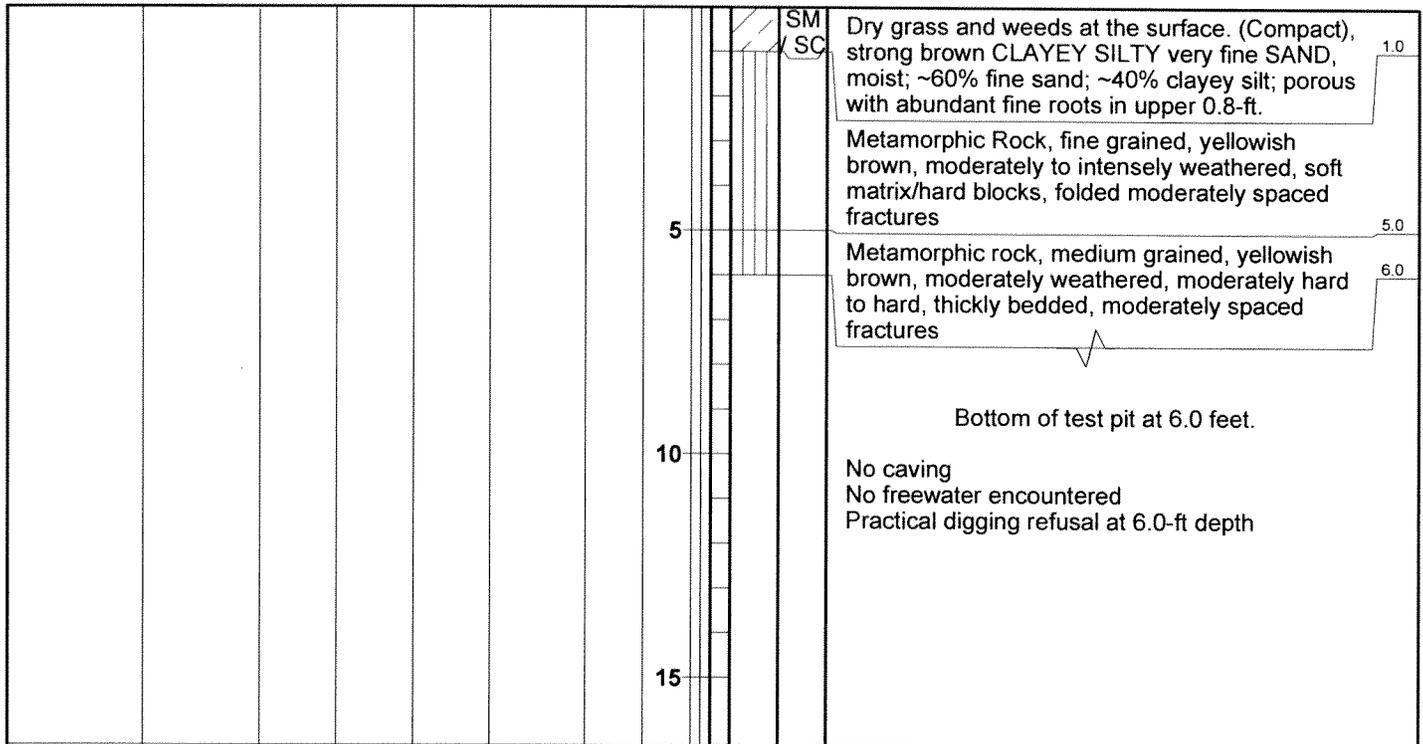
TEST PIT TP-13

TYPE: CAT 420 D Backhoe

SURFACE ELEVATION: 716.0

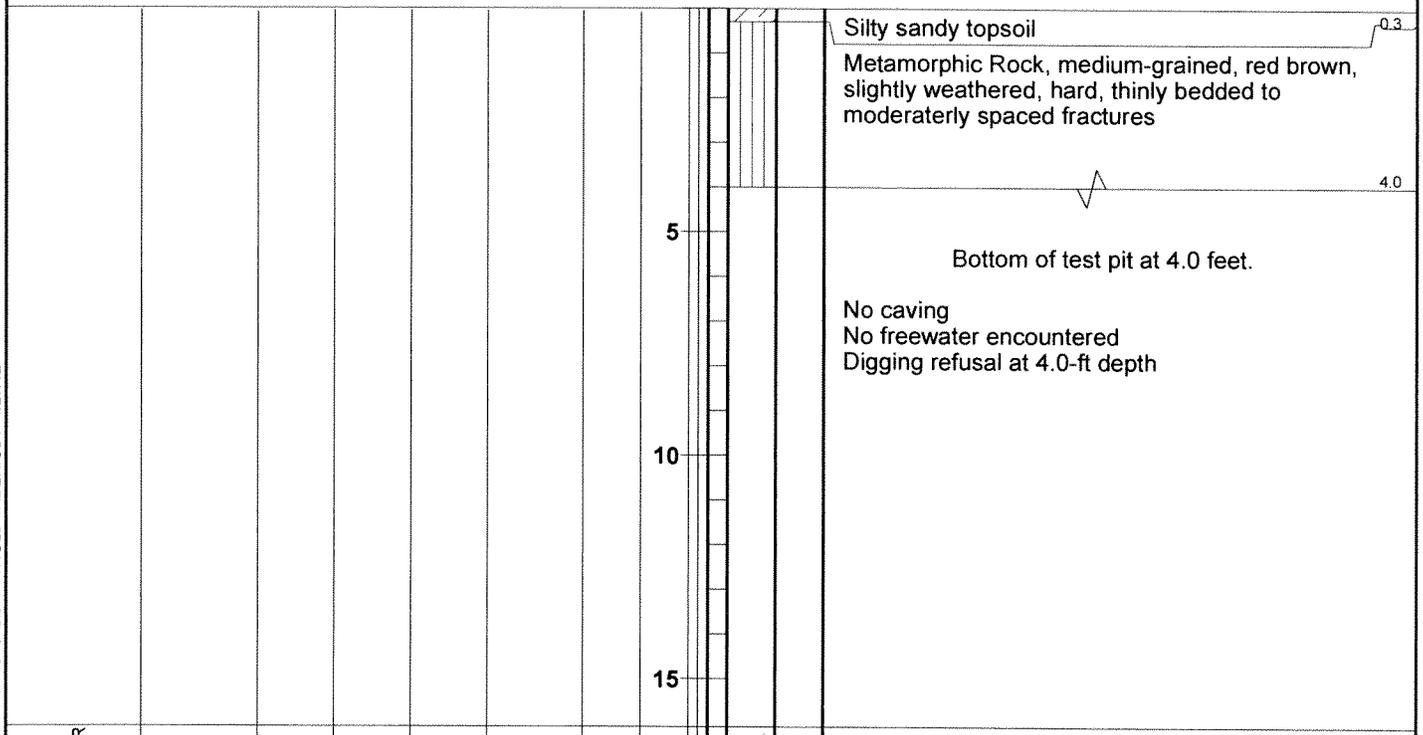
TEST PIT TP-14

POCKET PENETROMETER (tsf)	OTHER TESTS	DRY DENSITY (lbs/cu. ft.)	Moisture (%)	BLOWS/FOOT 350 ft-lb	SAMPLE SIZE (inches)	SAMPLE No.	DEPTH IN FEET	MATERIAL SYMBOL UNIFIED SOIL CLASS	THE TEST PIT LOGS SHOW SUBSURFACE CONDITIONS AT THE DATES AND LOCATIONS INDICATED AND IT IS NOT WARRANTED THAT THEY ARE REPRESENTATIVE OF SUBSURFACE CONDITIONS AT OTHER LOCATIONS AND TIMES.
									LOGGED BY: BDM
									DATE: 01-17-2012

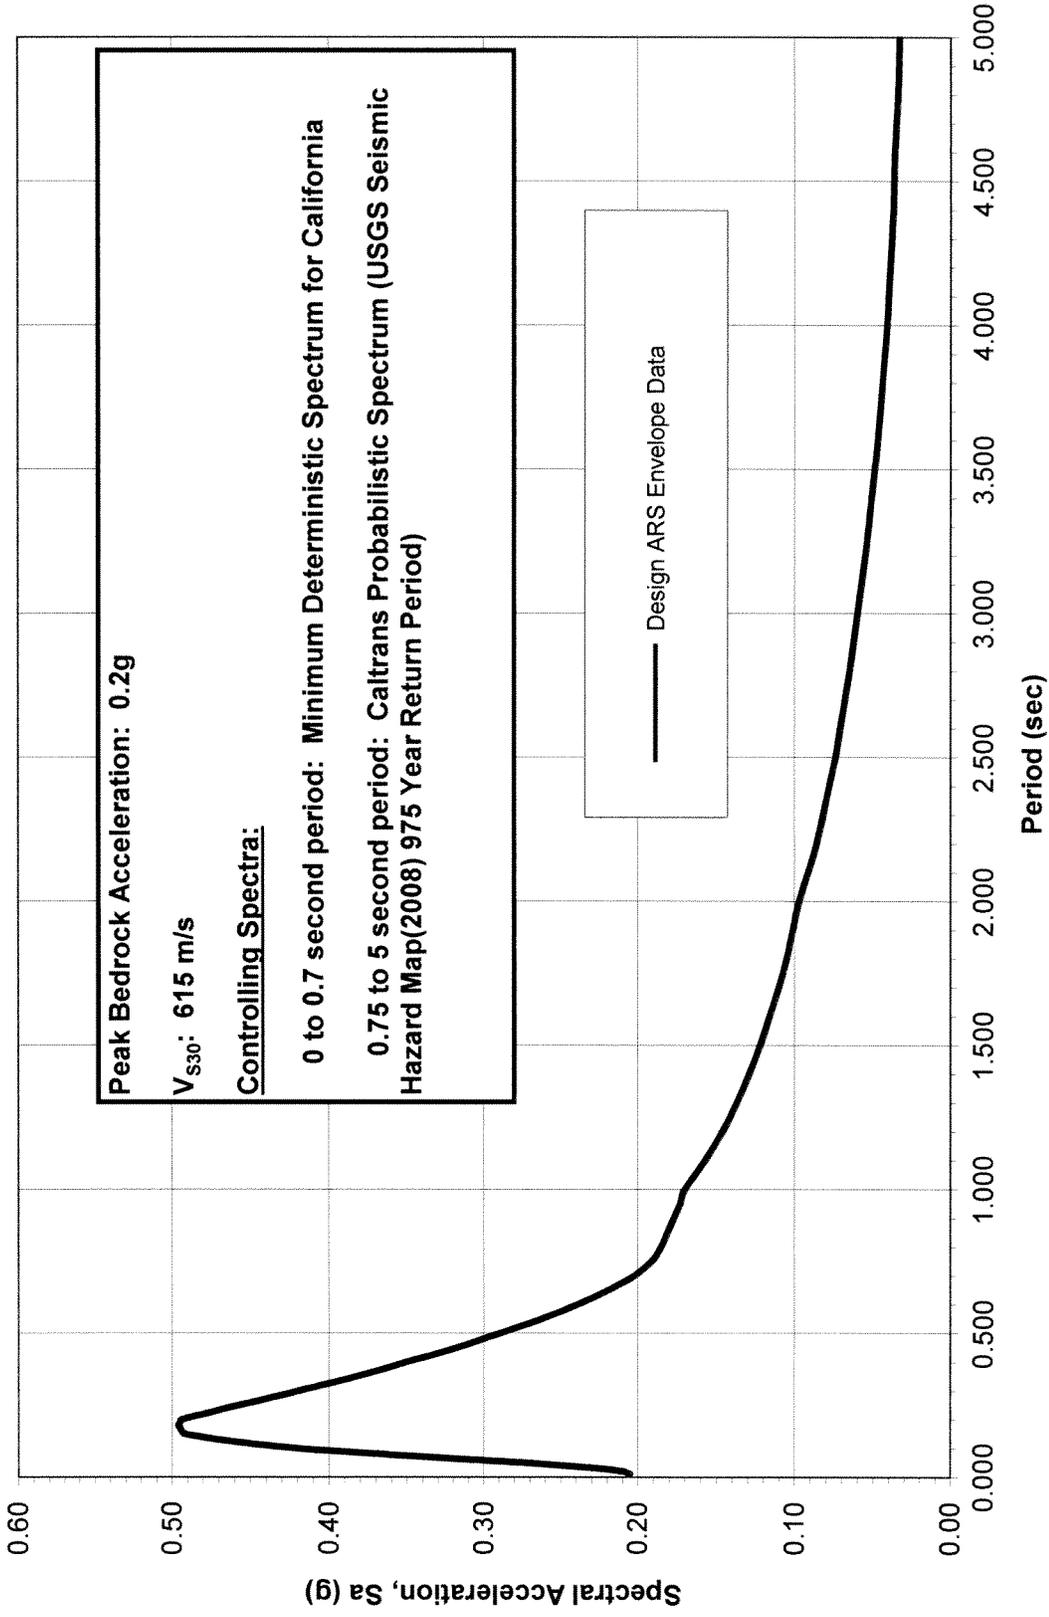
Figure-5

Caltrans ARS Online Envelope Spectrum New York Creek Pedestrian Bridge

The Caltrans ARS Online Envelope Spectrum (considering both deterministic and probabilistic analyses) is included as Figure-5. For the 0 to 0.7 second portion of the ARS envelope curve, the minimum deterministic spectrum for the State of California controls. For the >0.7 second portion of the ARS envelope spectrum, the Caltrans ARS Online Probabilistic Response (the 2008 USGS 5% in 50 years hazard curve) is the controlling source spectrum.
