GEOTECHNICAL REPORT UPDATE
BASS LAKE ROAD REALIGNMENT - PHASE 2
EL DORADO COUNTY, CALIFORNIA

ENGEO INCORPORATED

PROJECT NO. 4235.5.050.01

FEBRUARY 2, 2005

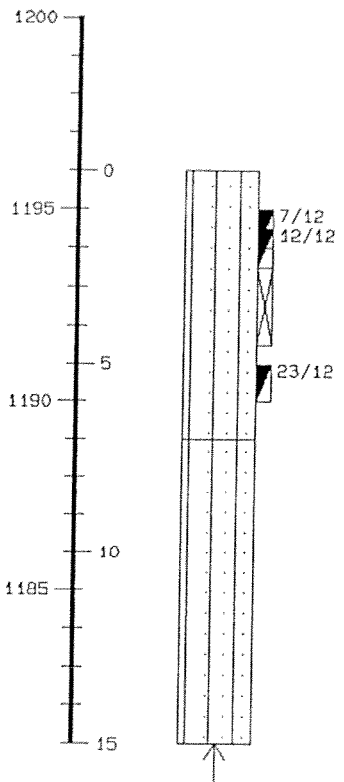
ELEV DEPTH	SOIL SYMBOLS SAMPLER SYMBOLS AND FIELD TEST DATA	USCS	Soil Description	Remarks	Sample Number	Density p.c.f.	Moisture %
<div style="display: flex; flex-direction: column; align-items: center;"> <div style="margin-bottom: 10px;">1200</div> <div style="margin-bottom: 10px;">0</div> <div style="margin-bottom: 10px;">1195</div> <div style="margin-bottom: 10px;">5</div> <div style="margin-bottom: 10px;">1190</div> <div style="margin-bottom: 10px;">10</div> <div style="margin-bottom: 10px;">1185</div> <div style="margin-bottom: 10px;">15</div> </div>

<div style="margin-bottom: 10px;">SM</div> <div style="margin-bottom: 10px;">SM</div>	<div style="margin-bottom: 10px;">Dark red-brown, moist, loose moderately dense silty sand with a little clay.</div> <div style="margin-bottom: 10px;">Olive brown, moist, dense, silty sand with clay.</div> <div style="margin-bottom: 10px;">Color grades to grey-brown.</div>	<div style="margin-bottom: 10px;">Clayier with depth; some scattered pebbles.</div> <div style="margin-bottom: 10px;">Moderately weathered granite rock. Drilling more difficult.</div> <div style="margin-bottom: 10px;">Difficult drilling.</div> <div style="margin-bottom: 10px;">Near refusal</div>	<div style="margin-bottom: 10px;">11-1 11-2 CB-11</div> <div style="margin-bottom: 10px;">11-3</div>

Total Depth 15 feet. No GW. No caving.

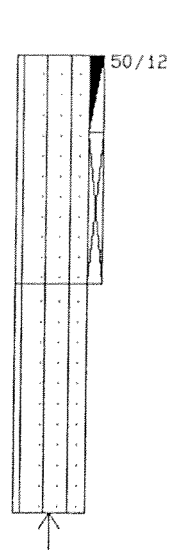
ELEV DEPTH	SOIL SYMBOLS SAMPLER SYMBOLS AND FIELD TEST DATA	USCS	Soil Description	Remarks	Sample Number	Density p.c.f.	Moisture %
<div style="display: flex; align-items: center;"> <div style="margin-right: 10px;"> <p>1142.5</p> <p>0</p> <p>1140</p> <p>2.5</p> <p>1137.5</p> <p>5</p> </div>

</div>	<p>50/12</p>	<p>SM- ML</p>	<p>Dark red-brown, moist, mod. dense, silty sand to sandy silt.</p>	<p>13-1</p> <p>CB-13</p>			
		<p>SM</p>	<p>Brown, moist, very dense, slightly weathered granite rock.</p>	<p>Difficult drilling</p>

Bottom at 6 feet. Refusal

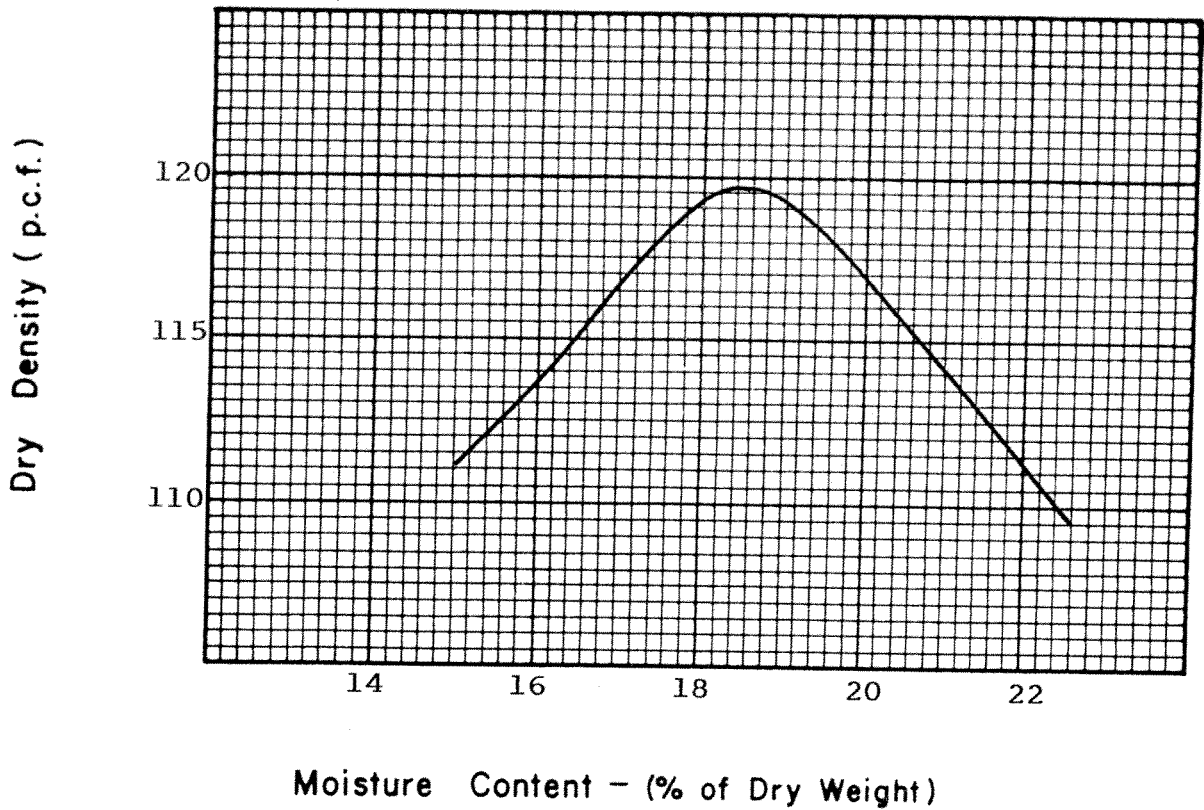
Sample : CB-5

Description : Red-brown sandy SILT, trace clay

Optimum Moisture Content : 18.5 %
