GEOTECHNICAL REPORT

**SILVER SPRINGS RESIDENTIAL
DEVELOPMENT AND
OFFSITE IMPROVEMENTS**

EL DORADO COUNTY, CALIFORNIA

PROJECT NO. 7125.5.001.01

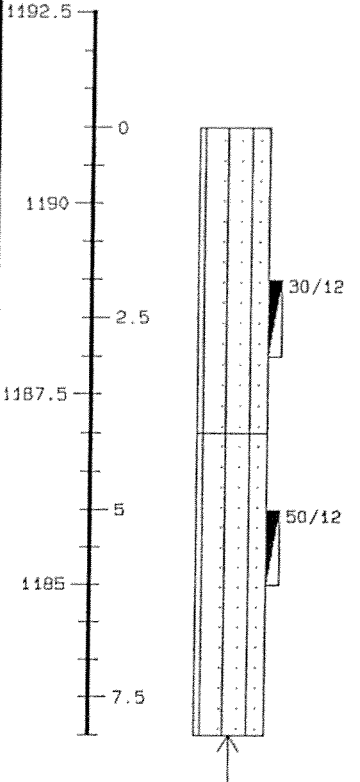
ELEV DEPTH	SOIL SYMBOLS SAMPLER SYMBOLS AND FIELD TEST DATA	USCS	Soil Description	Remarks	Sample Number	Density p.c.f.	Moisture %
<div style="display: flex; align-items: center;"> <div style="margin-right: 10px;"> <p>1192.5</p> <p>0</p> <p>1190</p> <p>2.5</p> <p>1187.5</p> <p>5</p> <p>1185</p> <p>7.5</p> </div>

</div>		<p>SM</p> <p>SM</p>	<p>Brown, moist, moderately dense, silty sand with scattered pebbles.</p> <p>Brown to gray-brown, moist, dense, silty sand.</p>	<p>Some clay lenses.</p> <p>Moderately weathered granite rock.</p> <p>Difficult drilling.</p>	<p>14-1</p> <p>14-2</p>	<p>113.8</p> <p>116.9</p>	<p>14.2</p> <p>10.2</p>

Bottom at 8 feet. No GW. No caving.
Refusal
