Geotechnical Study
(December 10, 2024)

**SUBJECT: Geotechnical Study
Proposed Costco Fuel Facility
Silva Valley Parkway
El Dorado Hills, California
CW# 18-0487**

**GEOTECHNICAL STUDY
PROPOSED COSTCO FUEL FACILITY
SILVA VALLEY PARKWAY
EL DORADO HILLS, CALIFORNIA
CW# 18-0487
KLEINFELDER PROJECT NO. 20193141.002A**

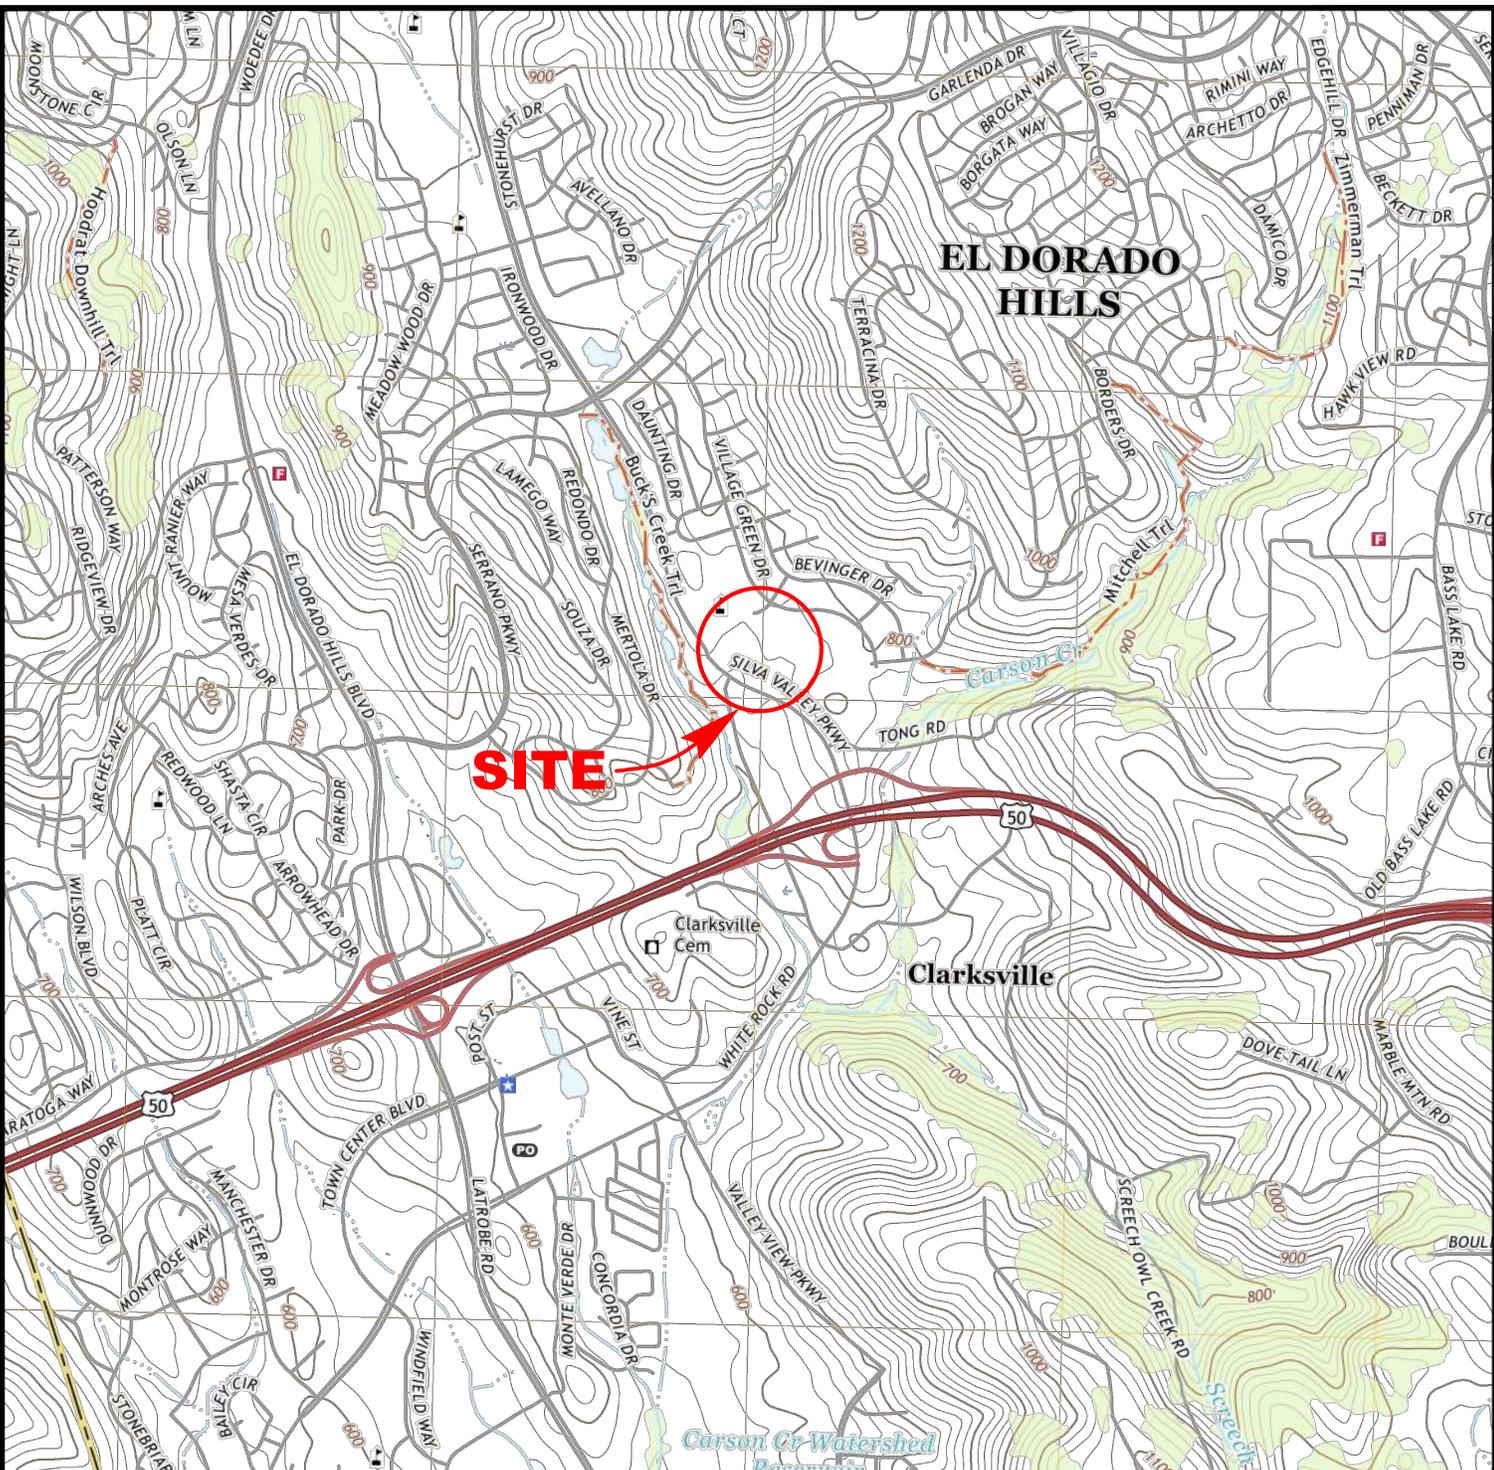
FIGURE
1

REFERENCE:
Clarksville, ca. Quadrangle California 7.5-Minute Series

PROPOSED COSTCO FUEL FACILITY
SILVA VALLEY PARKWAY
EL DORADO HILLS, CALIFORNIA

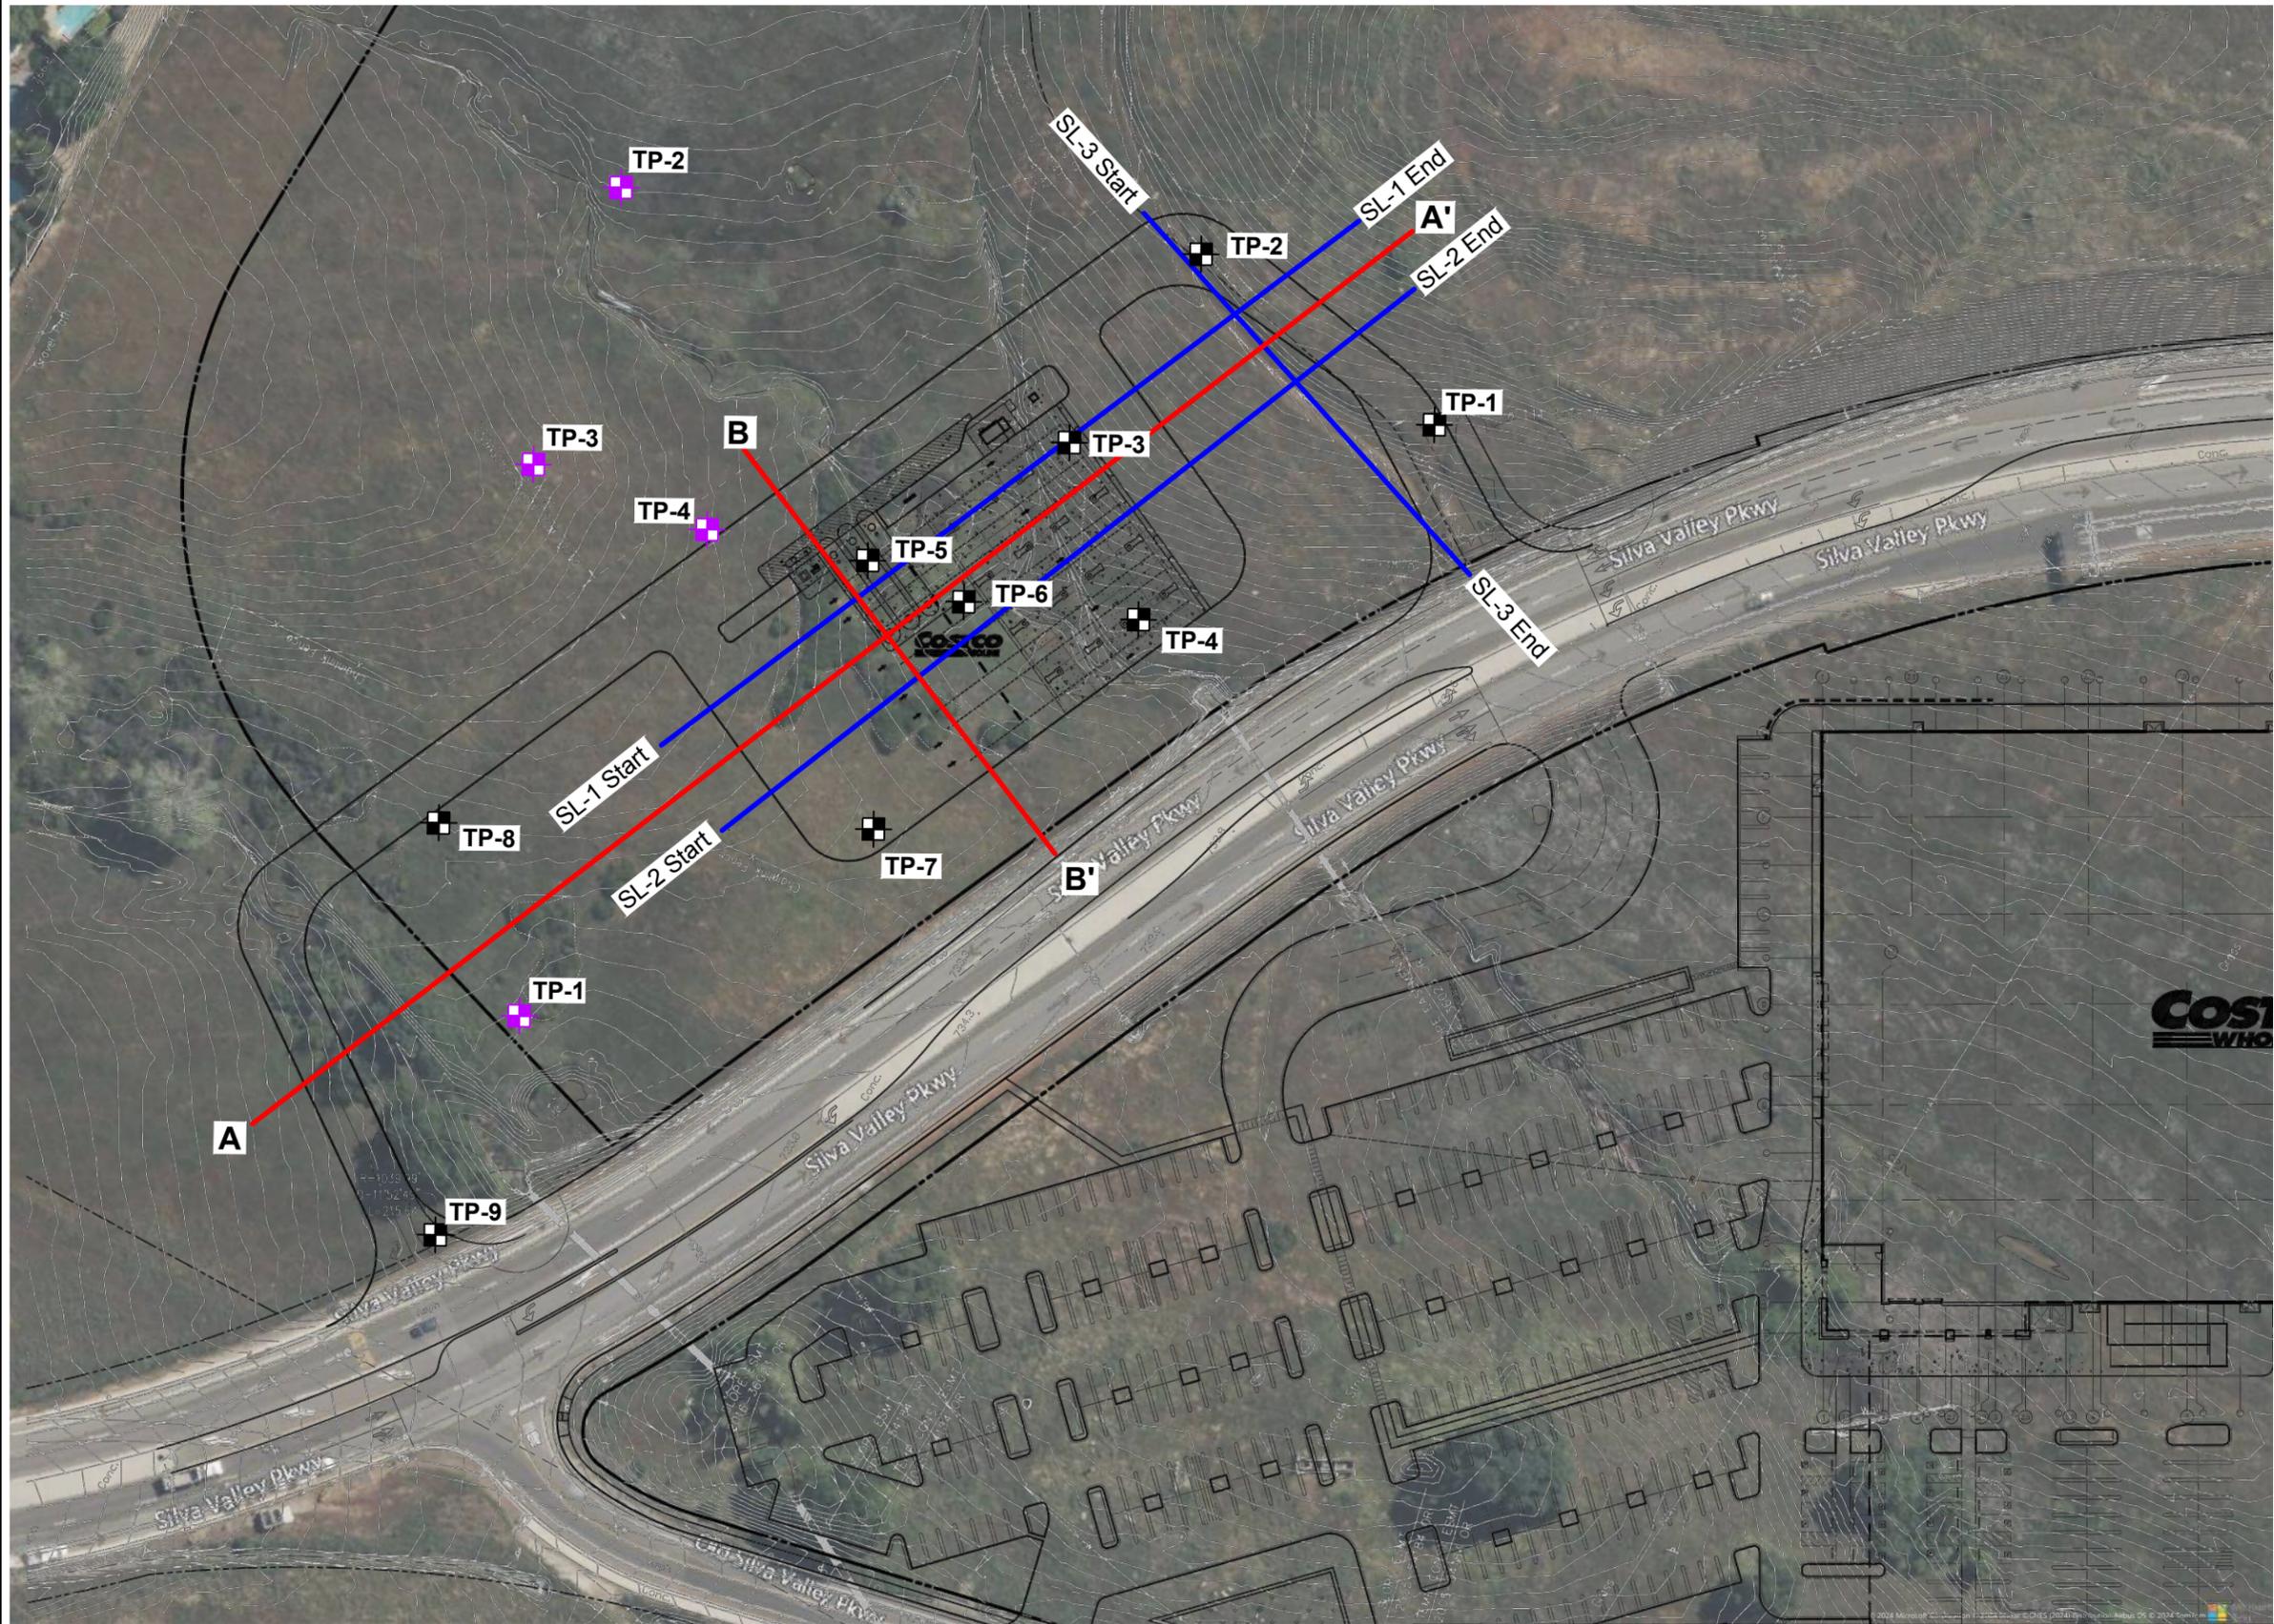
EXPLORATION LOCATION MAP

- CROSS SECTIONS
- SEISMIC LINES
- TEST PIT LOCATIONS (2024)
- TEST PIT LOCATIONS (2019)

REFERENCE:
PDF FILE: A18655 PRELIM GRADES

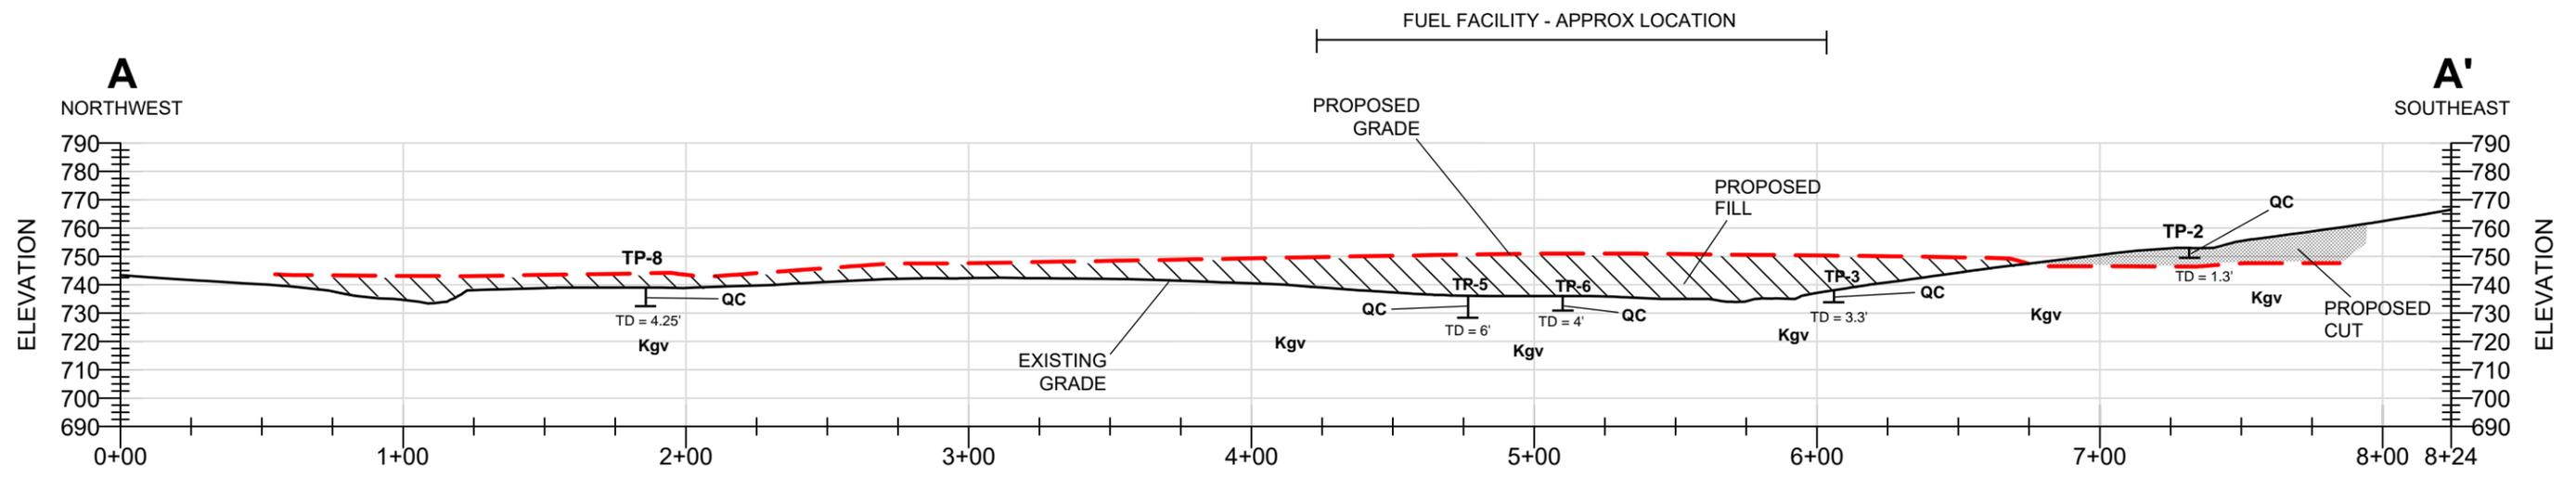
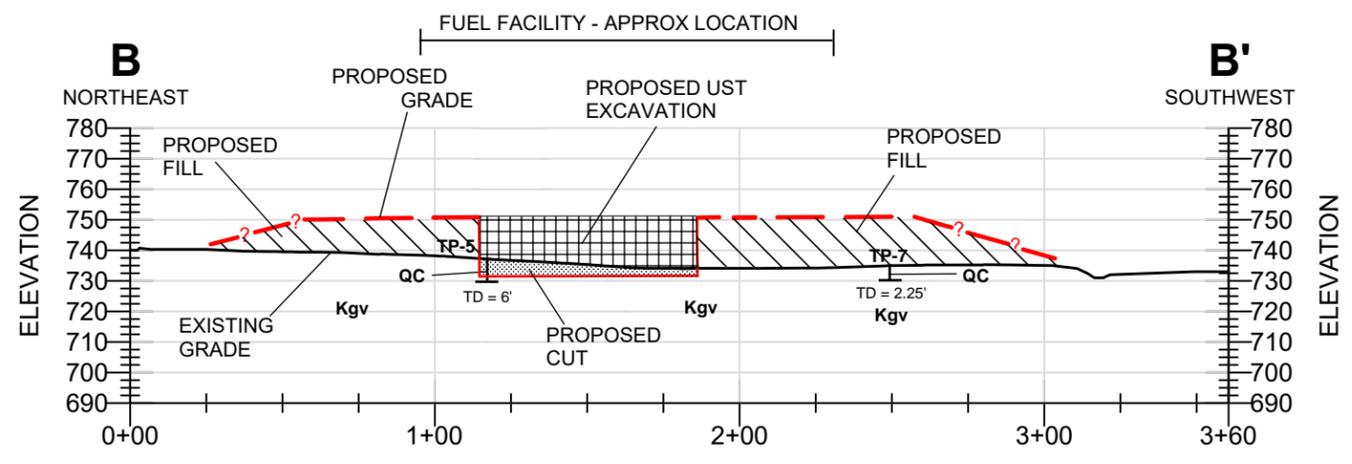
- QC** Colluvial/Residual Soils comprised of sandy silts and lean clays with variable amount of sand and gravel. Observed to be approximately 1 to 5 feet thick.
- Kgv** Metavolcanic Rock - Highly Weathered within upper 10 feet (Vp = 3,000 to 6,000 ft/s), Slightly Weather intact rock below 10 to 15 feet bgs (Vp > 6,000 ft/s)

- Based on the results of the seismic refraction lines, the near surface soils are comprised of a thin colluvium/residual soil layer varying in thickness from approximately 1½ to 5 feet thick. Below the colluvium/residual soil lies bedrock comprised of highly weathered and fractured metavolcanic rock ($V_p = 3,000$ to $6,000$ ft/s). The strength of this highly weathered rock layer increases in depth and is approximately 10 feet thick. The highly weather rock layer is underlain by slightly weathered, intact rock ($V_p > 6,000$ ft/s). The depth to the bottom of this layer varies from approximately 10 to 20 feet bgs.

- Soils and rock with velocities of less than 3,000 fps can usually be excavated with conventional earth moving equipment. The intermediate material (velocities between 3,000 fps and 6,000 fps) would likely require heavy equipment and possibly localized use of jackhammers, ram-hoes, or selective blasting to provide cost-effective excavation. Where materials with velocities in excess of 6,000 fps are found, blasting would normally be required for efficient fragmentation. However, if the rock is thinly bedded, jointed, or fractured, it may be possible to break the rock with heavy ripping using a single shank ripper or large ram-hoe. The resulting fragments will be of a size consistent with the fracture spacing and the progress of excavation would be very slow.

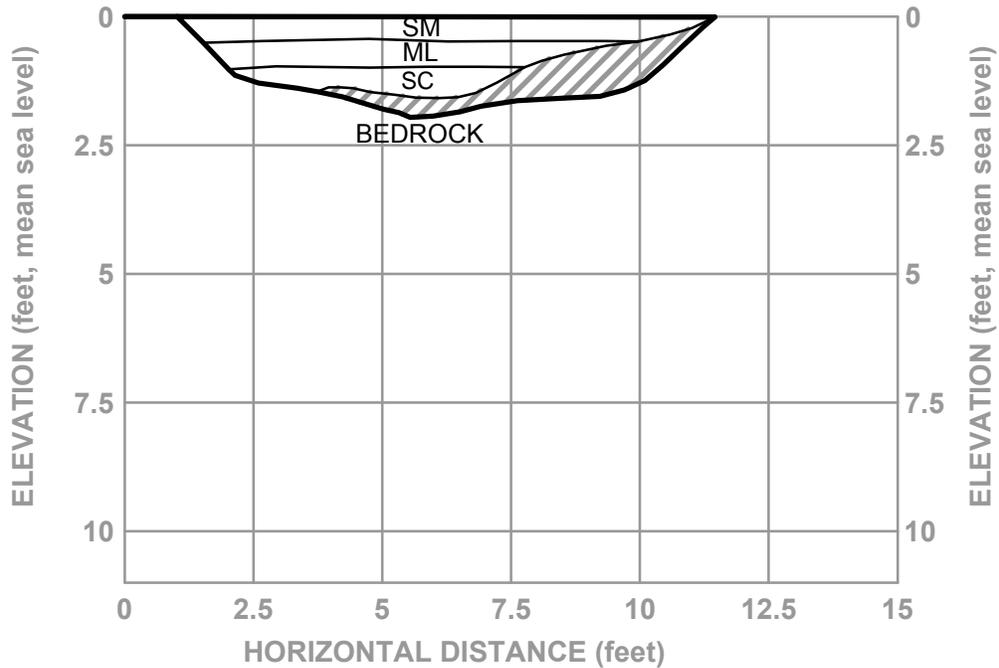
PROJECT NO.: 20193141	TEST PIT LOG TP-1	APPENDIX
	DRAWN BY: DA CHECKED BY: DD DATE: 7/11/2024 REVISED: 7/29/2024	PROPOSED COSTCO FUEL FACILITY SILVA VALLEY PARKWAY EL DORADO HILLS, CALIFORNIA	A-3

The test pit was terminated at approximately 2 ft. below ground surface. The test pit was backfilled with on July 09, 2024.

GROUNDWATER LEVEL INFORMATION:
Groundwater was not observed during excavation or after completion.
GENERAL NOTES:
The exploration location and elevation are approximate and were estimated by Kleinfelder.

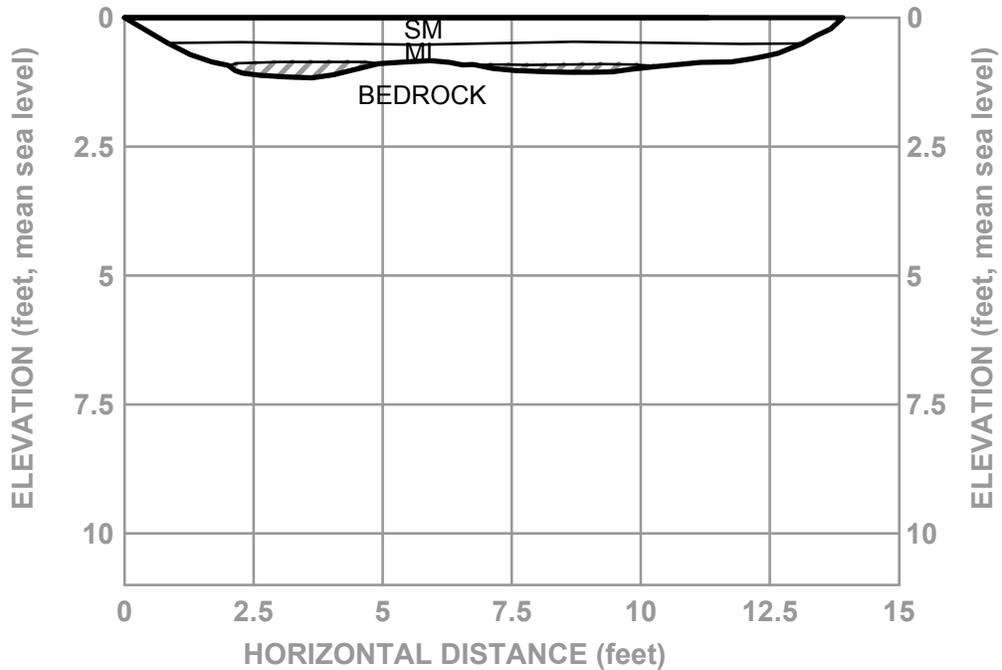
TEST PIT LOG TP-2
 PROPOSED COSTCO FUEL FACILITY
 SILVA VALLEY PARKWAY
 EL DORADO HILLS, CALIFORNIA

The test pit was terminated at approximately 1.5 ft. below ground surface. The test pit was backfilled with on July 09, 2024.

GROUNDWATER LEVEL INFORMATION:
 Groundwater was not observed during excavation or after completion.
GENERAL NOTES:
 The exploration location and elevation are approximate and were estimated by Kleinfelder.

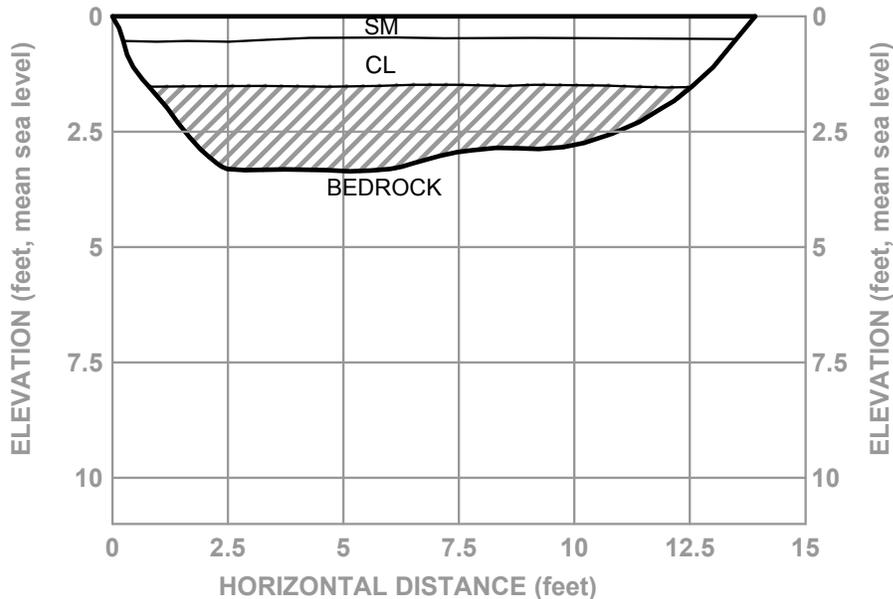
Bright People. Right Solutions.	PROJECT NO.: 20193141	TEST PIT LOG TP-3 PROPOSED COSTCO FUEL FACILITY SILVA VALLEY PARKWAY EL DORADO HILLS, CALIFORNIA	APPENDIX
	DRAWN BY: DA		A-5
CHECKED BY: DD	DATE: 7/11/2024		
REvised: 7/29/2024			PAGE: 1 of 1

The test pit was terminated at approximately 3.5 ft. below ground surface. The test pit was backfilled with on July 09, 2024.

GROUNDWATER LEVEL INFORMATION:
Groundwater was not observed during excavation or after completion.
GENERAL NOTES:
The exploration location and elevation are approximate and were estimated by Kleinfelder.

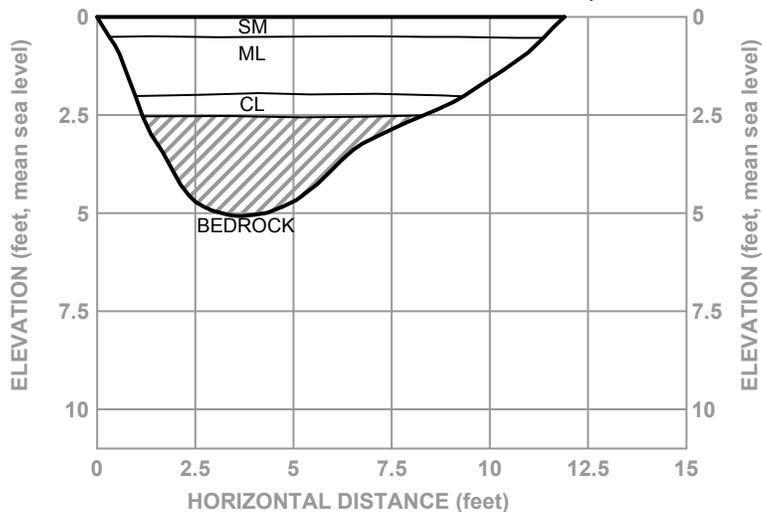
TEST PIT LOG TP-4
 PROPOSED COSTCO FUEL FACILITY
 SILVA VALLEY PARKWAY
 EL DORADO HILLS, CALIFORNIA

The exploration location and elevation are approximate and were estimated by Kleinfelder.

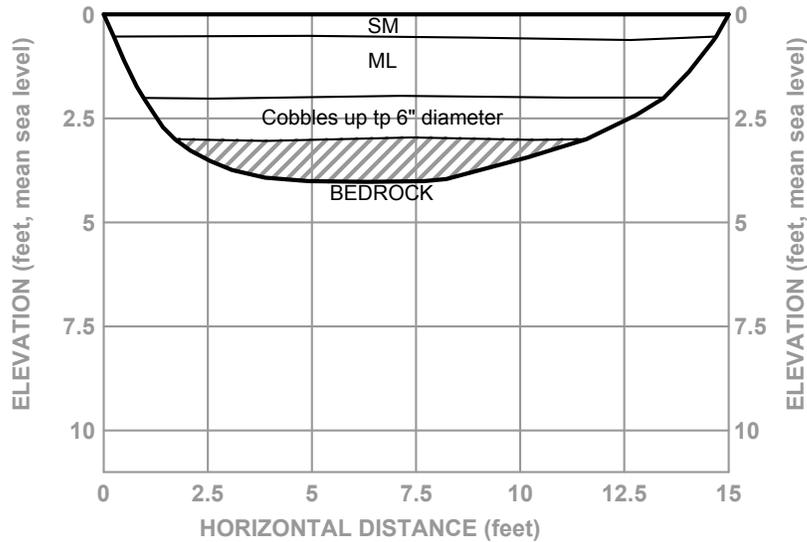
TEST PIT LOG TP-6
 PROPOSED COSTCO FUEL FACILITY
 SILVA VALLEY PARKWAY
 EL DORADO HILLS, CALIFORNIA

The test pit was terminated at approximately 4 ft. below ground surface. The test pit was backfilled with on July 09, 2024.

GROUNDWATER LEVEL INFORMATION:
Groundwater was not observed during excavation or after completion.
GENERAL NOTES:
The exploration location and elevation are approximate and were estimated by Kleinfelder.

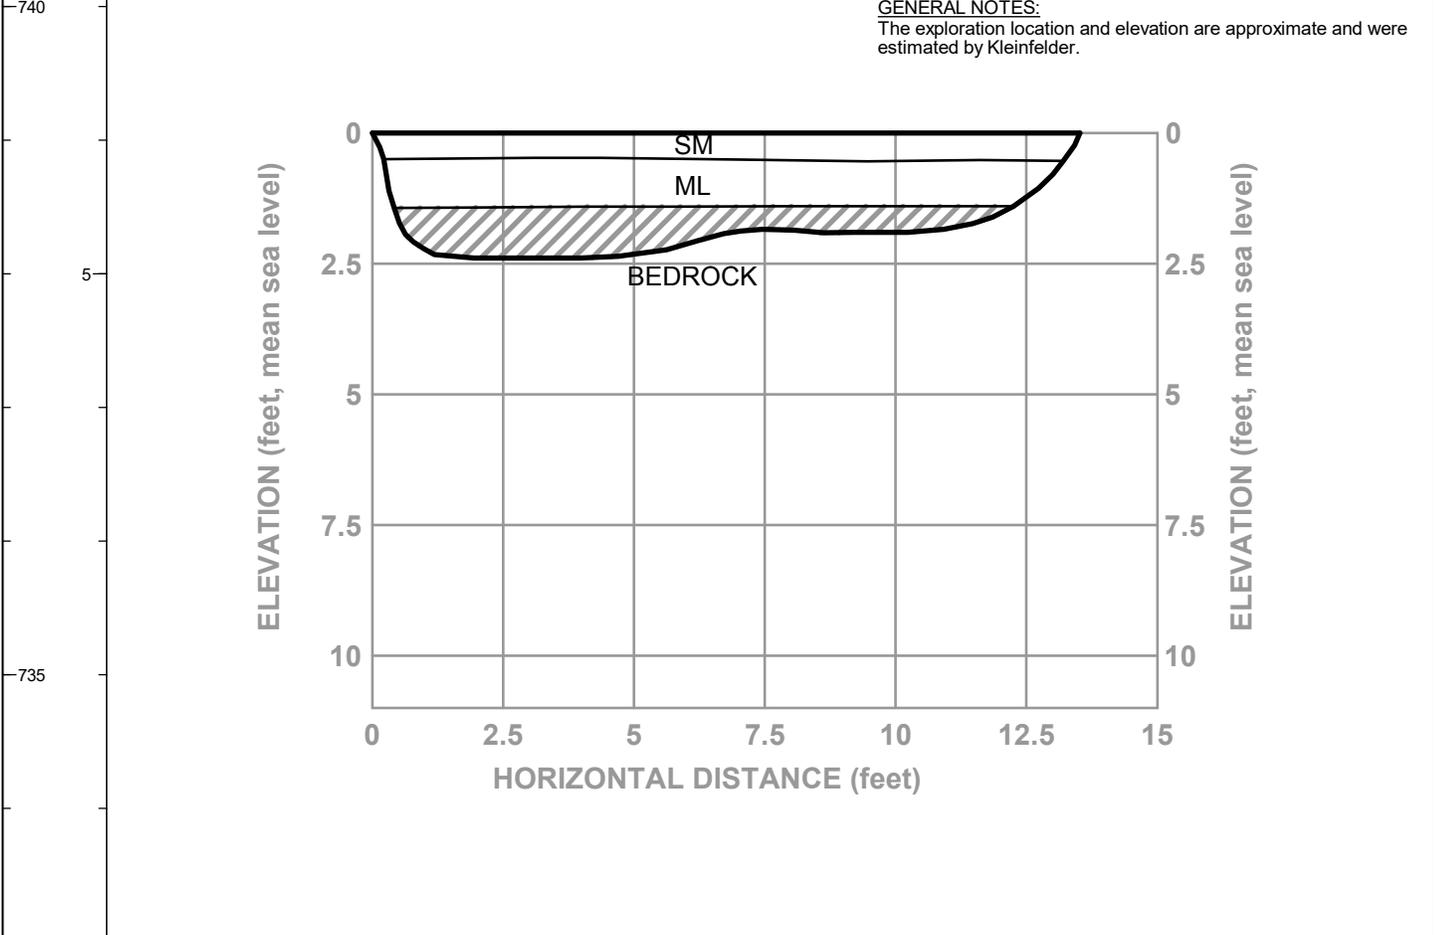
Bright People. Right Solutions.	PROJECT NO.: 20193141	TEST PIT LOG TP-7	APPENDIX
	DRAWN BY: DA	PROPOSED COSTCO FUEL FACILITY SILVA VALLEY PARKWAY EL DORADO HILLS, CALIFORNIA	A-9
CHECKED BY: DD	DATE: 7/11/2024		
	REVISED: 7/29/2024		PAGE: 1 of 1

The test pit was terminated at approximately 2.5 ft. below ground surface. The test pit was backfilled with on July 09, 2024.

GROUNDWATER LEVEL INFORMATION:
 Groundwater was not observed during excavation or after completion.
GENERAL NOTES:
 The exploration location and elevation are approximate and were estimated by Kleinfelder.

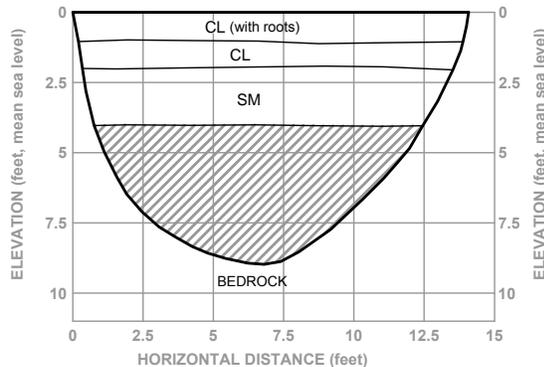
TEST PIT LOG TP-9
 PROPOSED COSTCO FUEL FACILITY
 SILVA VALLEY PARKWAY
 EL DORADO HILLS, CALIFORNIA

The test pit was terminated at approximately 9 ft. below ground surface. The test pit was backfilled with on July 09, 2024.

GROUNDWATER LEVEL INFORMATION:
Groundwater was not observed during excavation or after completion.
GENERAL NOTES:
The exploration location and elevation are approximate and were estimated by Kleinfelder.

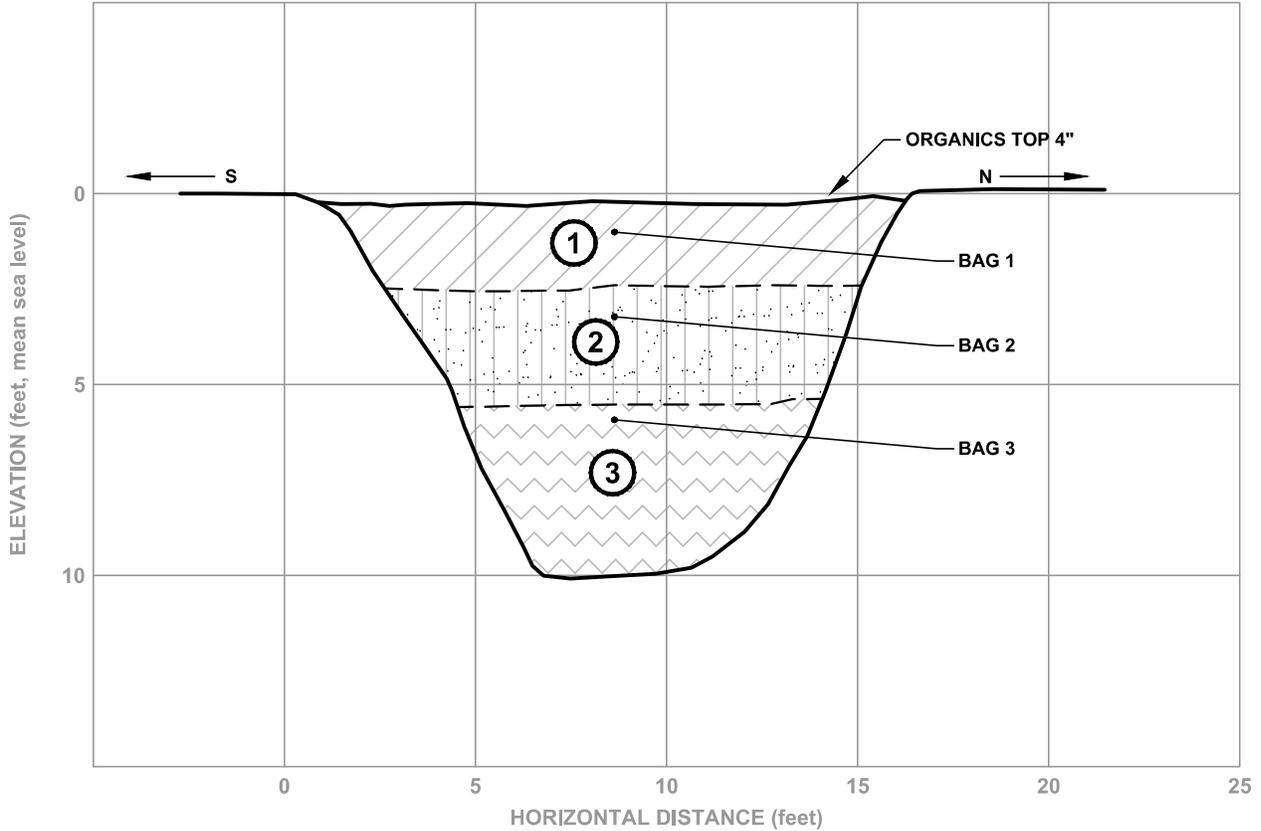
PROJECT NO. 20193141 DRAWN BY: JDS CHECKED BY: DD DATE: 02/21/2019 REVISED:	TEST PIT LOG TP-1 CSM COSTCO EL DORADO HILLS SILVA VALLEY PARKWAY EL DORADO HILLS, CALIFORNIA	FIGURE A-1
---	---	---	---------------

UNIT NO.	MATERIALS DESCRIPTION
①	SANDY LEAN CLAY (CL) - reddish brown, moist, soft, fine grained sand, medium plasticity, at 2' perched groundwater
②	SILTY SAND WITH GRAVEL (SM) - moist, coarse grained sand, 1/4"-1" angular gravels
③	METAVOLCANIC ROCK - well defined foliation, decomposed to highly weathered, extremely weak to weak, intensely fractured, behaves like silty gravel, at 9' highly fractured, weak

Latitude: 38.662952
Longitude: -121.05795

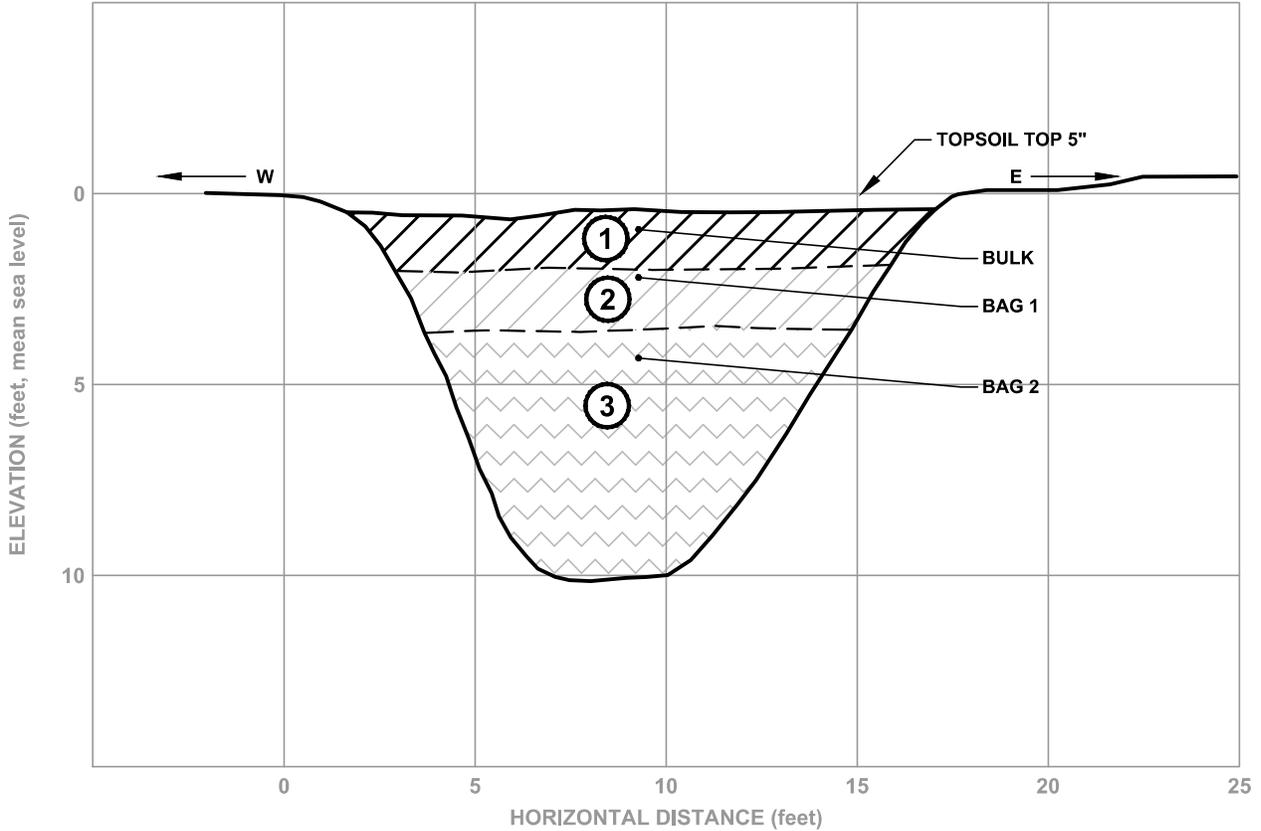
PROJECT NO. 20193141 DRAWN BY: JDS CHECKED BY: DD DATE: 02/21/2019 REVISED:	TEST PIT LOG TP-2 CSM COSTCO EL DORADO HILLS SILVA VALLEY PARKWAY EL DORADO HILLS, CALIFORNIA	FIGURE A-2
---	---	---	-------------------

UNIT NO.	MATERIALS DESCRIPTION
①	FAT CLAY WITH SAND (CH) - wet, very soft, fine grained sand, high plasticity, at 2' perched groundwater
②	SANDY LEAN CLAY WITH GRAVEL (CL) - pale olive, moist, medium stiff, fine grained sand, medium plasticity, 1/4" angular gravel
③	METAVOLCANIC ROCK - highly weathered, highly fractured, slight foliation, at 8' pockets of moderately fractured rock but only about 10-20% of total

Latitude: 38.66314
Longitude: -121.05639

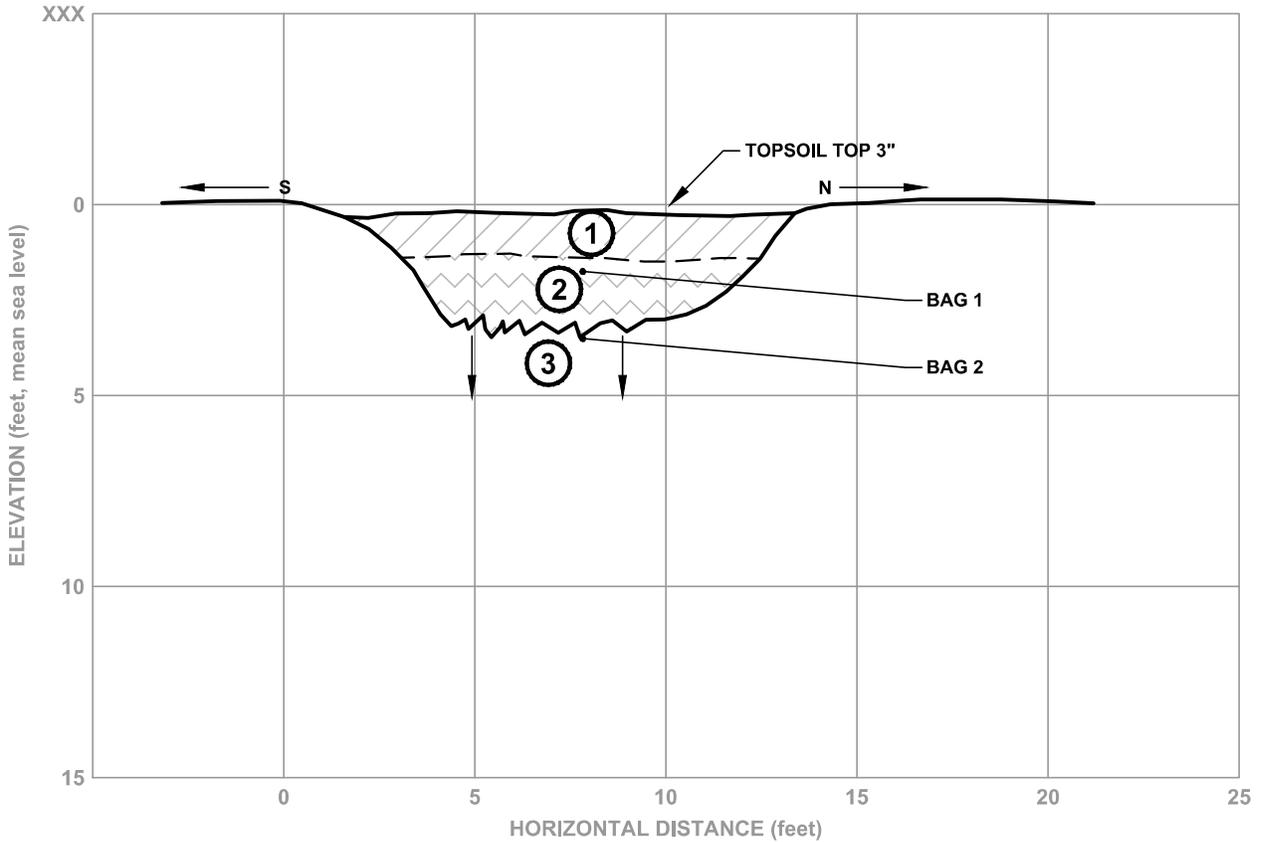
FIGURE
 A-3

UNIT NO.	MATERIALS DESCRIPTION
①	SANDY LEAN CLAY (CL) - reddish brown, moist, soft, medium plasticity, PP = 0.5
②	METAVOLCANIC ROCK - highly weathered, strong, highly fractured, well defined foliation's, some pockets of moderately fractured
③	METAVOLCANIC ROCK - moderately weathered, strong, moderately fractured, well defined foliation, 8" pieces observed, refusal at 3'-3" deep
Latitude: 38.66296 Longitude: -121.05699

TEST PIT LOG
 TP-3
 CSM COSTCO EL DORADO HILLS
 SILVA VALLEY PARKWAY
 EL DORADO HILLS, CALIFORNIA

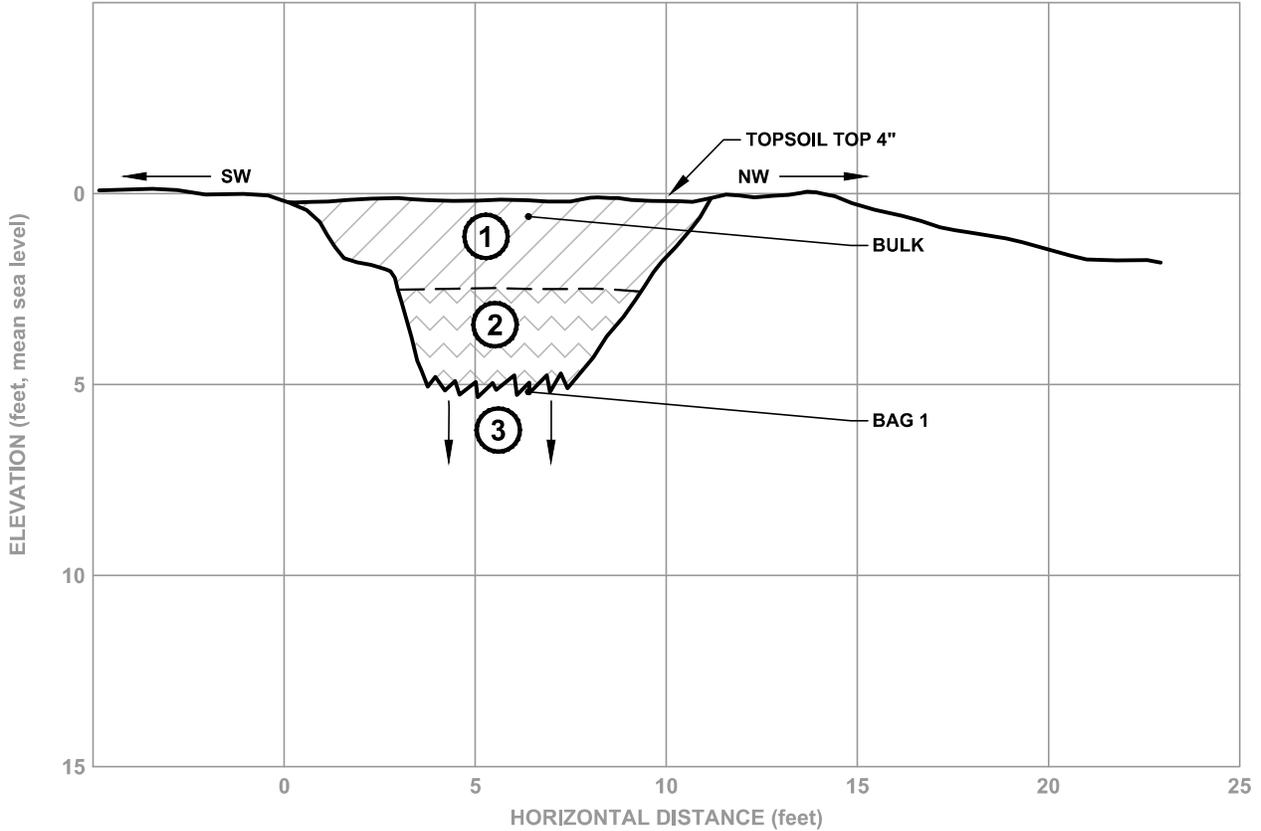
UNIT NO.	MATERIALS DESCRIPTION
①	SANDY LEAN CLAY (CL) - wet, free flowing water, soft, fine grained sand, medium plasticity, 1/4" gravel
②	METAVOLCANIC ROCK - highly weathered, medium strong, highly fractured, moderately foliated, behaves like poorly graded sand with gravel
③	METAVOLCANIC ROCK - moderately weathered, strong, moderately fractured, refusal at 5' deep Latitude: 38.66263 Longitude: -121.05695

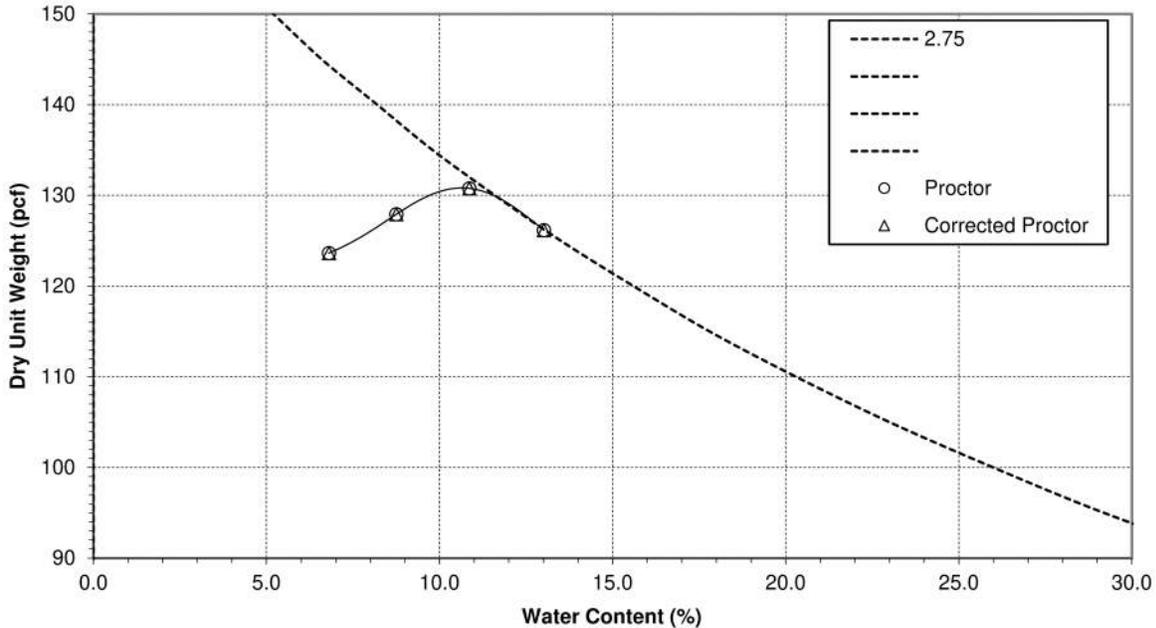
Location: **TP-4 Sample 2 @ 1-2'**

Material Description: **Dark Reddish Brown Sandy Lean CLAY with Gravel**

Test Method: ASTM D1557 B	Uncorrected	Corrected
Maximum Dry Unit Weight (pcf)	130.8	na
Optimum Water Content (%)	10.7	na
Oversize Fraction, retained on 3/4 (%)		<5
Bulk Specific Gravity of Oversize Fraction		na

Rammer Type: Manual

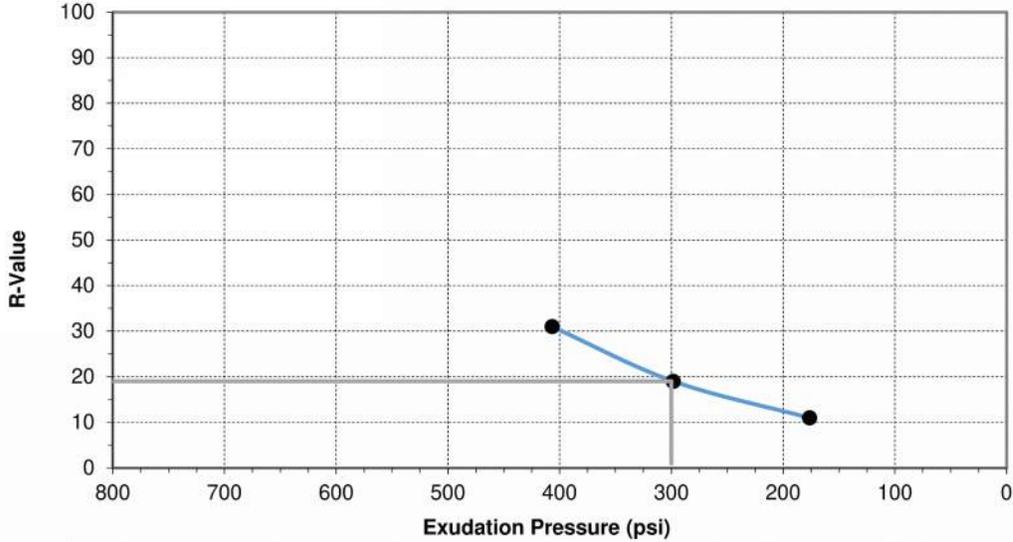
Specific Location: **TP-8-1.0-2.0'**

Material Description: **Dark Reddish Brown Lean CLAY with gravel**

Briquette No.	A	B	C
Dry Unit Weight at Test (pcf)	116.5	121.1	119.0
Expansion Pressure (psf)	39	104	87
Exudation Pressure (psi)	176	407	298
Moisture at Time of Test (%)	17.1	15.2	16.1
Resistance Value	11	31	19
R - VALUE AT 300 PSI EXUDATION PRESSURE:			19

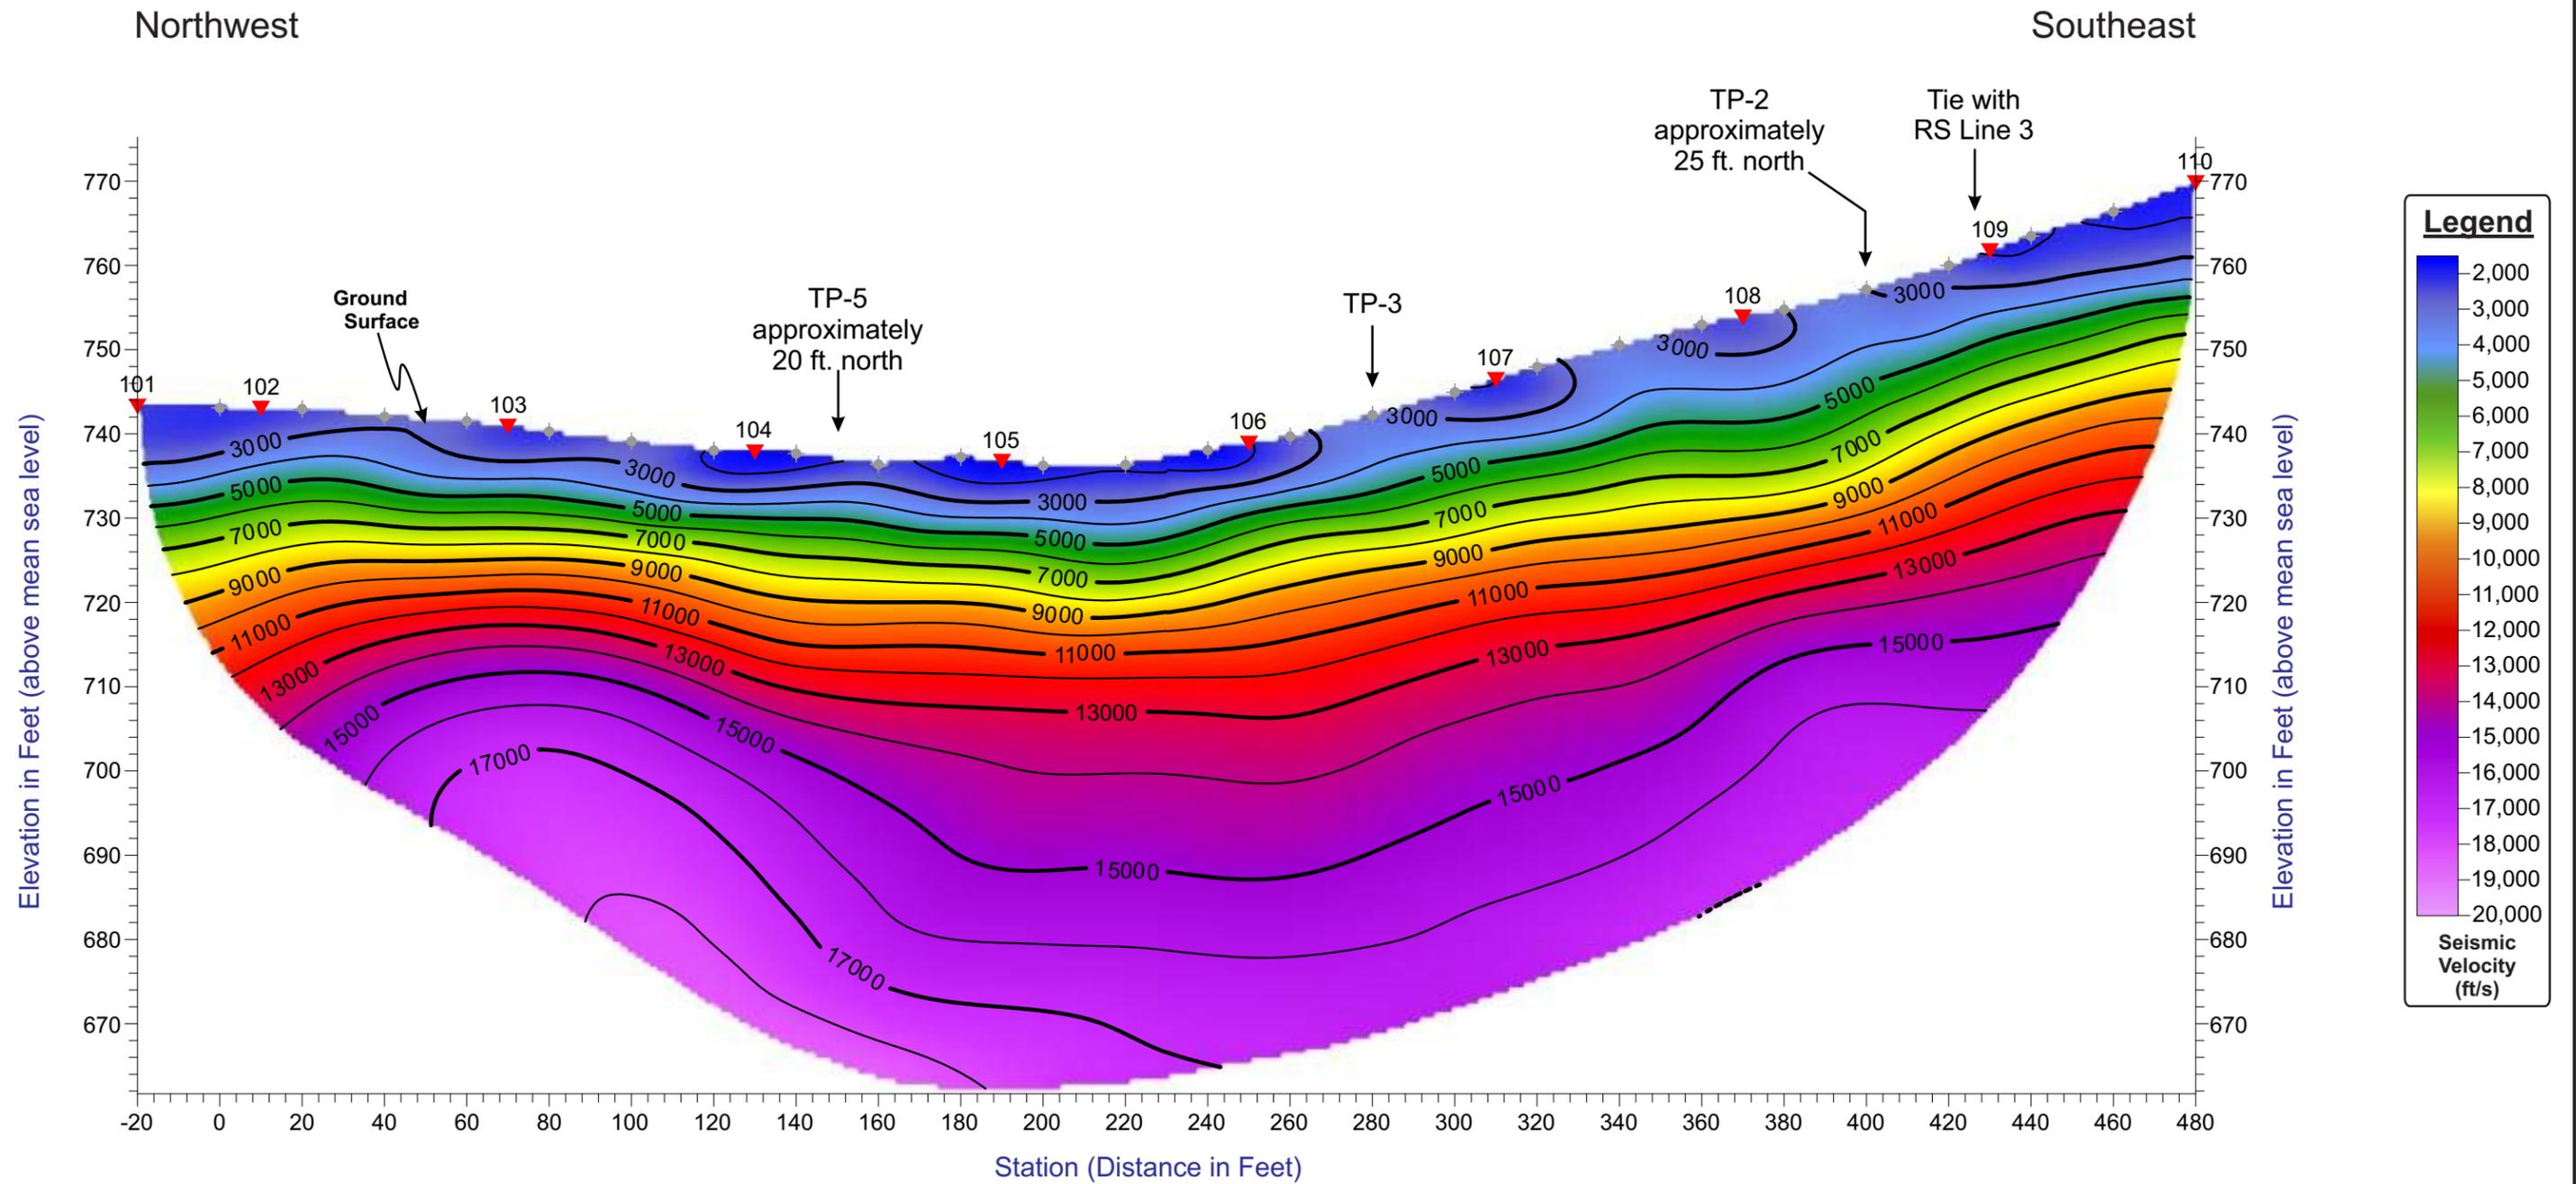
Figure 3

Seismic Velocity Section • RS Line 1

Scale:
 Horizontal: 1" = 40'
 Vertical: 1" = 20'

The results of this refraction seismic investigation are summarized by Figures 3 through 5. These seismic velocity sections, which were created through the inversion process, have very low error and provide a high degree of lateral definition of the seismic velocity horizons found beneath each line. The seismic velocity sections have been scaled from 1,500 ft/s to 20,000 ft/s for the velocity window. Horizontal and vertical axes have been scaled to 40 feet per inch in the horizontal and 20 feet per inch in the vertical.

RS Line 1 (Figure 3)
