Geotechnical Study
(December 10, 2024)

**SUBJECT: Geotechnical Study
Proposed Costco Fuel Facility
Silva Valley Parkway
El Dorado Hills, California
CW# 18-0487**

**GEOTECHNICAL STUDY
PROPOSED COSTCO FUEL FACILITY
SILVA VALLEY PARKWAY
EL DORADO HILLS, CALIFORNIA
CW# 18-0487
KLEINFELDER PROJECT NO. 20193141.002A**

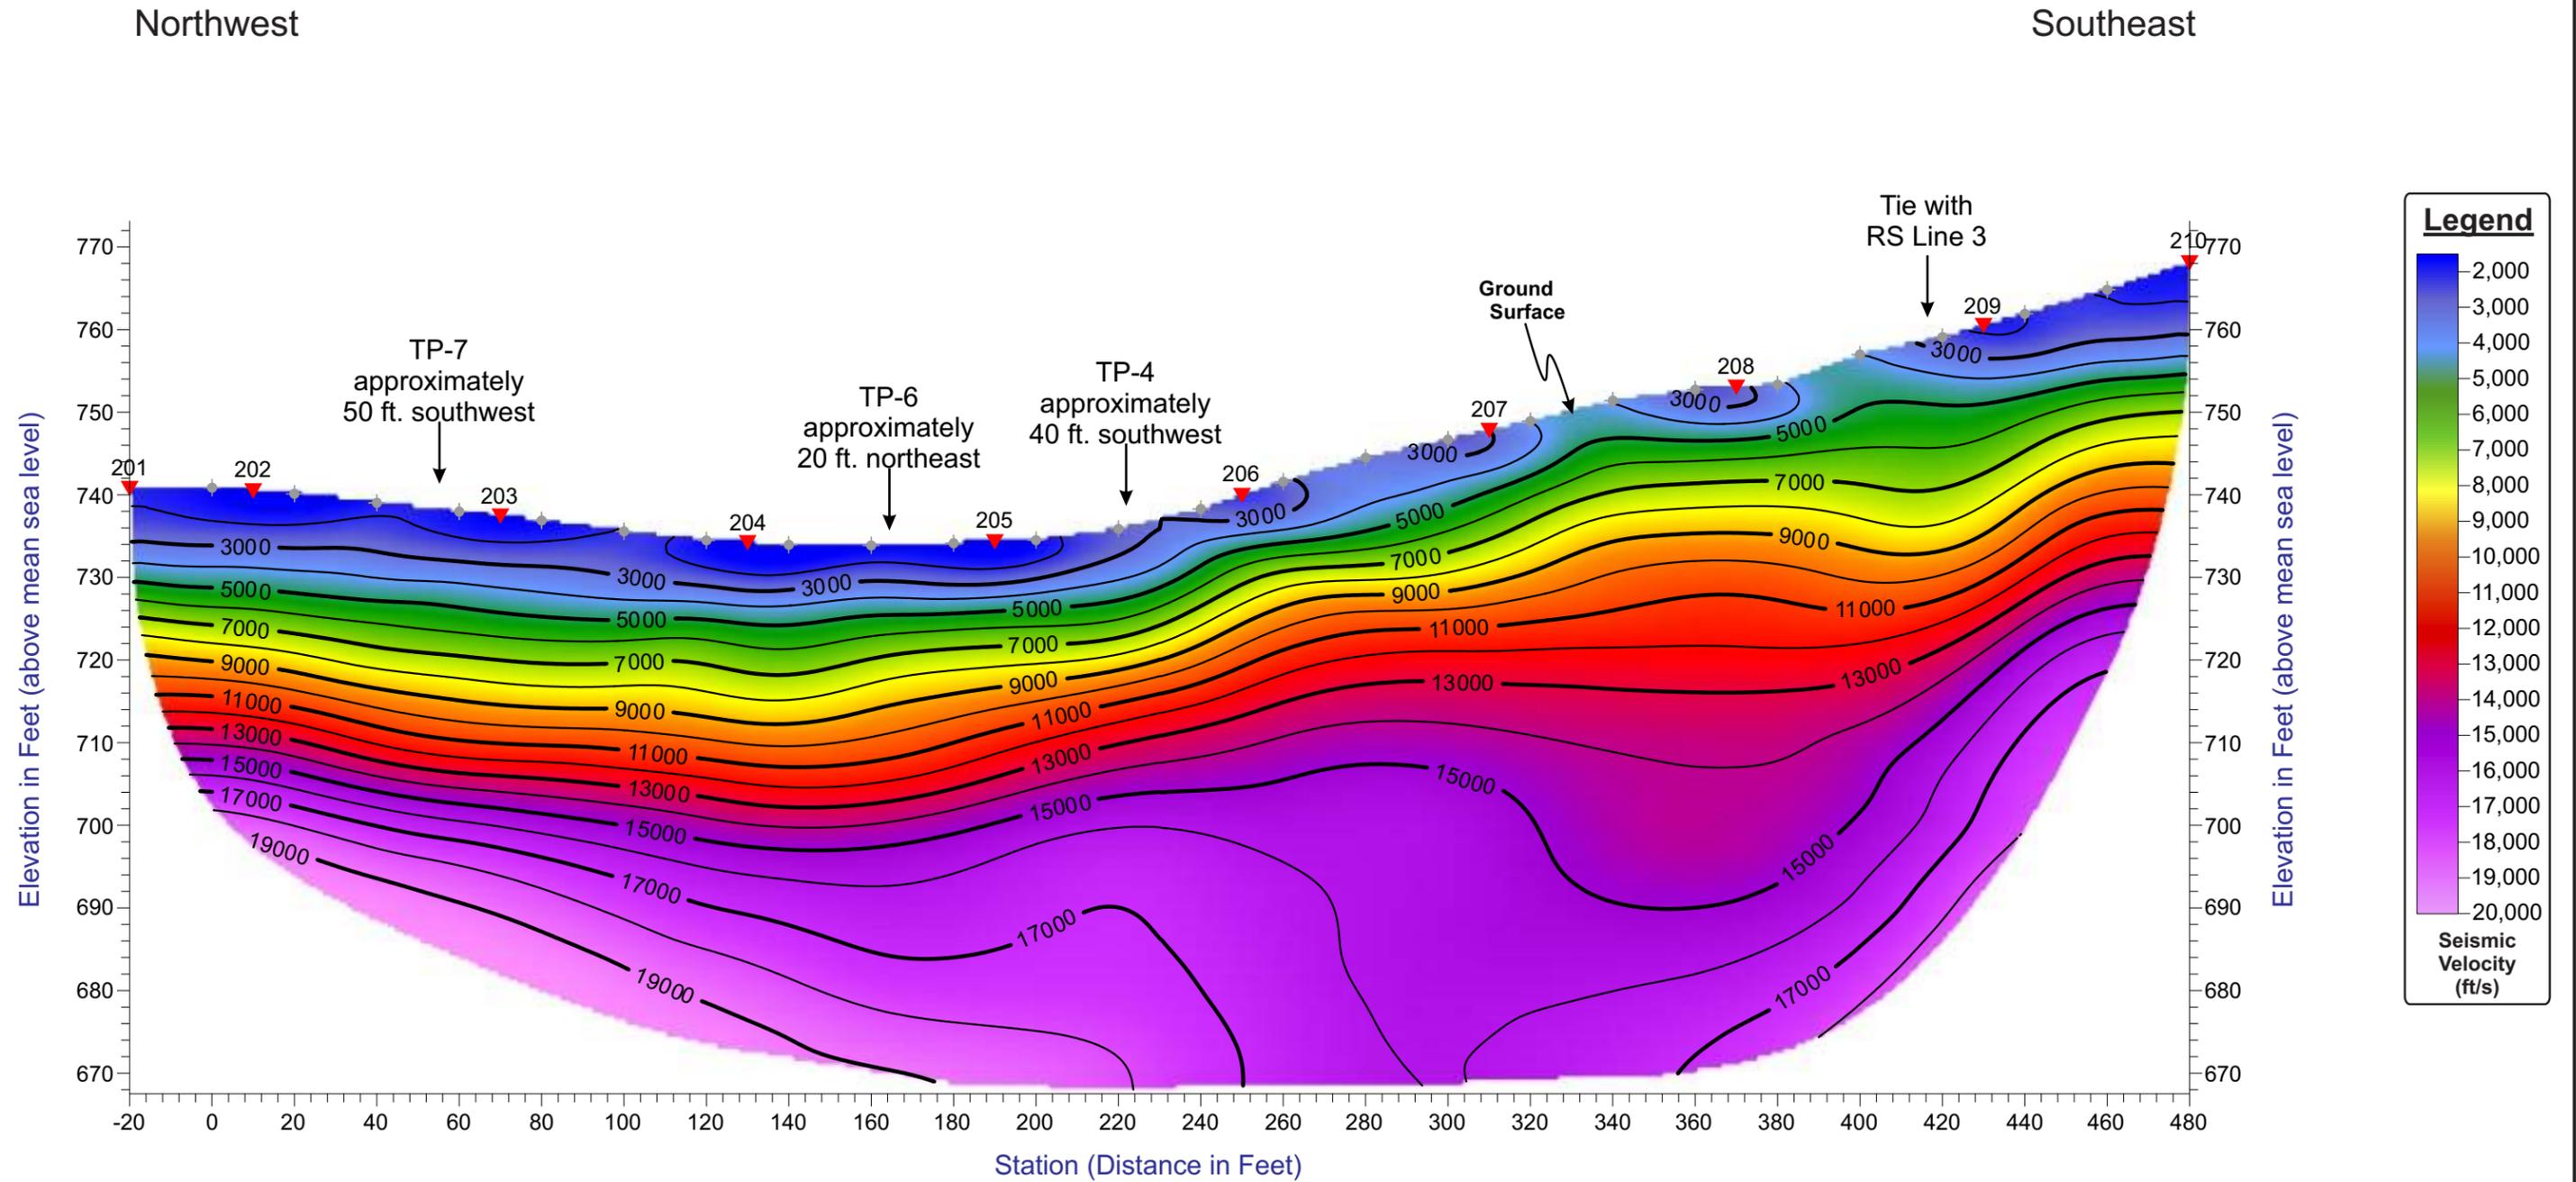
Figure 4

Seismic Velocity Section • RS Line 2

Scale:
Horizontal: 1" = 40'
Vertical: 1" = 20'

The results of this refraction seismic investigation are summarized by Figures 3 through 5. These seismic velocity sections, which were created through the inversion process, have very low error and provide a high degree of lateral definition of the seismic velocity horizons found beneath each line. The seismic velocity sections have been scaled from 1,500 ft/s to 20,000 ft/s for the velocity window. Horizontal and vertical axes have been scaled to 40 feet per inch in the horizontal and 20 feet per inch in the vertical.

RS Line 2 (Figure 4)

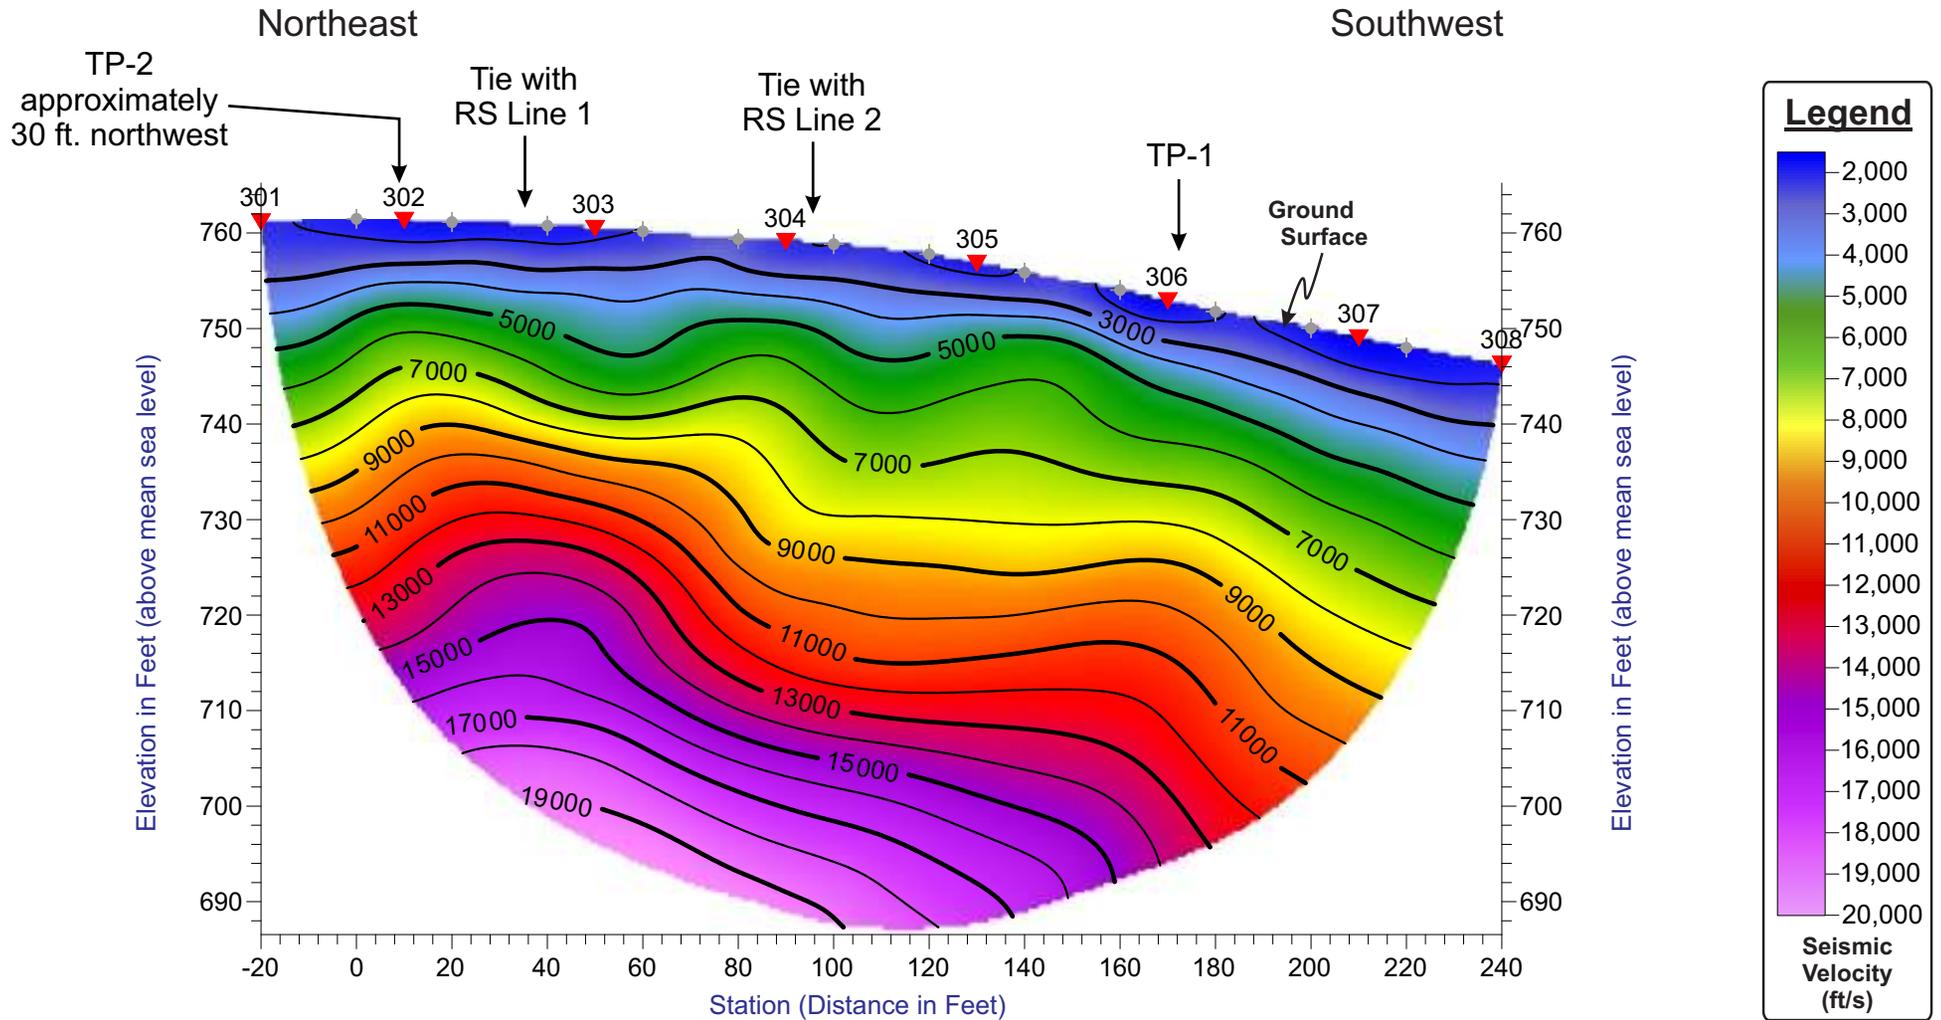
Figure 5

Seismic Velocity Section • RS Line 3

Scale:
Horizontal: 1" = 40'
Vertical: 1" = 20'

RS Line 3 (Figure 5)

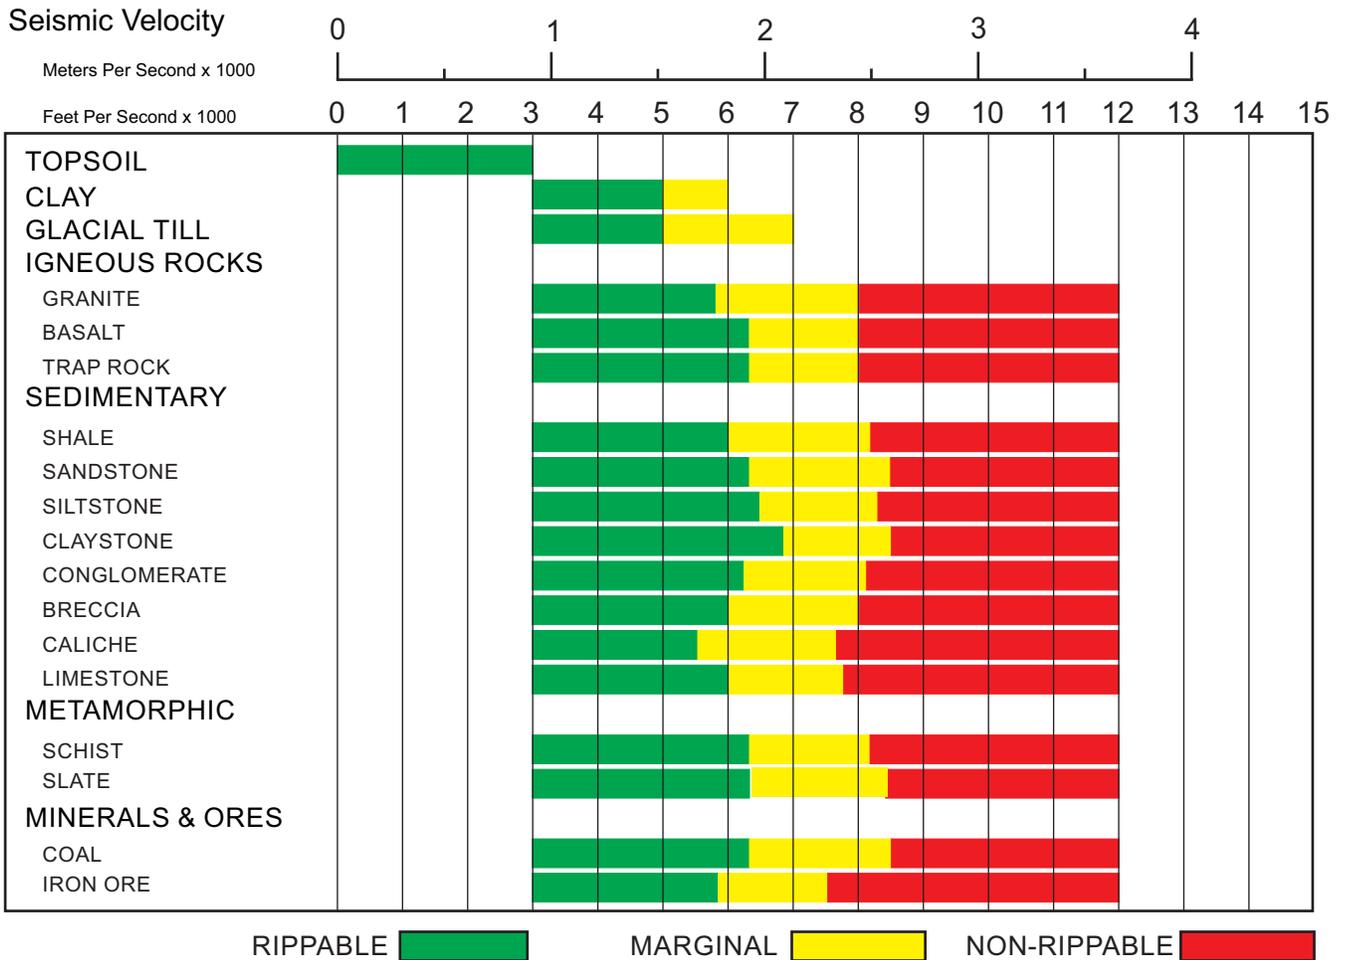
D8R/D8T

Multi or Single Shank No. 8 Ripper
 Estimated by Seismic Wave Velocities

* Based on the Caterpillar Performance Handbook Edition 49 - September, 2019

Seismic p-wave velocities are related to both rock hardness and fracture density. Rippability has been empirically correlated to refraction seismic velocities by Caterpillar Inc., as displayed on Figure 6 for a CAT D8R/D8T (Caterpillar Performance Handbook, Edition 49, September, 2019). According to this chart, metamorphic/sedimentary rock, in this case slates and shales, becomes marginally rippable around 6,000 to 6,300 ft/s and non-rippable around 8,200 ft/s for a D8R/D8T dozer with multiple or single shank No. 8 ripper. These estimations are based on the published values for igneous rocks on the CAT chart; however, site geology and topography may cause some variations of these values.

In general, rippability with a CAT D8R/D8T (or equivalent) should not be problematic to the depths noted above for each RS Line; however, depending on the maximum depth of excavation, progress may be slower or difficult as zones of higher velocity material are encountered. Should this be the case, drilling and blasting may be the most effective method to fracture the rock for further excavation.

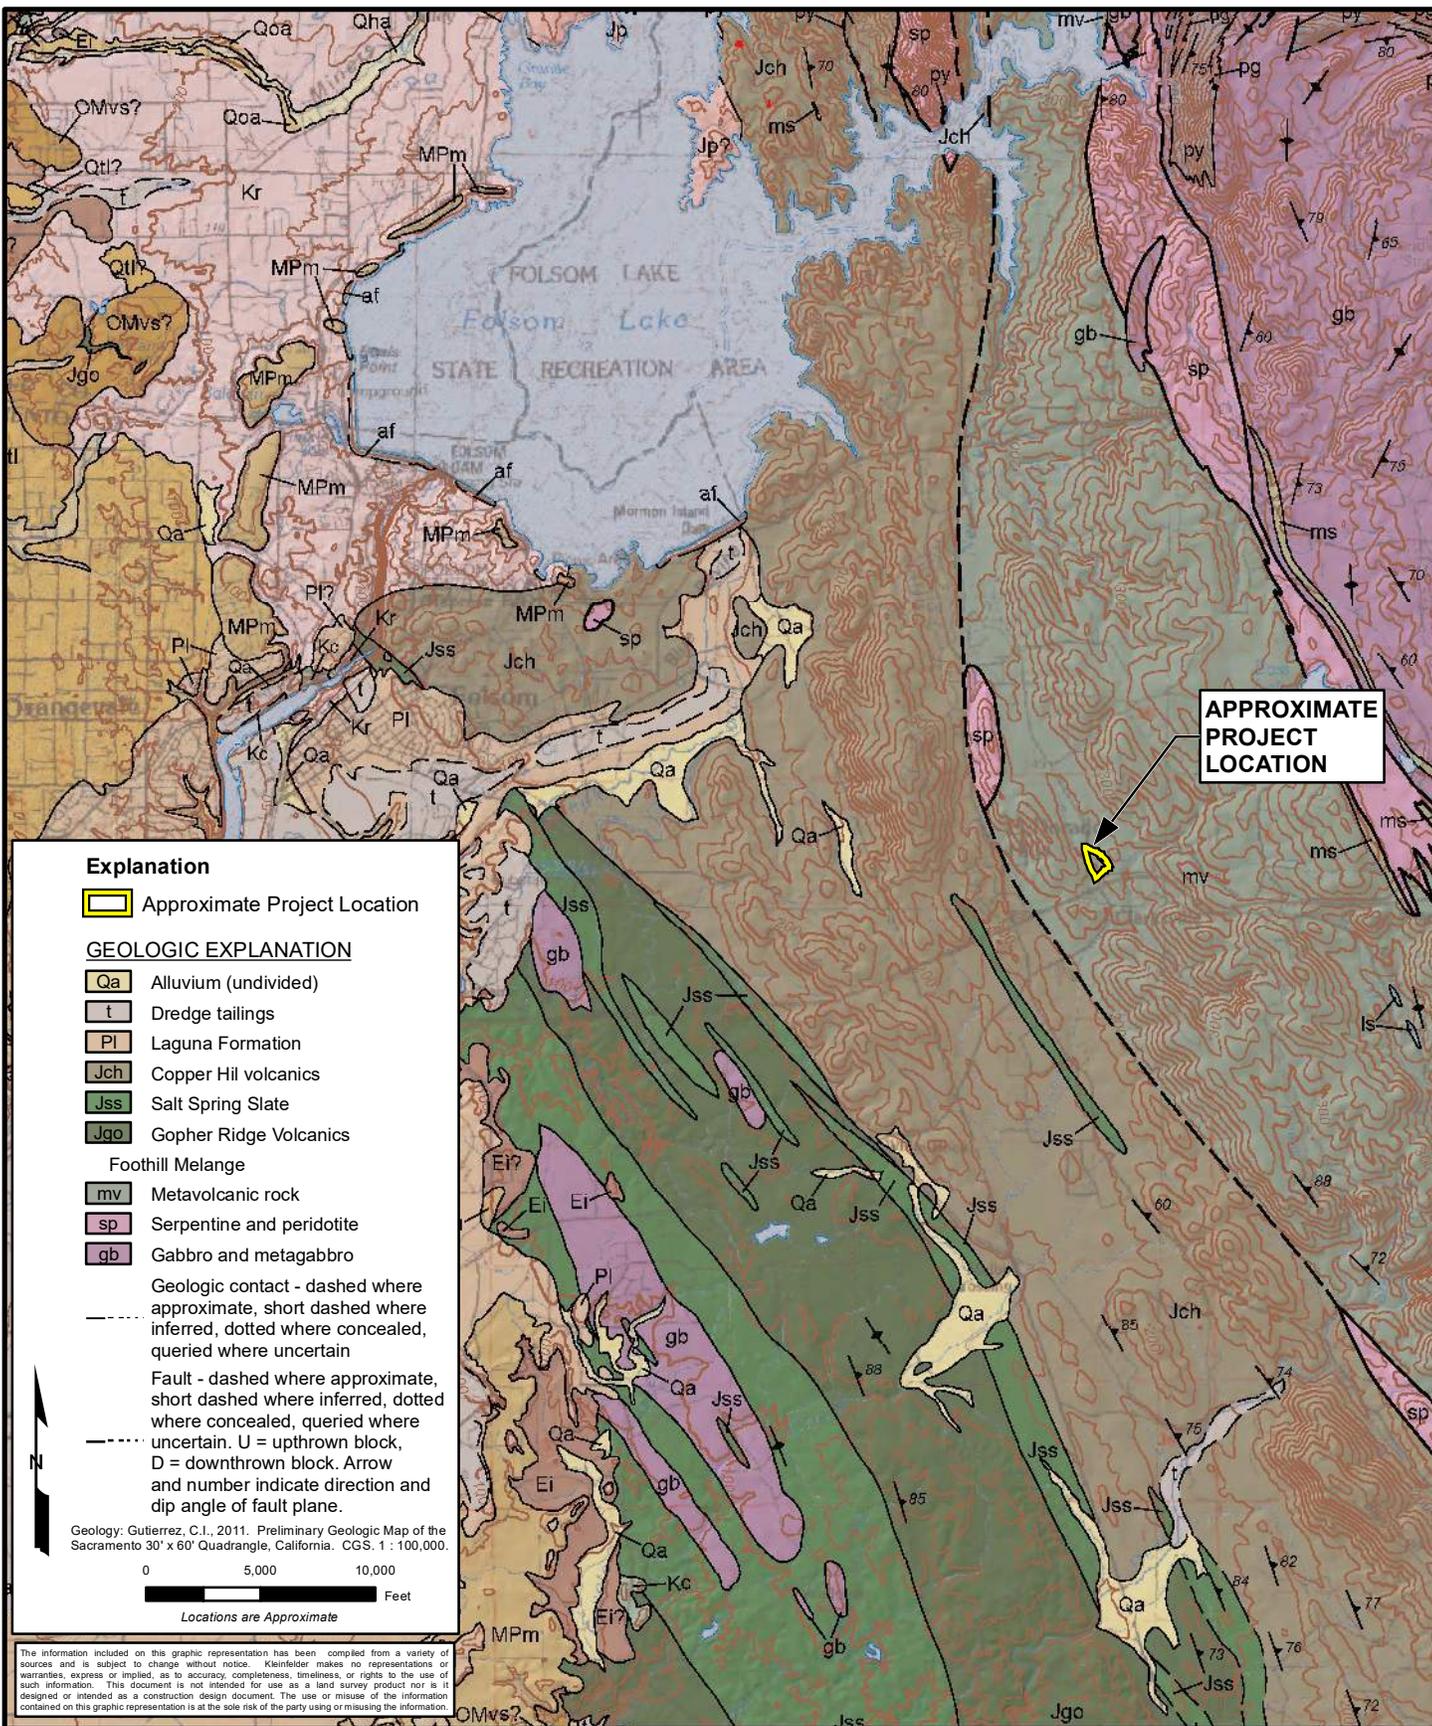
PROJECT: 20193141	REGIONAL GEOLOGY MAP	FIGURE
	DRAWN: OCT 2019		
	DRAWN BY: KFH	CSM COSTCO EL DORADO HILLS SILVA VALLEY PARKWAY EL DORADO HILLS, CALIFORNIA	3
	CHECKED BY: DD		
FILE NAME: Fig3_Geo.mxd

The subject site is situated in the gently rolling topography that forms the western foothills of the Sierra Nevada Mountains. The western foothills are broadly tilted, dipping westward, and uplifted increasingly to the east, due to maximum uplift of the Sierra Nevada at its eastern edge. The Sierra Nevada is comprised mostly of large, north-south elongated blocks of Mesozoic granitic terrain forming the backbone of California. The foothills in the project vicinity consist of a northwest-trending belt of metamorphosed volcanic and sedimentary rock that separate the Sierran crystalline basement rock (granites) from the Central Valley sediments. These rocks are distributed within three major north-south trending, fault-bounded lithologic terrains that extend along the length of the metamorphic belt. Rocks within these terrains have been isoclinally folded and metamorphosed on a regional scale and represent a “collage” of tectonically accreted blocks emplaced during convergent plate tectonism that occurred during the Early Paleozoic and Late Jurassic. Bedding, foliation, and major faults throughout the metamorphic belt normally trend northwest and dip steeply to the east. A map of the regional geology is provided in Figure 3 of this report.

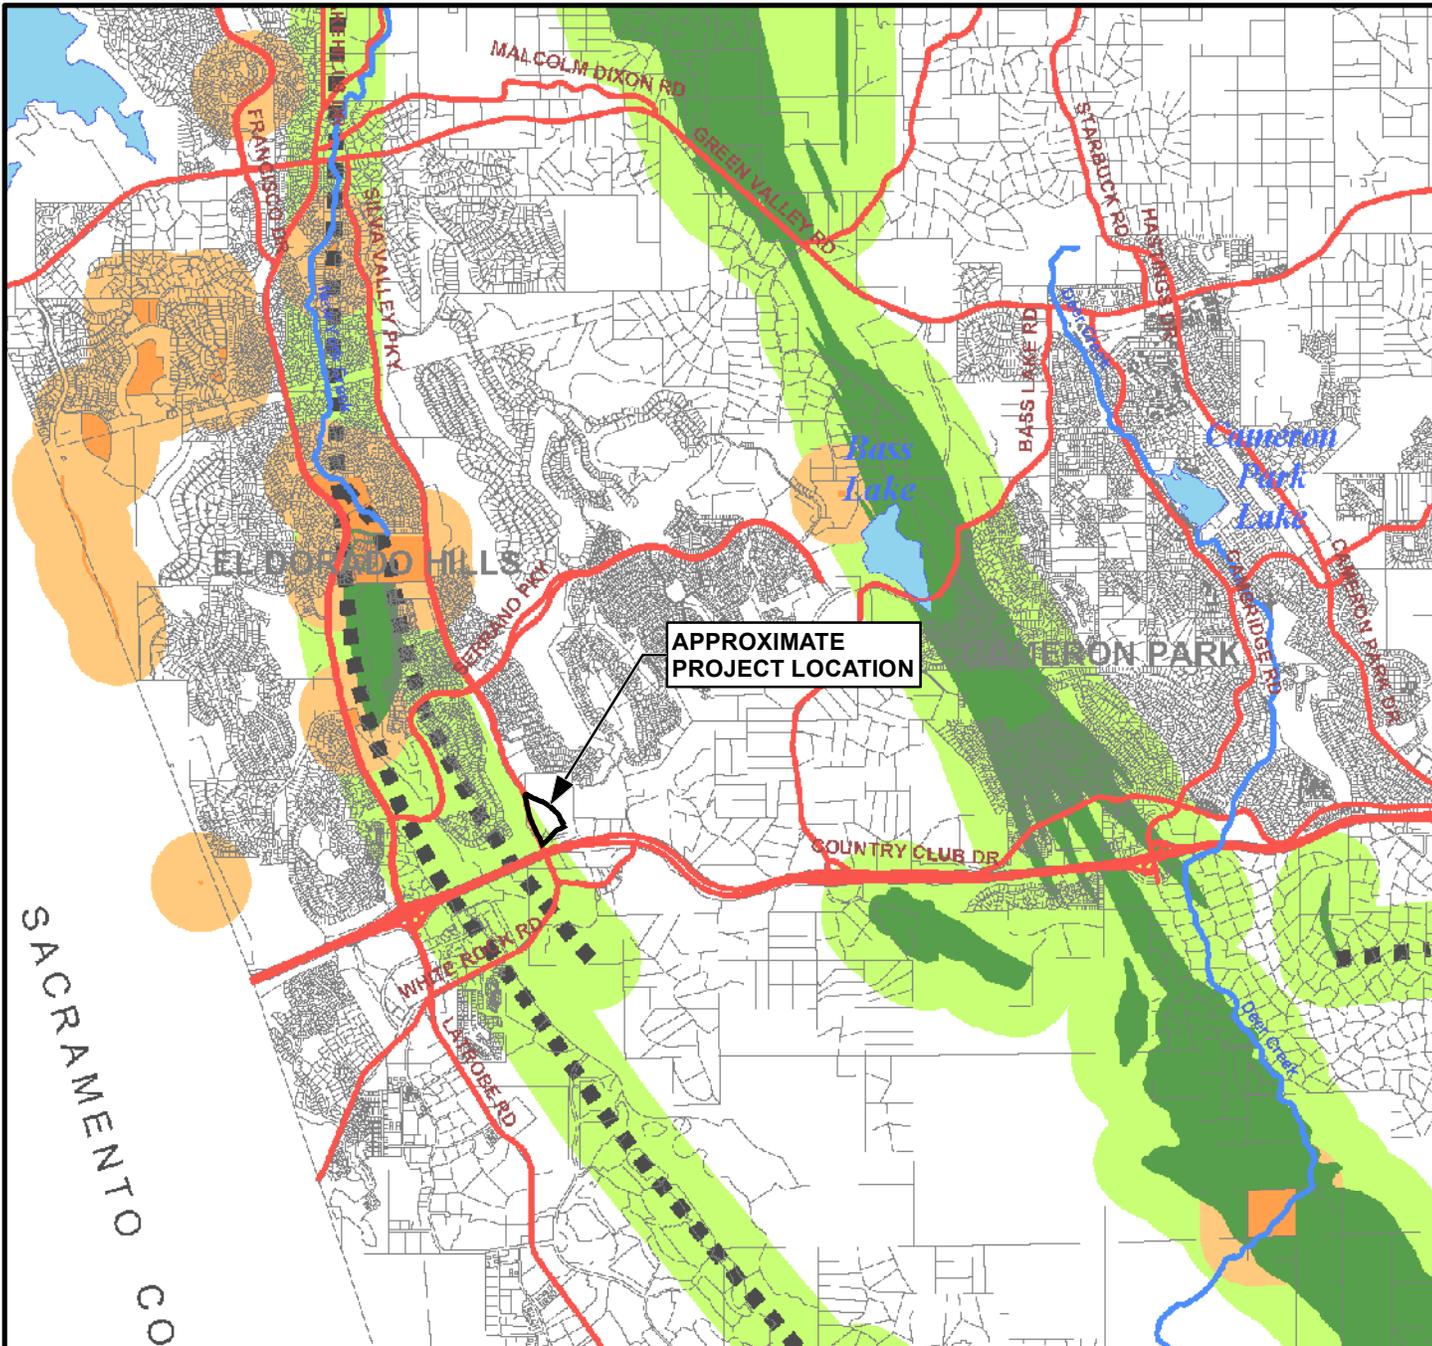
FIGURE
4

NATURALLY OCCURING ASBESTOS MAP

Figure 4 provides general guidelines as to the likelihood of encountering NOA for both El Dorado and Sacramento counties.

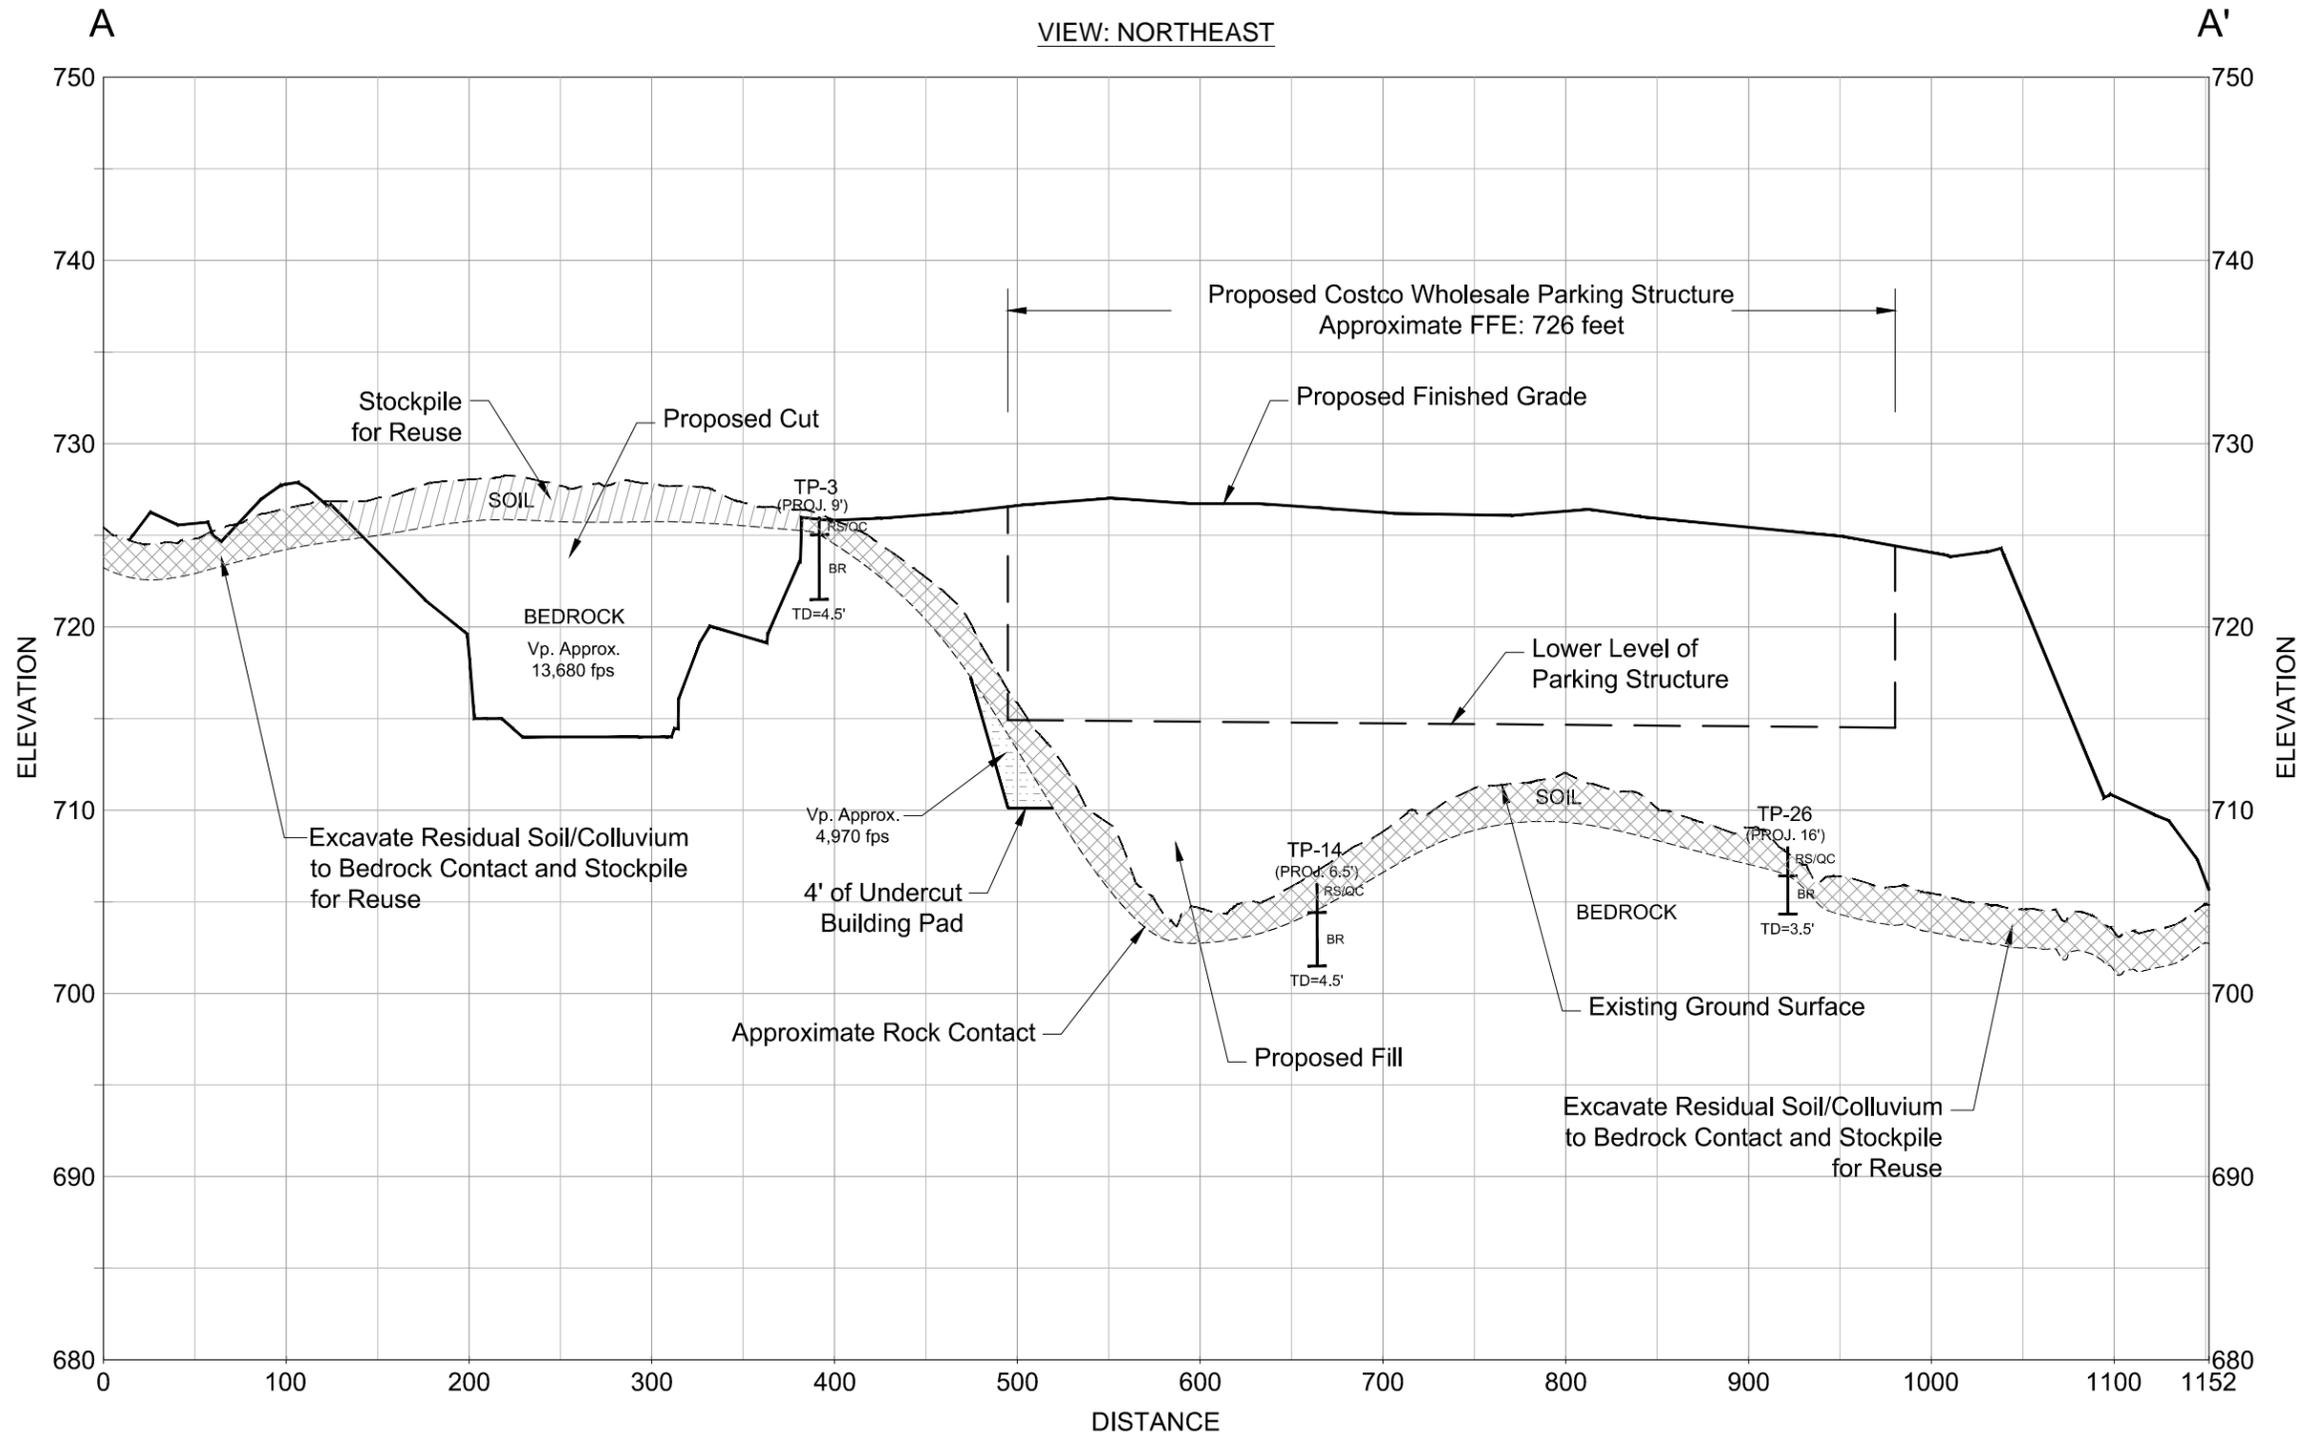
FIGURE
5

LEGEND
 RS/QC Residual Soil and/or Colluvium
 BR Bedrock

CROSS SECTION A - A'

- The residual soil/colluvial layer should be excavated to underlying weathered rock contact and stockpiled on site for reuse as structural fill. An estimate of the residual soil/colluvial layer thickness is shown on the cross sections (Figures 5 through 10).

Prior to grading and subgrade preparation, all vegetation should be cut and removed from the site. Roots and vegetative matter in excess of one inch should be removed by screening or raking soils to a minimum depth of 12 inches. Other than plant roots, organic matter in the topsoil is minimal based on our laboratory testing (between one and three percent). The topsoil can be re-used in site fills. The residual soil/colluvial layer should be excavated to underlying weathered rock contact and stockpiled on site for reuse as structural fill. An estimate of the residual soil/colluvial layer thickness is shown on the attached cross sections (Figures 5 through 10).

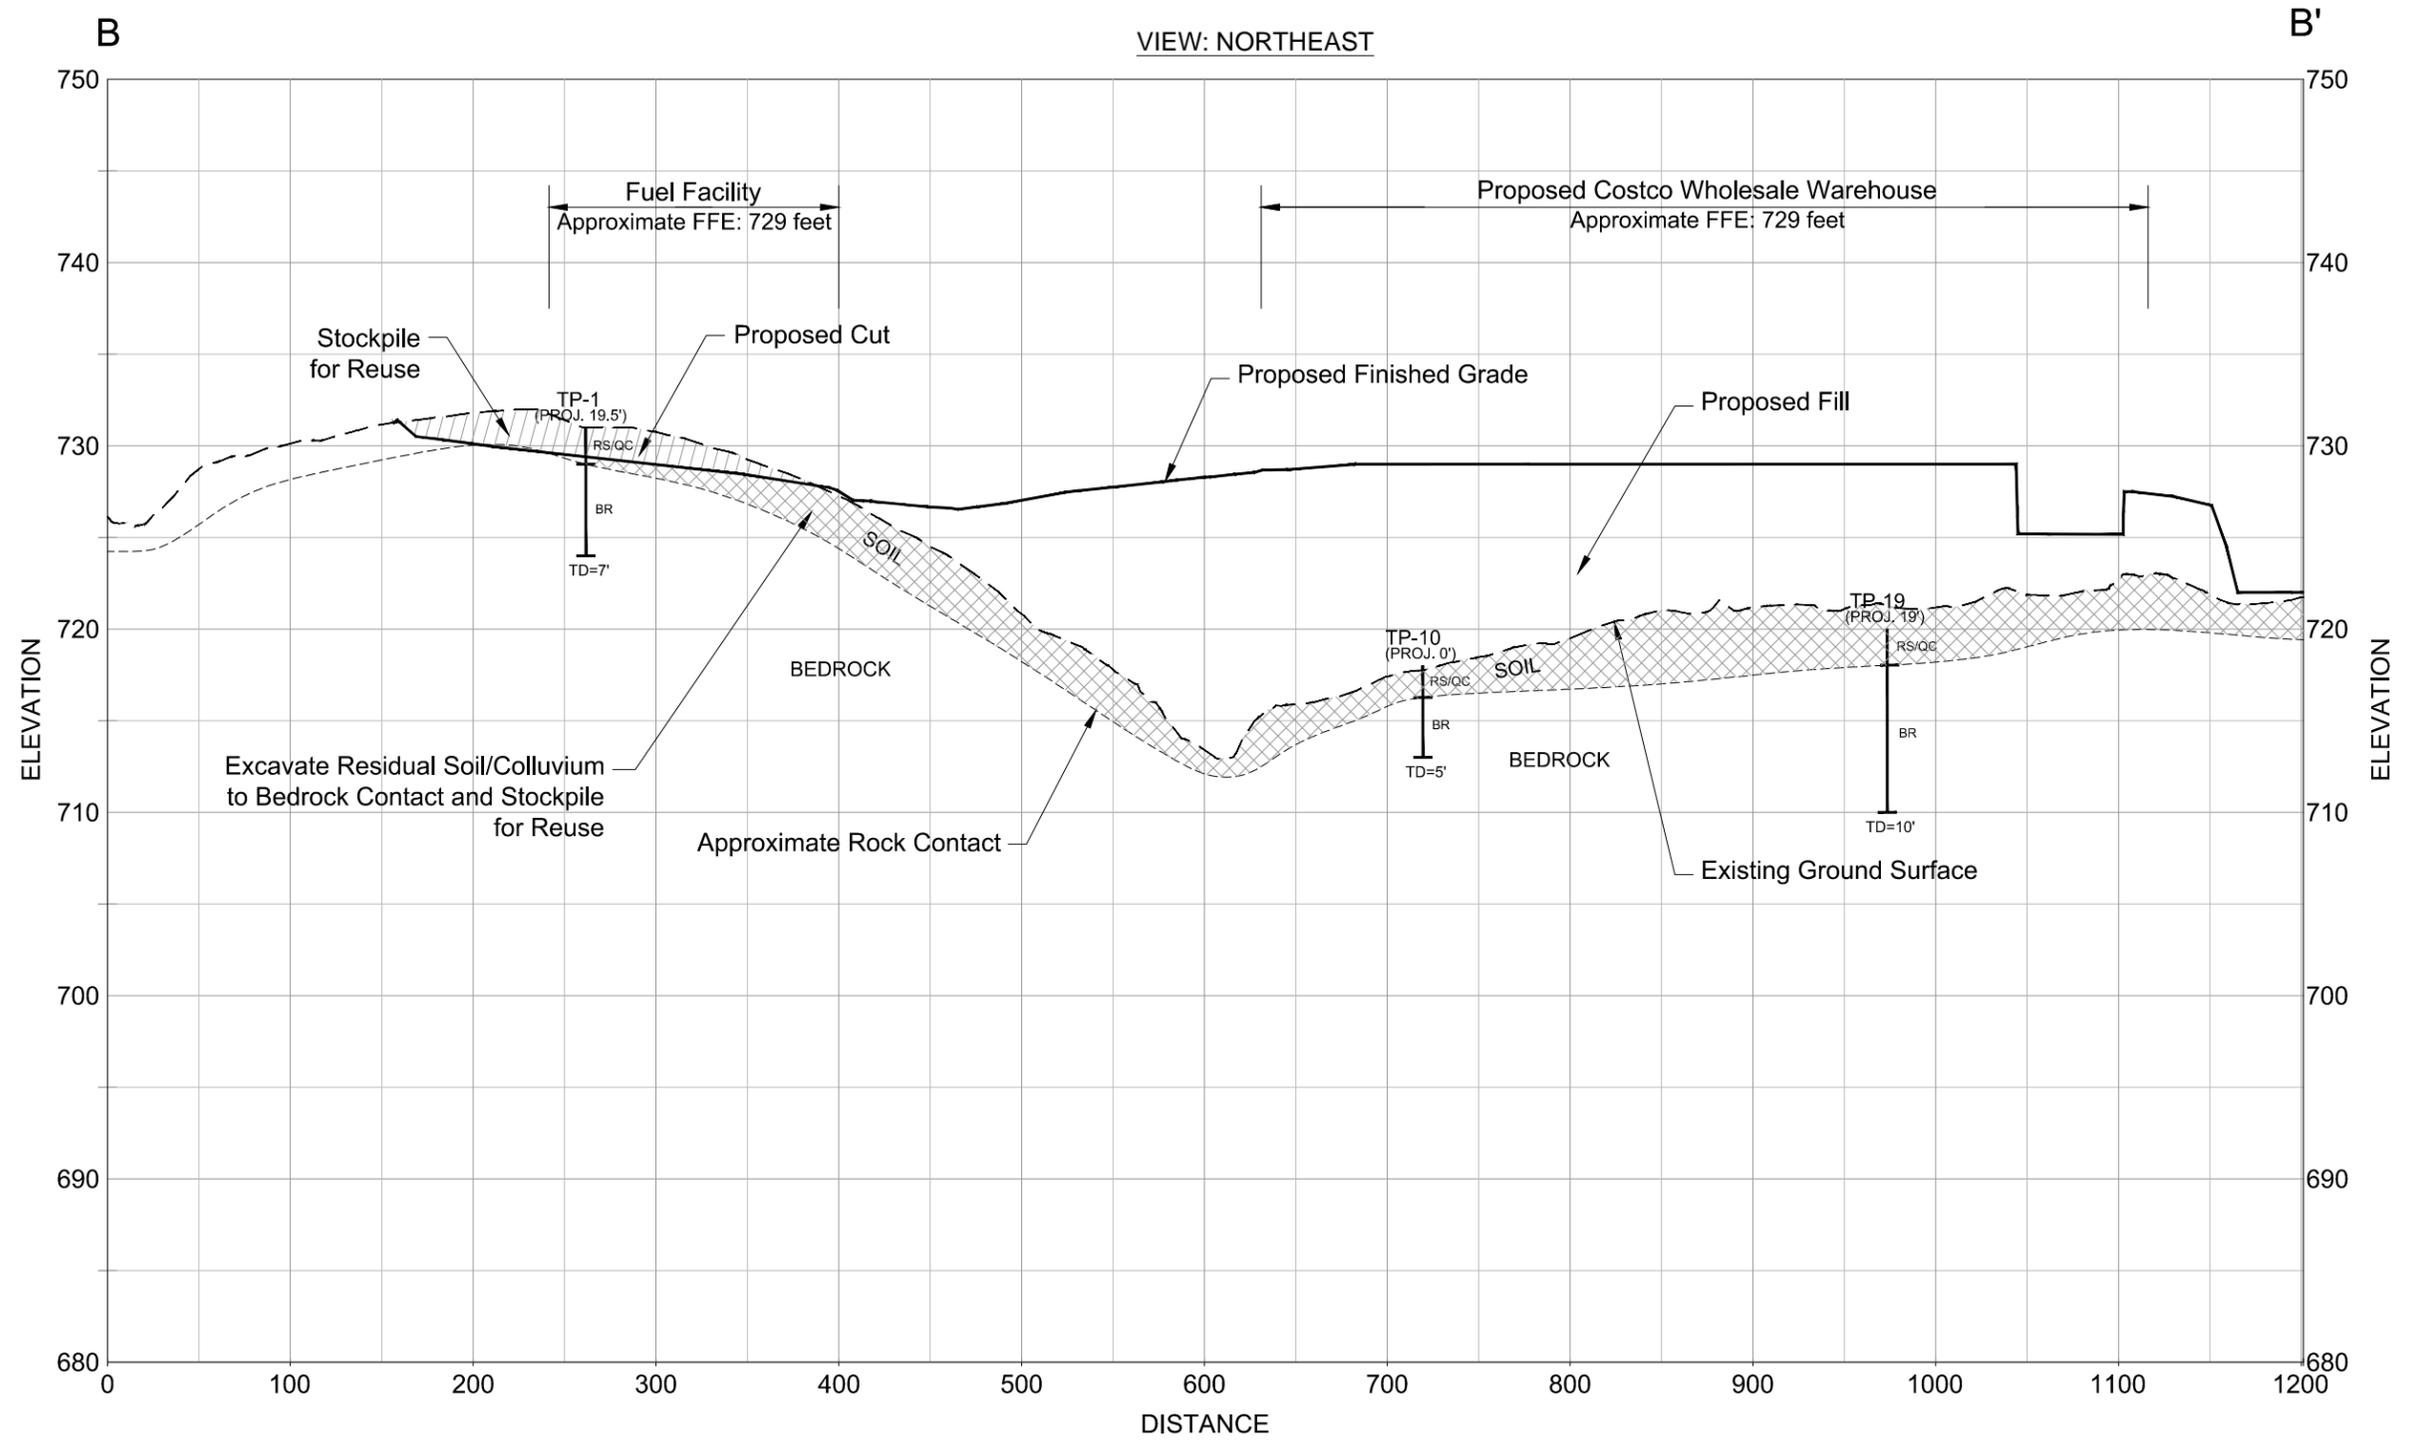
6

LEGEND
 RS/QC Residual Soil and/or Colluvium
 BR Bedrock

CROSS SECTION B - B'

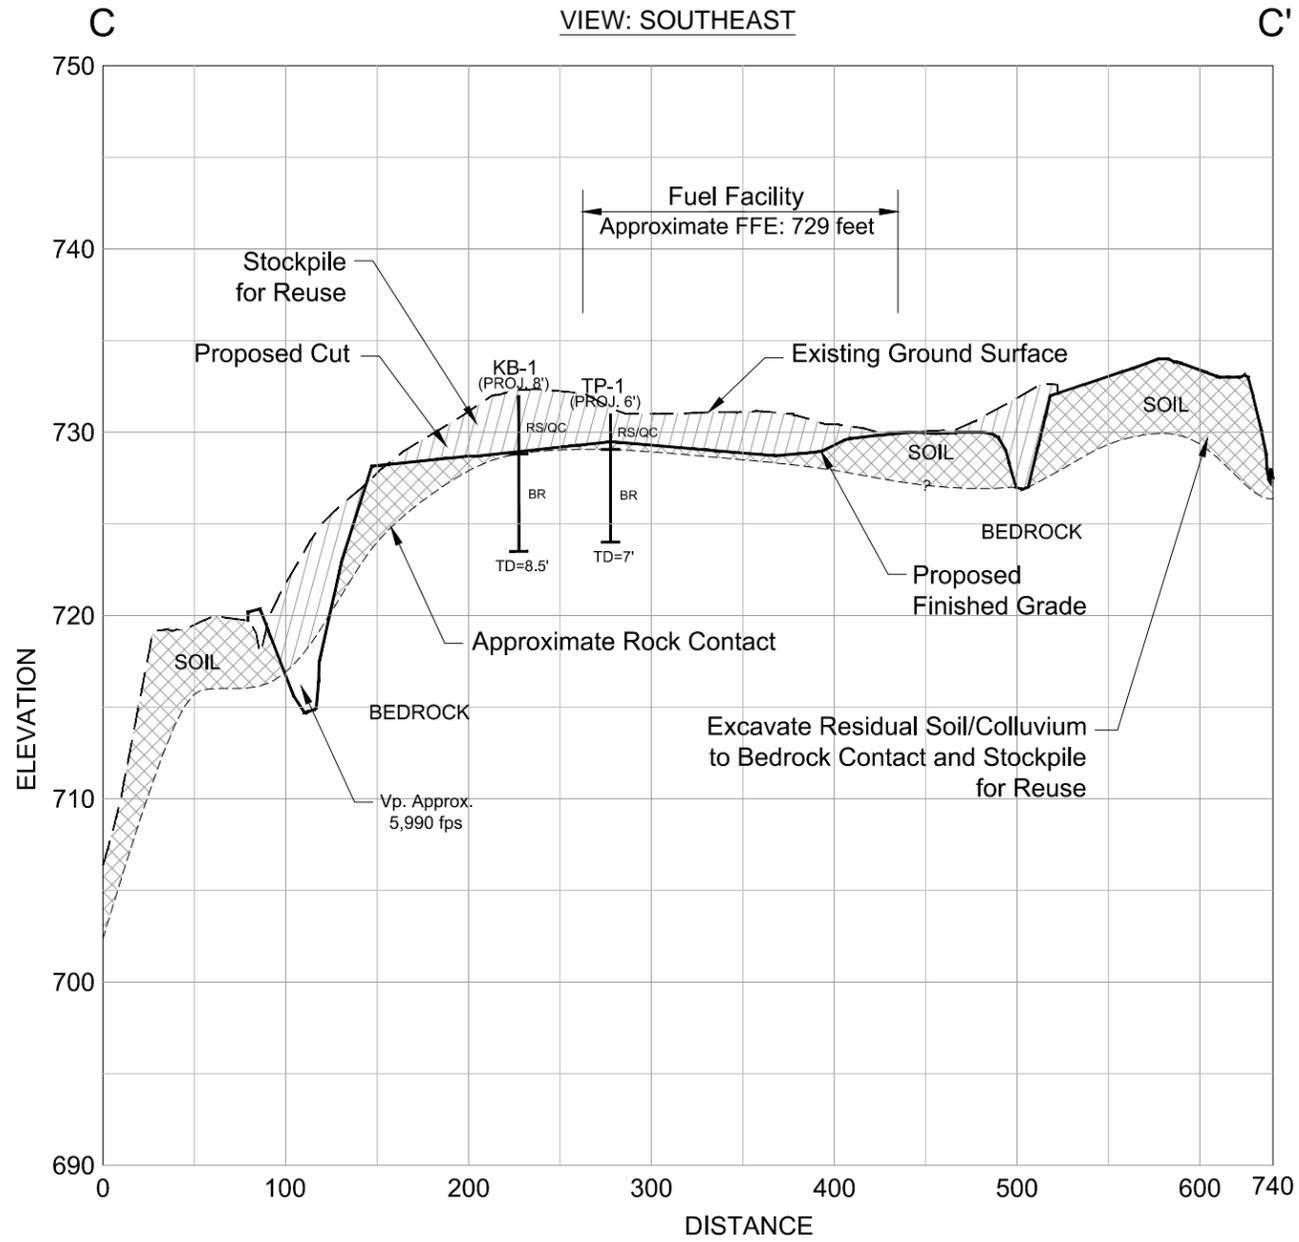
7

- RS/QC Residual Soil and/or Colluvium
- BR Bedrock

CROSS SECTION C - C'

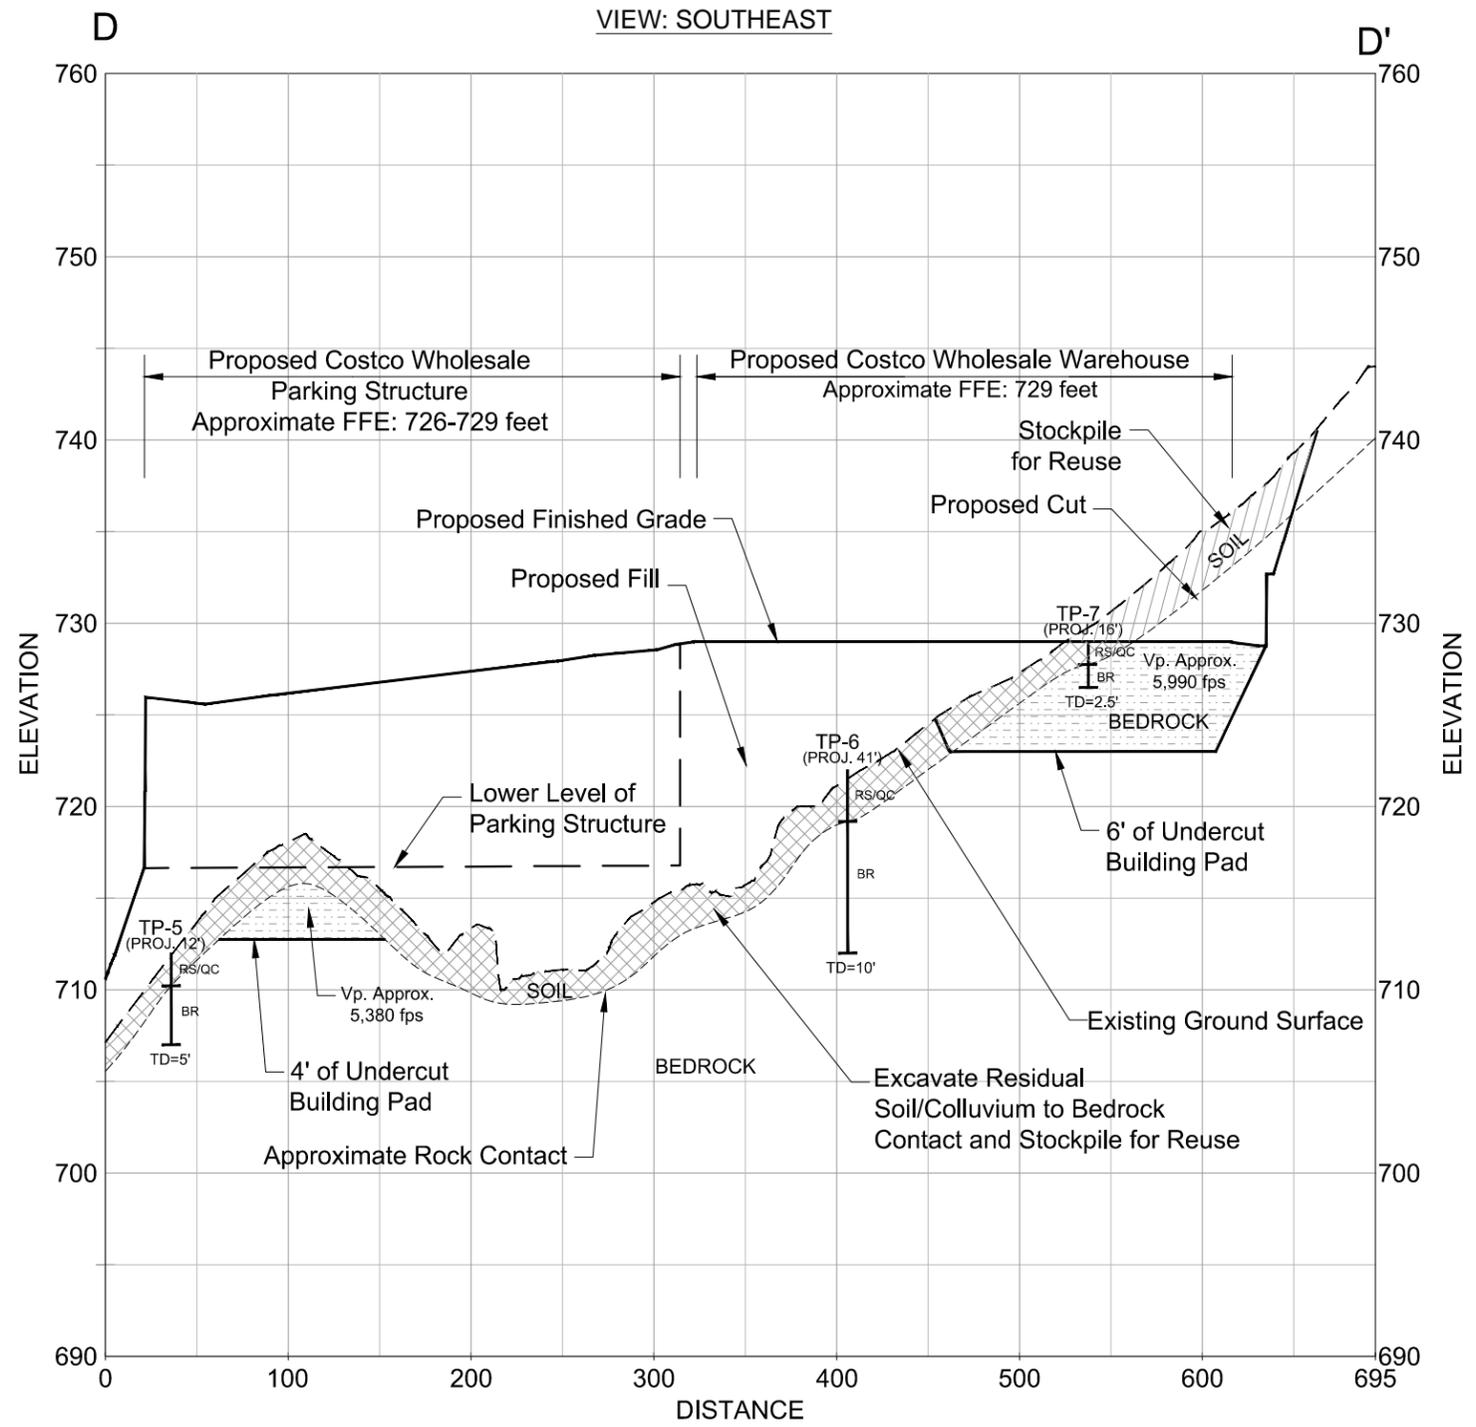
FIGURE
8

LEGEND
 RS/QC Residual Soil and/or Colluvium
 BR Bedrock

CROSS SECTION D - D'
CSM COSTCO EL DORADO HILLS SILVA VALLEY PARKWAY EL DORADO HILLS, CALIFORNIA
