Geotechnical Study
(December 10, 2024)

**SUBJECT: Geotechnical Study
Proposed Costco Fuel Facility
Silva Valley Parkway
El Dorado Hills, California
CW# 18-0487**

**GEOTECHNICAL STUDY
PROPOSED COSTCO FUEL FACILITY
SILVA VALLEY PARKWAY
EL DORADO HILLS, CALIFORNIA
CW# 18-0487
KLEINFELDER PROJECT NO. 20193141.002A**

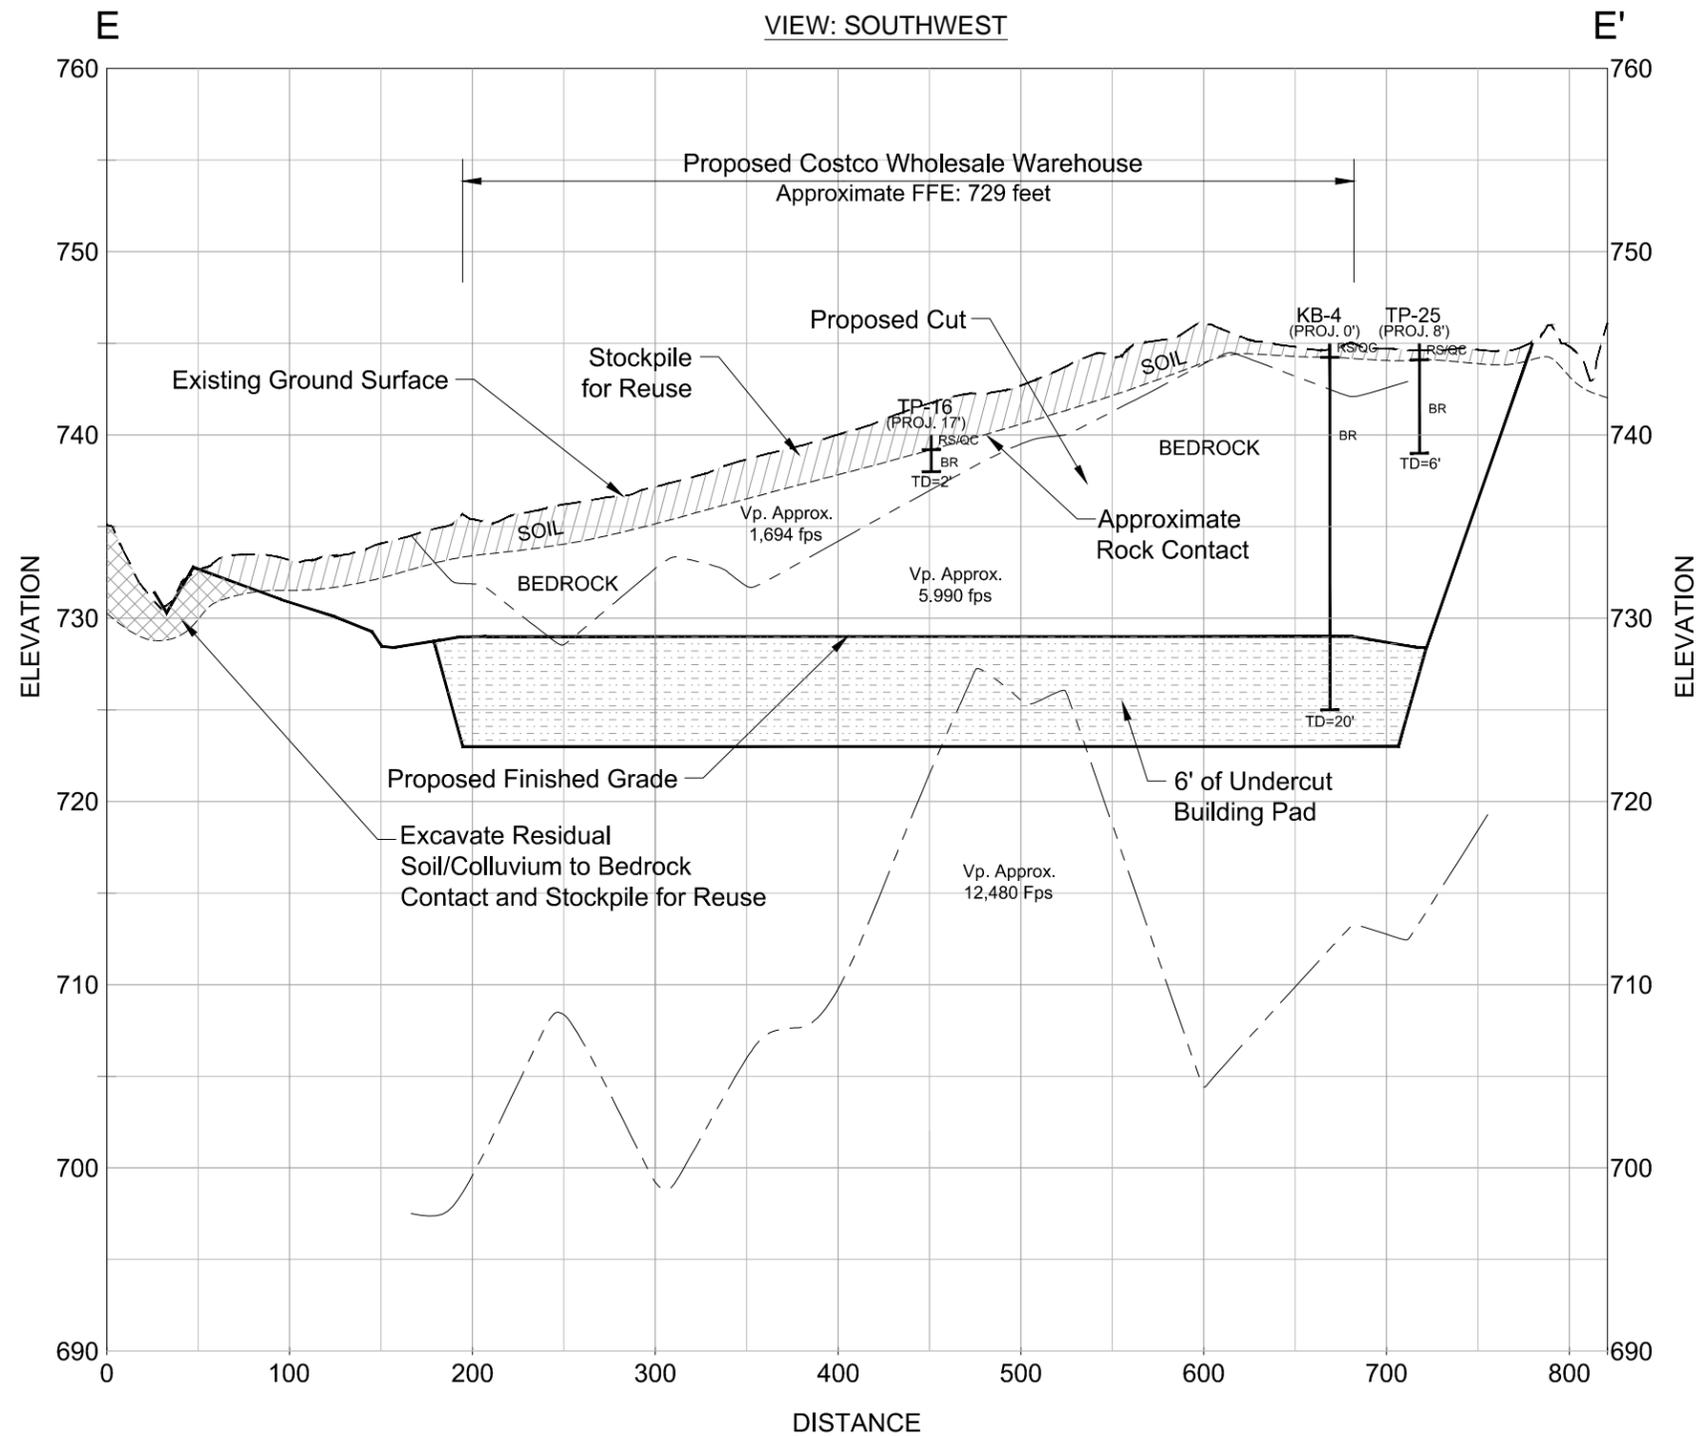
9

- RS/QC Residual Soil and/or Colluvium
- BR Bedrock
- Seismic Refraction Layer Contact with Layer Velocity

- The residual soil/colluvial layer should be excavated to underlying weathered rock contact and stockpiled on site for reuse as structural fill. An estimate of the residual soil/colluvial layer thickness is shown on the cross sections (Figures 5 through 10).

Prior to grading and subgrade preparation, all vegetation should be cut and removed from the site. Roots and vegetative matter in excess of one inch should be removed by screening or raking soils to a minimum depth of 12 inches. Other than plant roots, organic matter in the topsoil is minimal based on our laboratory testing (between one and three percent). The topsoil can be re-used in site fills. The residual soil/colluvial layer should be excavated to underlying weathered rock contact and stockpiled on site for reuse as structural fill. An estimate of the residual soil/colluvial layer thickness is shown on the attached cross sections (Figures 5 through 10).

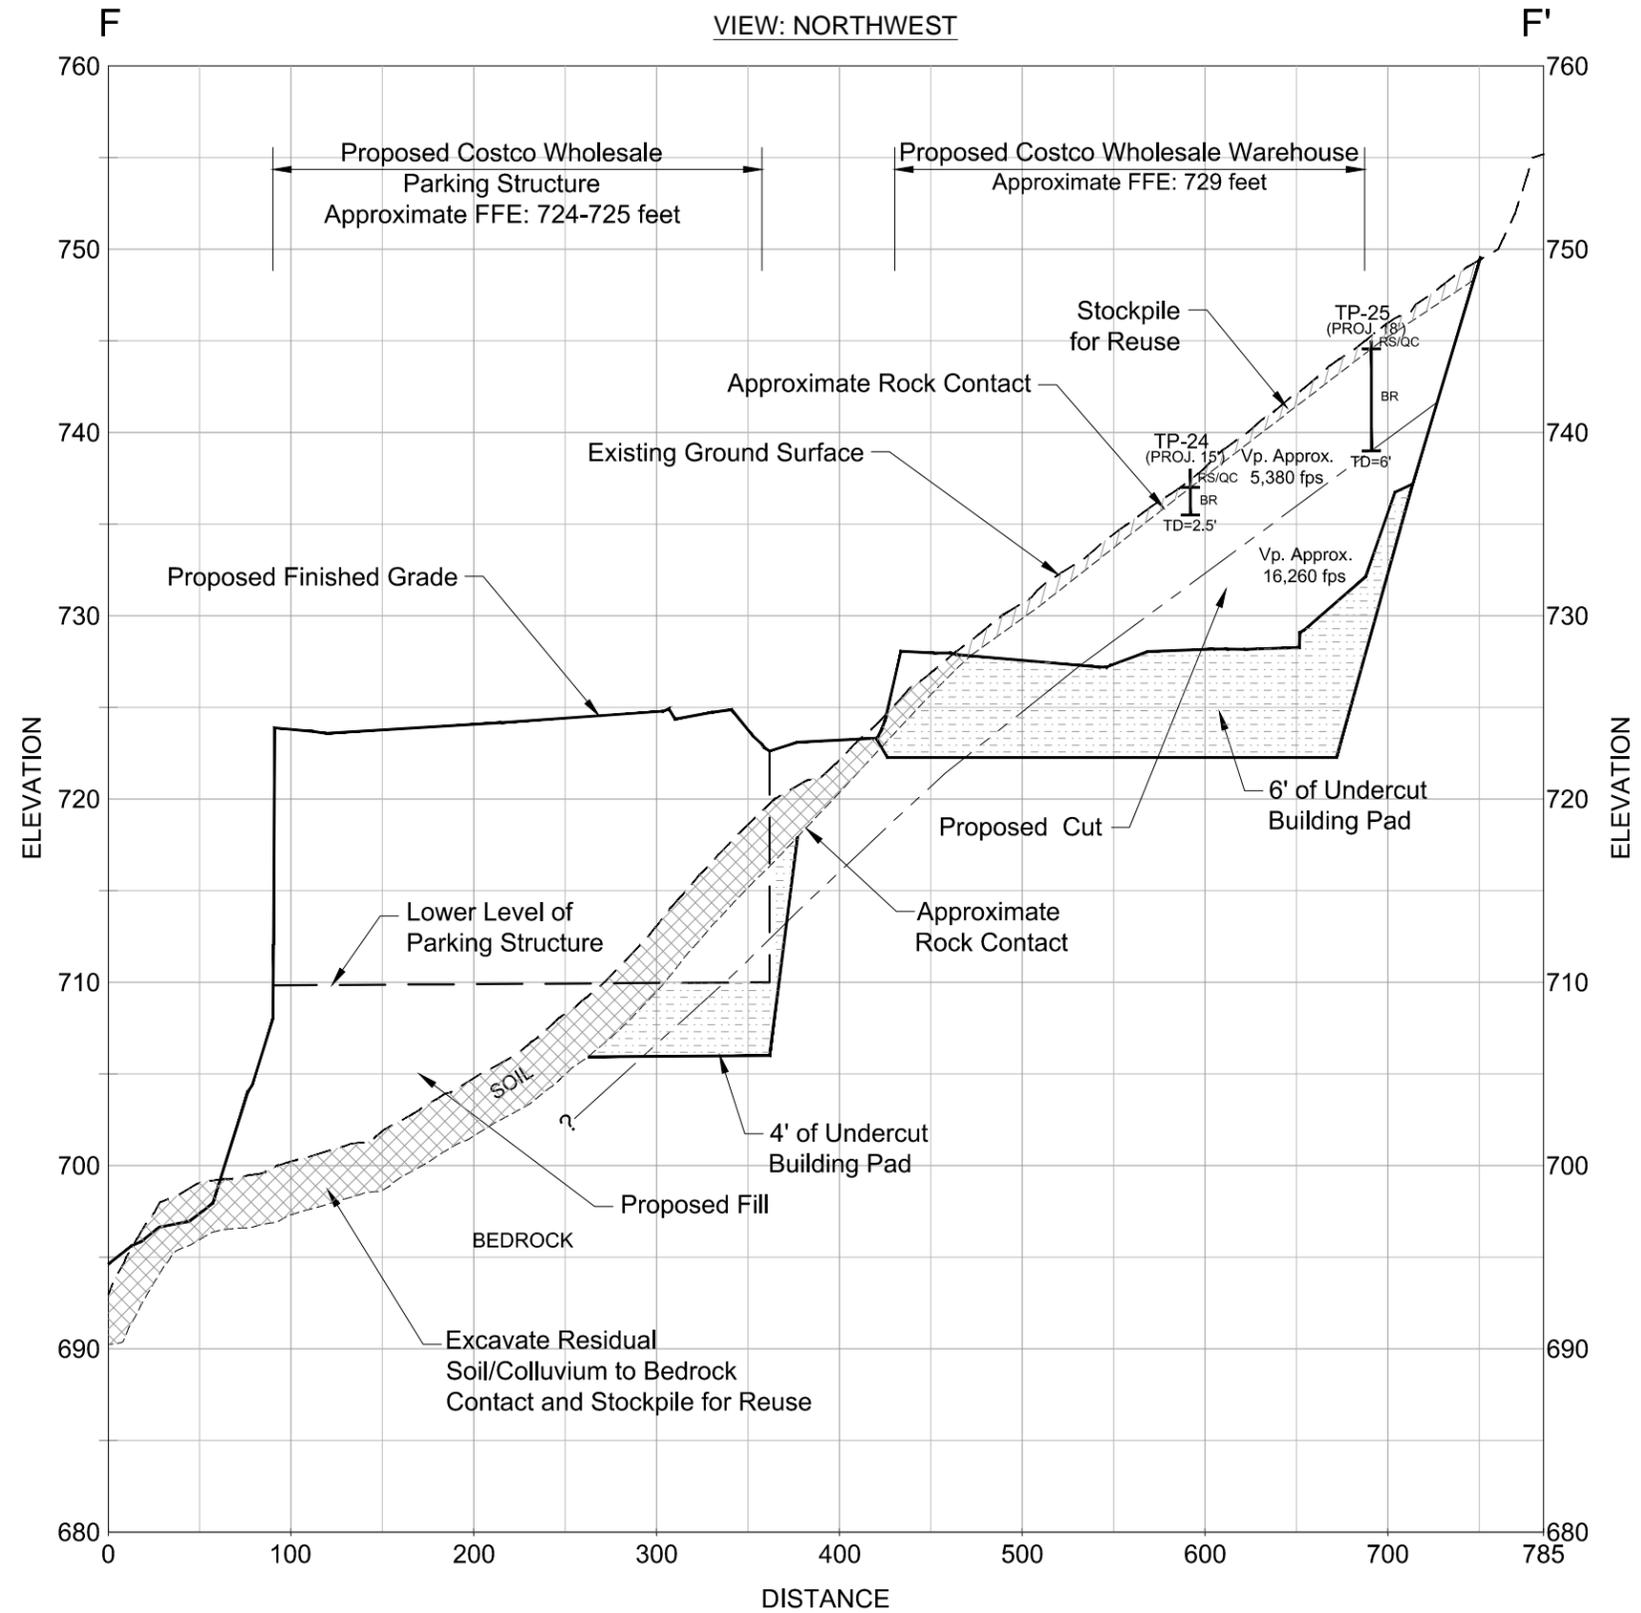
RS/QC	Residual Soil and/or Colluvium
BR	Bedrock
---	Seismic Refraction Layer with Layer Velocity

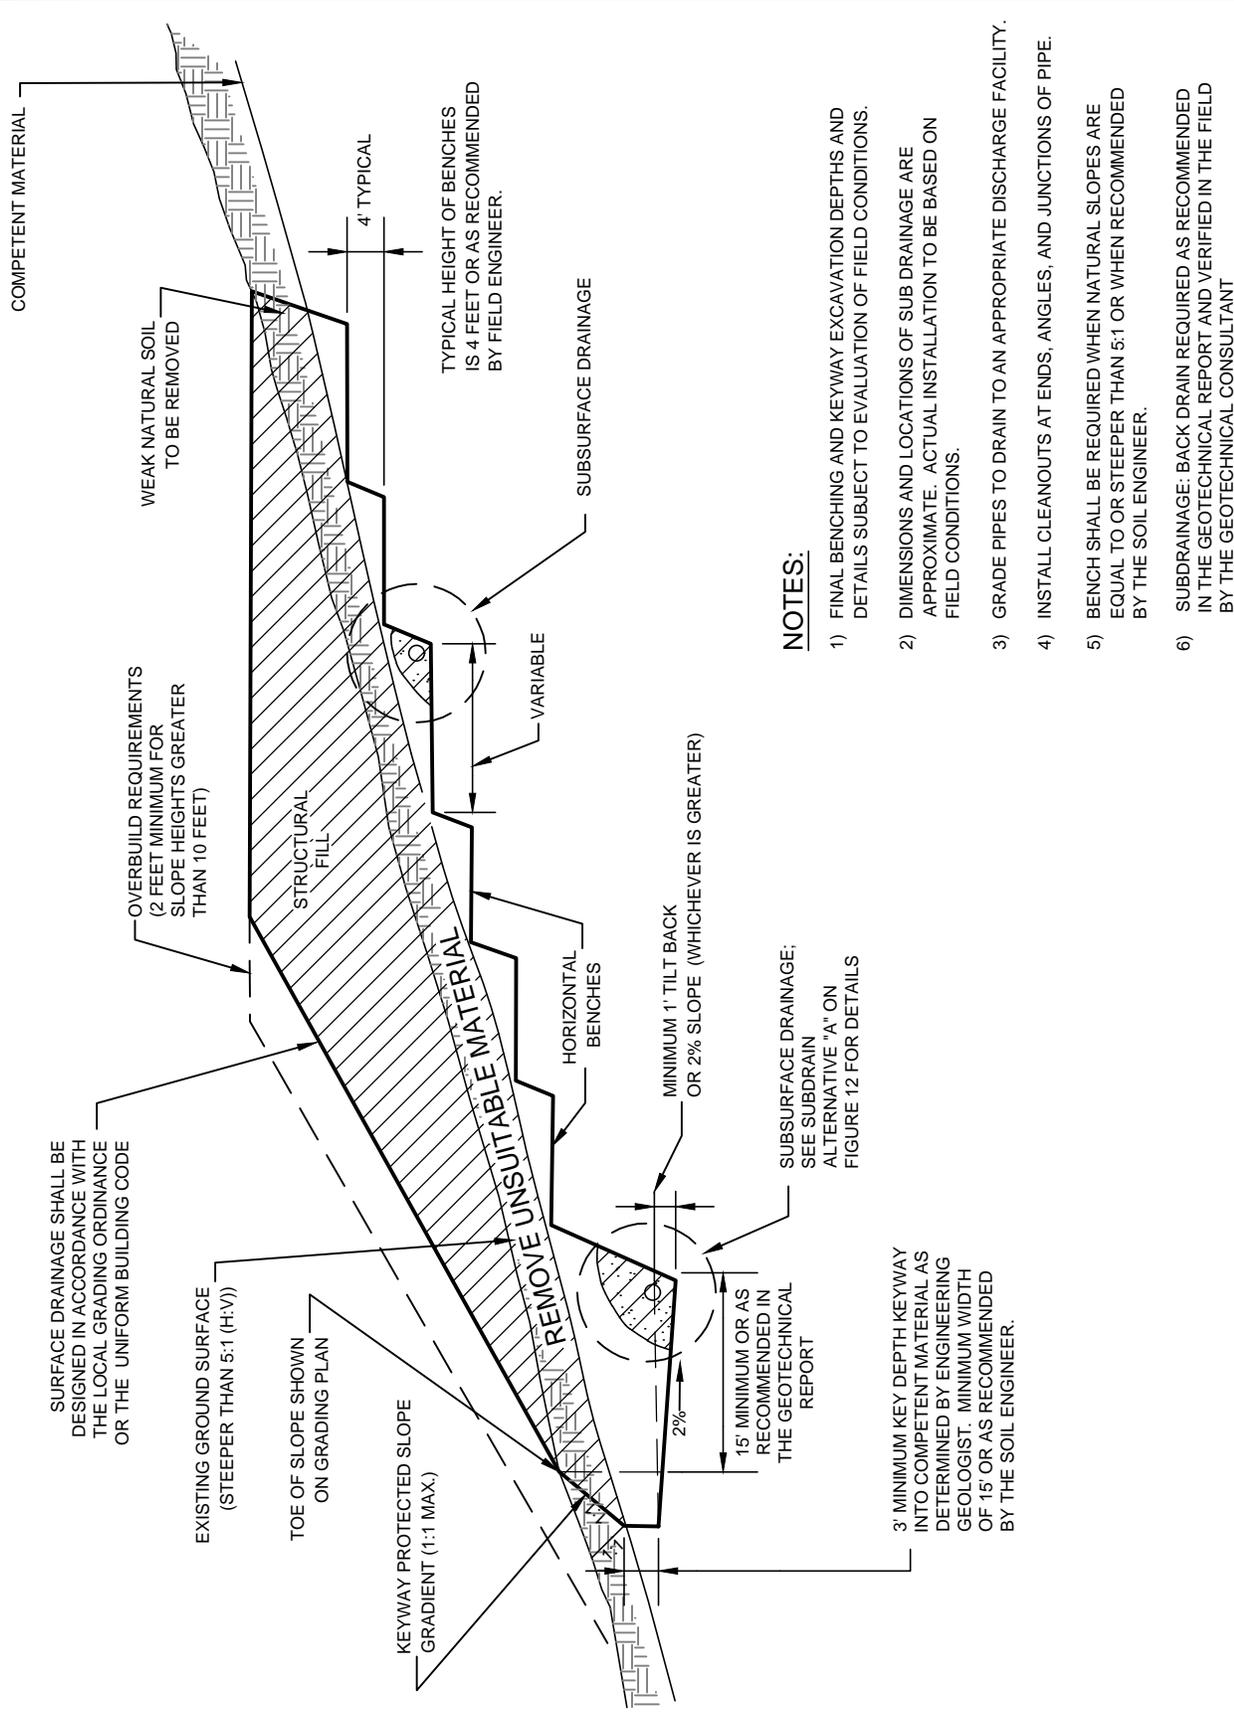
FIGURE
11

**TYPICAL ENGINEERED
FILL SLOPE/BENCHING DETAIL**

For areas above slopes, positive drainage should be established away from the top of slopes. This may be accomplished utilizing a brow ditch placed at the top of cut slopes to redirect surface runoff away from the slope face where drainage devices are not otherwise available. Site runoff should not be permitted to flow over the tops of slopes. Slope drains should also be installed within the fill slopes. Figures 11 and 12 show typical details for slope and canyon drains.

Permanent slopes should be constructed at 2:1 (horizontal to vertical) or flatter. Slopes will be subject to erosion and should be planted as soon as practicable. Where new fill slopes are to be constructed on hillsides or existing slopes, the topsoil, colluvial soils, and other materials considered unsuitable should be removed. Where the exposed slope is steeper than 5:1, or where recommended by personnel by our firm, the original ground on which fill is to be placed should be keyed and benched. The benches should extend in the underlying bedrock. Key should be at least 8 feet wide and sloped a minimum of 2% towards the slope. Benches should be at least 4 feet wide and not exceed 4 feet in height. Fill slopes should be overbuilt by 2 feet then cut back to facilitate compaction at the face. Fill and cut slopes should be observed by our firm during grading to evaluate the anticipated geologic conditions and make any necessary modifications. Slope drains should also be installed within the fill slopes to prevent building up hydrostatic pressures behind slopes, especially in areas of observed seepage. Figures 11 and 12 show typical details for slope and canyon drains.

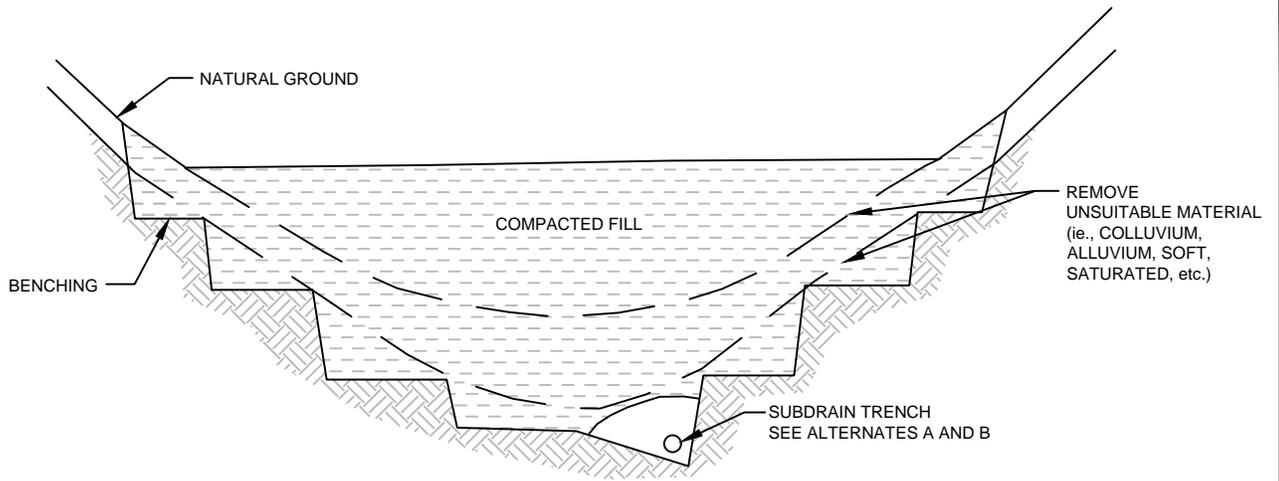
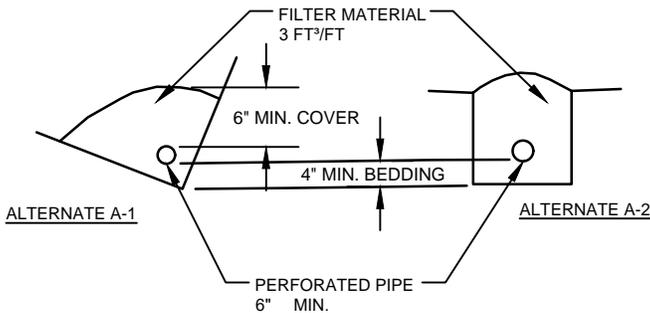
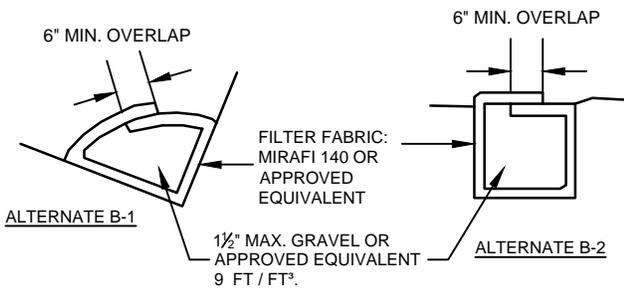
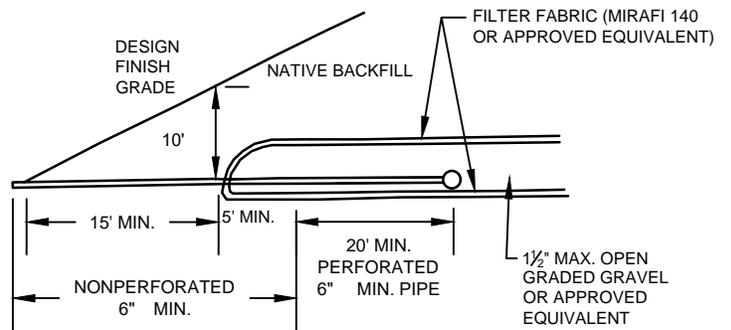
CANYON SUBDRAIN DETAIL

SUBDRAIN ALTERNATE A:
PERFORATED PIPE SURROUNDED BY FILTER MATERIAL

FILTER MATERIAL:
Filter material shall be class 2 permeable material per State of California Standards Specifications, or an approved alternate. Class 2 grading as follows:

SUBDRAIN ALTERNATE B:
1½" GRAVEL WRAPPED IN FILTER FABRIC.
6" MIN. OVERLAP

DETAIL OF CANYON SUBDRAIN TERMINOUS

SUBDRAIN INSTALLATION: SUBDRAIN PIPE SHALL BE INSTALLED WITH PERFORATIONS DOWN, OR AT LOCATIONS DESIGNATED BY THE GEOTECHNICAL CONSULTANT. OUTLET PIPE SHALL BE NON-PERFORATED PIPE.

SUBDRAIN TYPE: SUBDRAIN TYPE SHALL BE SCHEDULE 40 PVC PIPE OR AN APPROVED EQUIVALENT.

After the initial excavation of the residual/colluvial soils onsite. It is recommended that a perforated subdrain be installed within the creek bottom running from east to west through the project site. The drain may be “burrito wrapped” with filter fabric and surrounded by permeable drain rock prior to rock backfill operations onsite. Slope drains should also be installed within the fill slopes as discussed in Section 4.8. Figures 11 and 12 show typical details for slope and canyon drains.

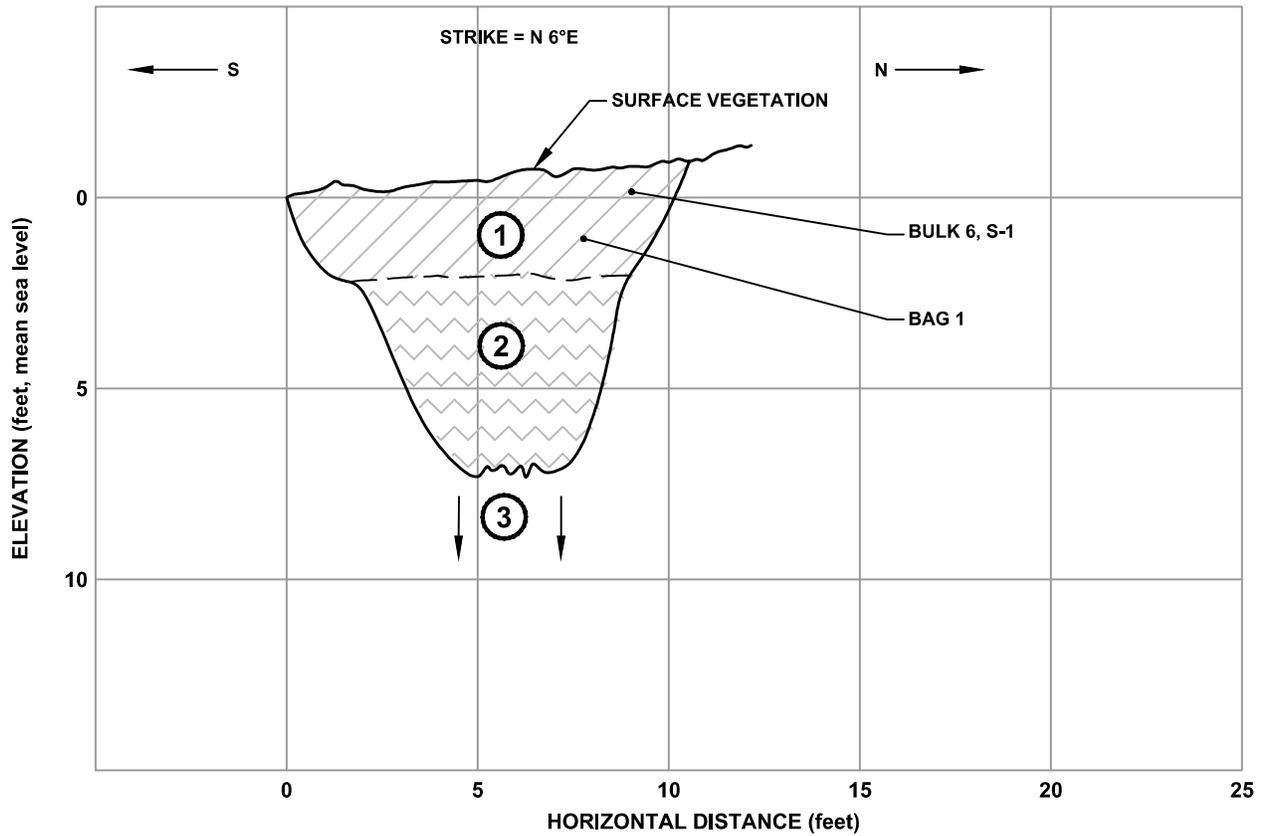
FIGURE
 A-7

UNIT NO.	MATERIALS DESCRIPTION
①	SANDY LEAN CLAY (CL) - brownish red, dry, medium plasticity, fine to medium sand, trace coarse sand, trace subangular gravel, rootlets (RESIDUAL SOIL)
②	METAVOLCANIC ROCK - bluish gray, dry, medium dense, highly weathered, medium strong to weak, slight foliation, similar to CLAYEY SAND with Gravel and Cobbles (SC); subangular METAVOLCANIC ROCK fragments up to 7"
③	METAVOLCANIC ROCK - bluish gray, moderately weathered, strong to medium strong, moderately to highly fractured, slight foliation, refusal at 7' depth
Latitude: 38.661071 Longitude: -121.05804

TEST PIT LOG
 TP-1
 CSM COSTCO EL DORADO HILLS
 SILVA VALLEY PARKWAY
 EL DORADO HILLS, CALIFORNIA

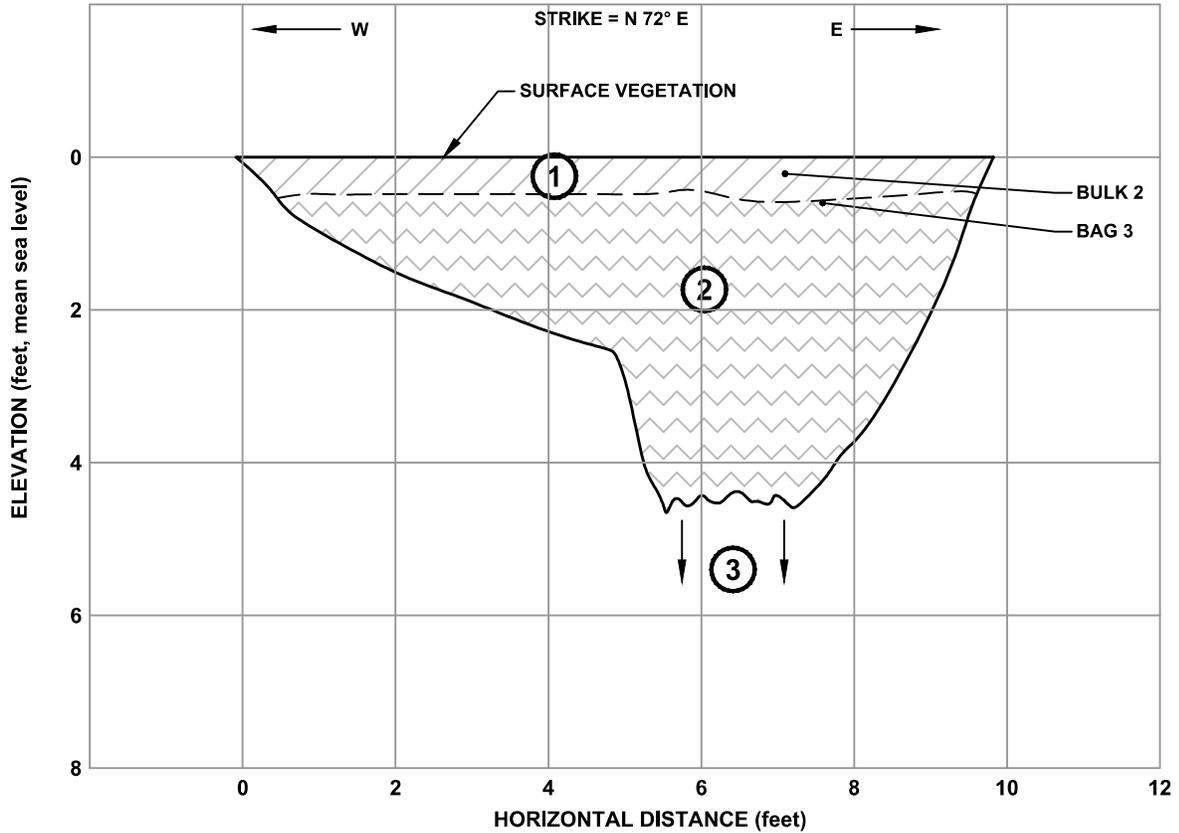
FIGURE
A-8

TEST PIT LOG
TP-2
CSM COSTCO EL DORADO HILLS
SILVA VALLEY PARKWAY
EL DORADO HILLS, CALIFORNIA

UNIT NO.	MATERIALS DESCRIPTION
①	SANDY LEAN CLAY (CL) - brownish red, dry, medium plasticity, fine to medium sand, trace fine gravel, rootlets (RESIDUAL SOIL)
②	METAVOLCANIC ROCK - bluish gray and olive, dry, highly weathered with moderately weathered sections, strong to medium strong/weak, highly to moderately fractured, well defined foliation, similar to CLAYEY SAND with Gravel, Cobbles, and Boulders (SC); fine to coarse sand, subangular METAVOLCANIC ROCK fragments up to 16"
③	METAVOLCANIC ROCK - bluish gray, moderately weathered, strong, moderately fractured, refusal at 4.5' depth Latitude: 38.660246 Longitude: -121.058017

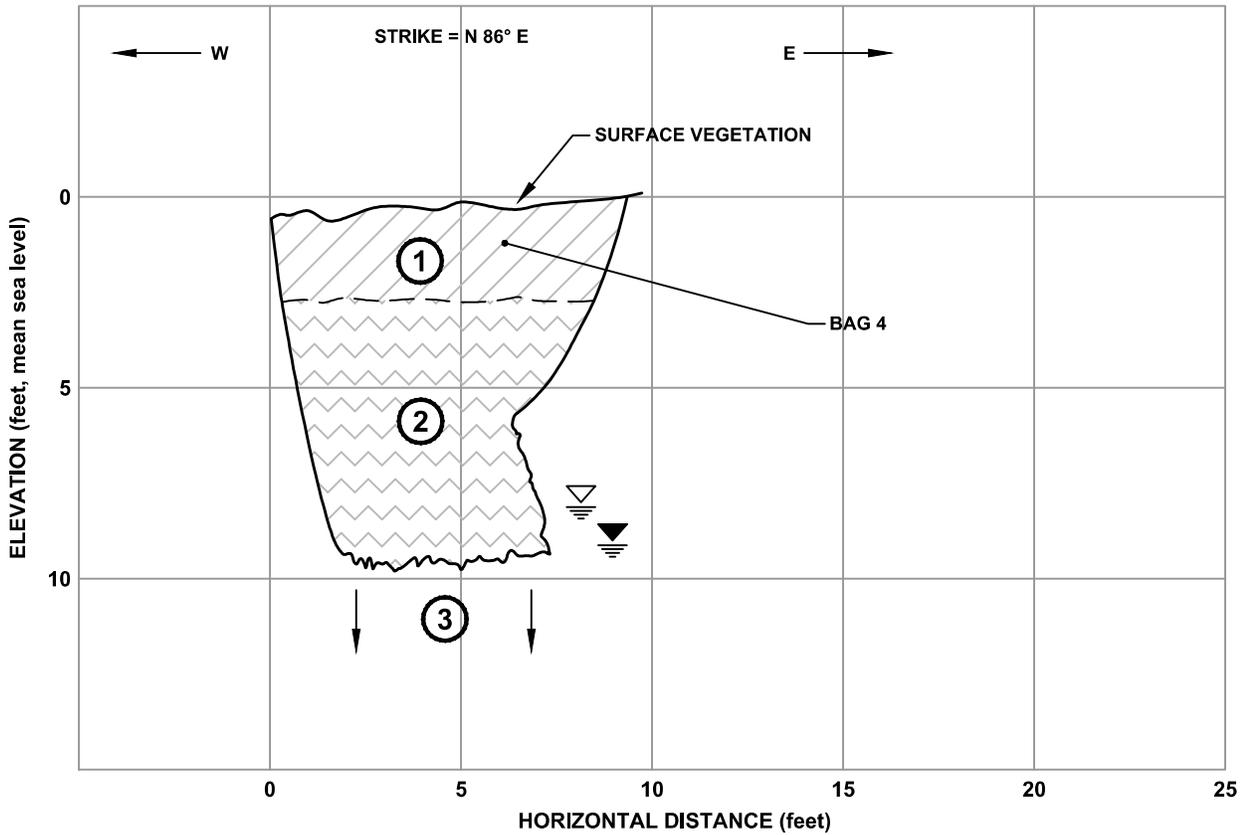
FIGURE
 A-9

TEST PIT LOG
 TP-3
 CSM COSTCO EL DORADO HILLS
 SILVA VALLEY PARKWAY
 EL DORADO HILLS, CALIFORNIA

UNIT NO.	MATERIALS DESCRIPTION
①	SANDY LEAN CLAY (CL) - brownish red, dry, medium plasticity, fine to coarse sand, trace subangular gravels up to 1.5", rootlets (RESIDUAL SOIL)
②	METAVOLCANIC ROCK - bluish gray and olive, dry, highly weathered, medium strong, highly fractured, slight foliation, similar to CLAYEY SAND with Gravels, Cobbles, and Boulders (SC); fine to coarse sand, subangular METAVOLCANIC ROCK fragments up to 13",
③	METAVOLCANIC ROCK - bluish gray, moderately weathered, strong, moderately fractured, refusal at 9.5' depth (Perched Groundwater hit at 8 feet deep, settled at 9 feet deep after excavation) Latitude: 38.660756 Longitude: -121.056944

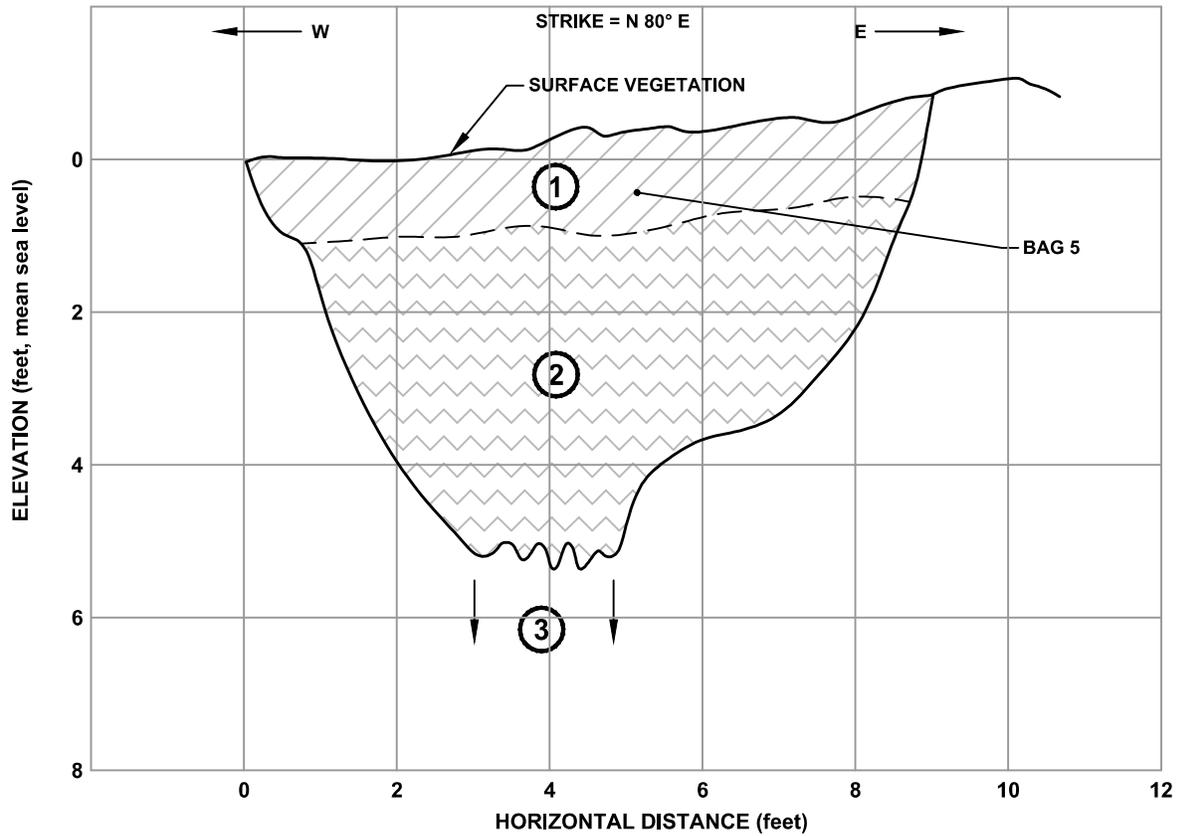
FIGURE
 A-10

TEST PIT LOG
 TP-4
 CSM COSTCO EL DORADO HILLS
 SILVA VALLEY PARKWAY
 EL DORADO HILLS, CALIFORNIA

UNIT NO.	MATERIALS DESCRIPTION
①	SANDY LEAN CLAY (CL) - brownish red, dry, medium plasticity, fine to medium sand, trace gravel, rootlets (RESIDUAL SOIL)
②	METAVOLCANIC ROCK - bluish gray and olive, dry, highly weathered, medium strong to strong, highly fractured, well defined foliation, similar to CLAYEY SAND with Gravel and Cobbles (SC); fine to coarse sand, subangular METAVOLCANIC ROCK fragments up to 12"
③	METAVOLCANIC ROCK - bluish gray, moderately weathered, strong, moderately fractured, well defined foliation, refusal at 5' depth Latitude: 38.659916 Longitude: -121.058112

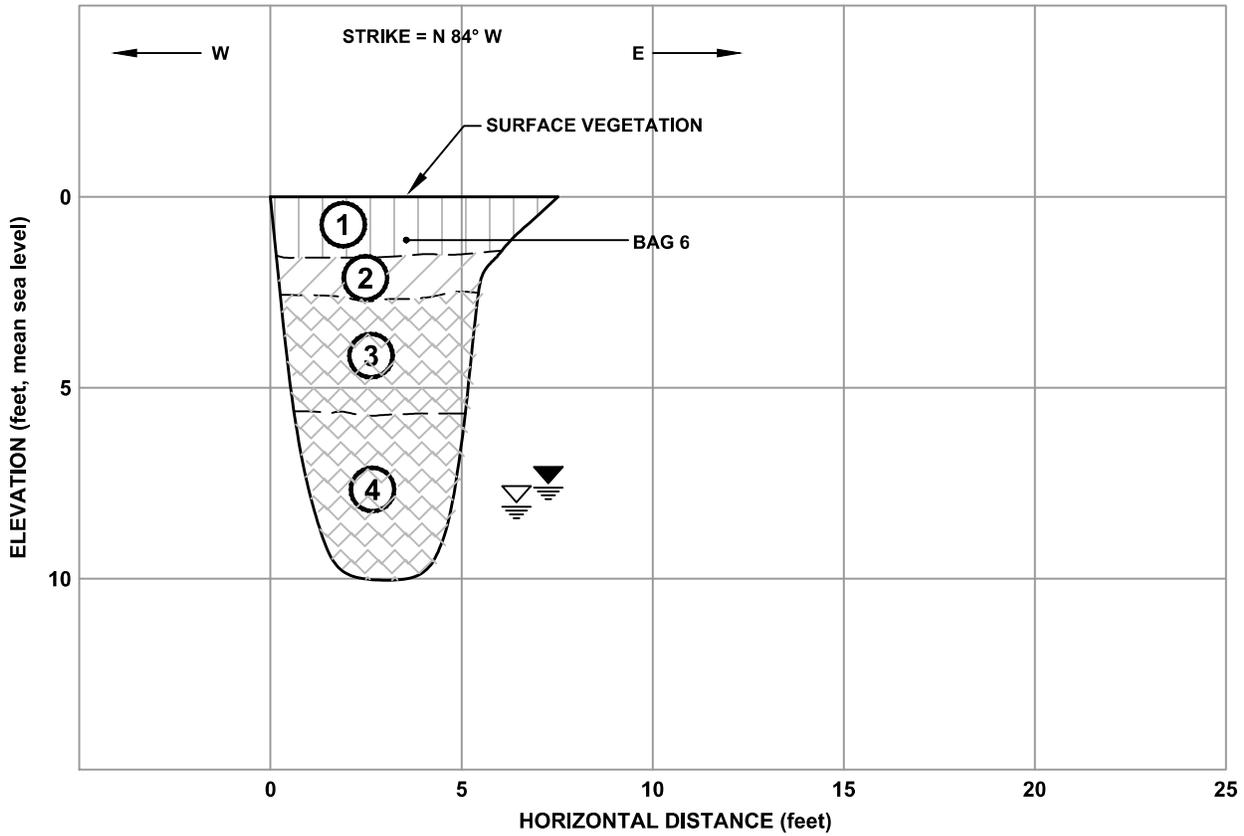
A-11

UNIT NO.	MATERIALS DESCRIPTION
①	SANDY SILT (ML) - dark brown, dry, non-plastic, subangular fine to coarse sand, trace gravels up to 1", rootlets (RESIDUAL SOIL)
②	LEAN CLAY with Sand (CL) - brownish red, dry, medium plasticity, fine to coarse sand, trace coarse gravels up to 2", rootlets (COLLUVIUM)
③	METAVOLCANIC ROCK - mottled dark olive, moist, dark reddish brown, and bluish gray, decomposed, similar to FAT CLAY (CH); high plasticity, trace fine sand
④	METAVOLCANIC ROCK - bluish gray, yellowish brown, and brownish red, moist, highly weathered, weak, highly to intensely fractured, slight foliation, similar to CLAYEY SAND with Gravel and Cobble (SC); fine to coarse sand, subangular METAVOLCANIC ROCK fragments up to 7"
	(Perched Groundwater hit at 8 feet deep, settled at 7.75 feet deep after excavation)
	Latitude: 38.660489 Longitude: -121.057038

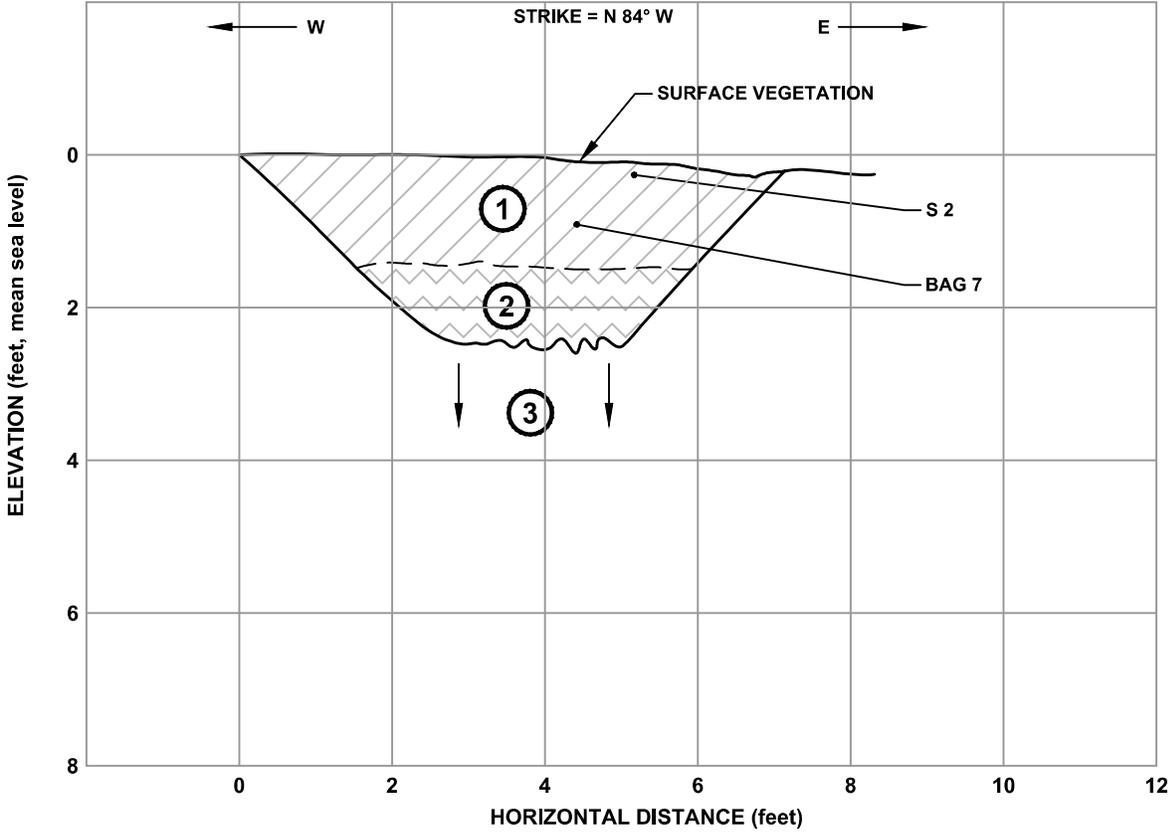
FIGURE
A-12

TEST PIT LOG
TP-6
CSM COSTCO EL DORADO HILLS
SILVA VALLEY PARKWAY
EL DORADO HILLS, CALIFORNIA

UNIT NO.	MATERIALS DESCRIPTION
①	SANDY LEAN CLAY with Gravel, Cobble and Boulders (CL) - brownish red, dry, medium plasticity, fine to coarse sand, subangular gravel and boulders up to 14", rootlets (FILL)
②	METAVOLCANIC ROCK - bluish gray and olive, moist, decomposed, similar to SAND LEAN CLAY (CL); fine to coarse sand, trace fine gravel, hard (PP = >4.5 tsf)
③	METAVOLCANIC ROCK - bluish gray, highly to mderately weathered, medium strong to strong, moderately fractured, slight foliation, refusal at 2.5' depth Latitude: 38.660608 Longitude: -121.056594

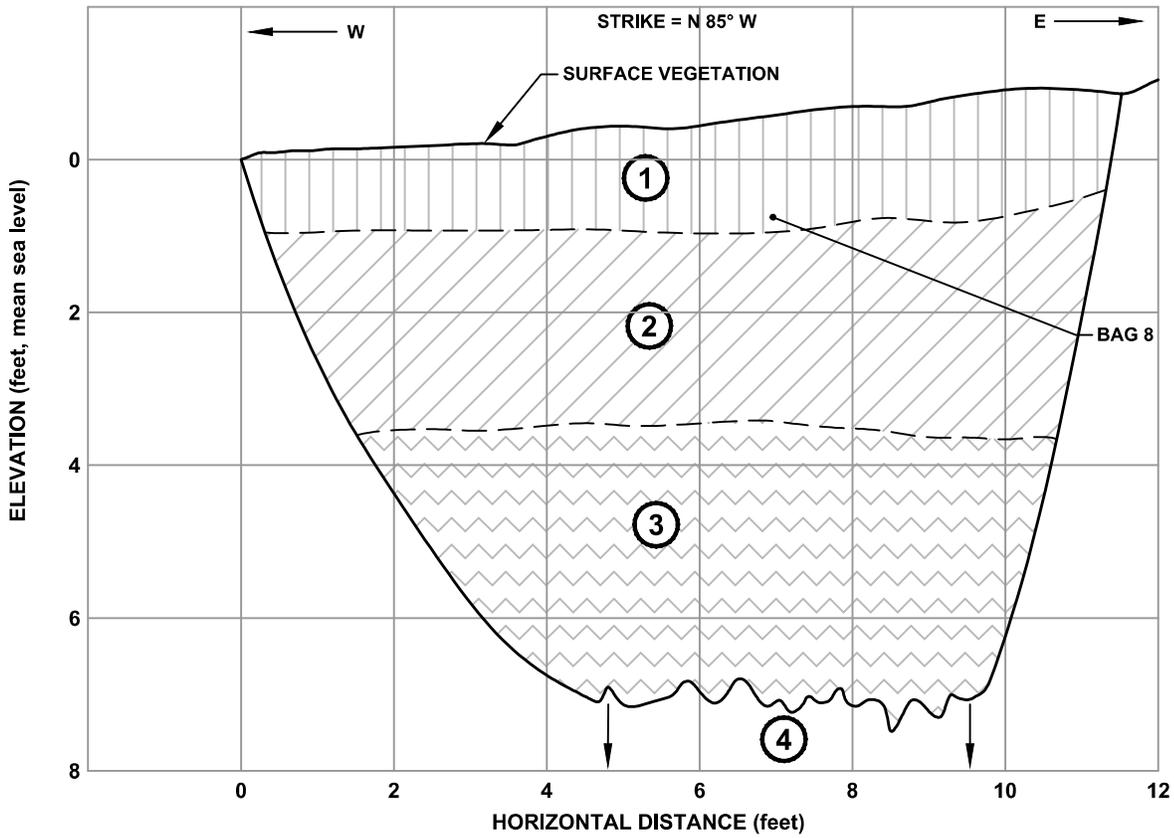
A-13

UNIT NO.	MATERIALS DESCRIPTION
①	SANDY SILT (ML) - dark brown, dry, non-plastic, fine to coarse sand, trace gravel up to 3/4", rootlets (COLLUVIUM)
②	LEAN CLAY with SAND (CL) - dark reddish brown, dry, medium plasticity, fine to coarse sand, subangular gravels up to 3", rootlets (COLLUVIUM)
③	METAVOLCANIC ROCK - bluish gray, yellowish brown, and brownish red, dry to moist, highly weathered, weak to medium strong, highly to intensely fractured, well defined foliation, similar to CLAYEY SAND with Gravel and Cobble (SC); fine to coarse sand, subangular METAVOLCANIC ROCK fragments up to 9"
④	METAVOLCANIC ROCK - bluish gray, moderately weathered, strong, moderately fractured, refusal at 7' depth Latitude: 38.660183 Longitude: -121.057085

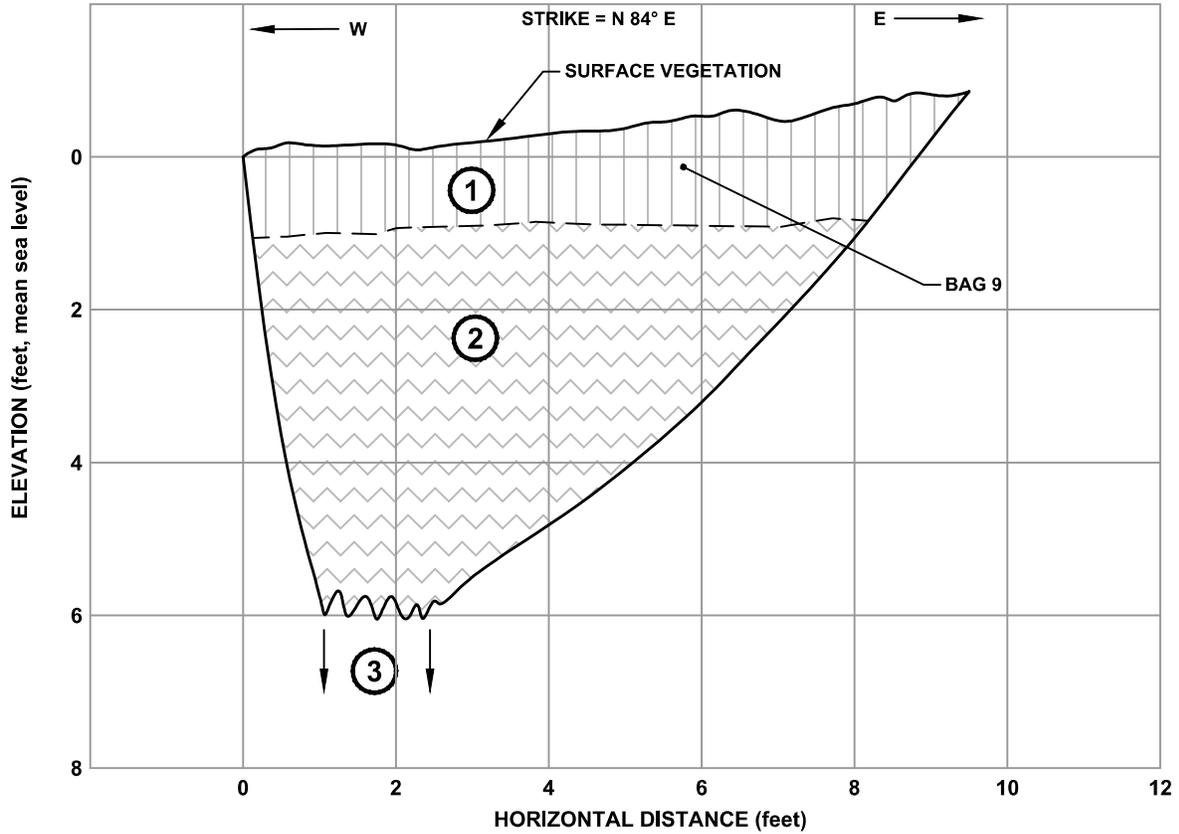
FIGURE
A-14

TEST PIT LOG
TP-8
CSM COSTCO EL DORADO HILLS
SILVA VALLEY PARKWAY
EL DORADO HILLS, CALIFORNIA

UNIT NO.	MATERIALS DESCRIPTION
①	SANDY SILT (ML) - dark brown and reddish brown, dry, non-plastic, fine to coarse sand, trace gravels up to 1", rootlets (COLLUVIUM)
②	METAVOLCANIC ROCK - bluish gray and olive, dry to moist, highly to moderately weathered, medium strong, highly fractured, slight foliation, similar to CLAYEY SAND with Gravel, Cobbles, and Boulders (SC); fine to coarse sand, subangular gravel, cobbles, and boulders up to 6"
③	METAVOLCANIC ROCK - bluish gray, moderately weathered, strong, slight foliation, moderately fractured, refusal at 6' depth Latitude: 38.659967 Longitude: -121.057360

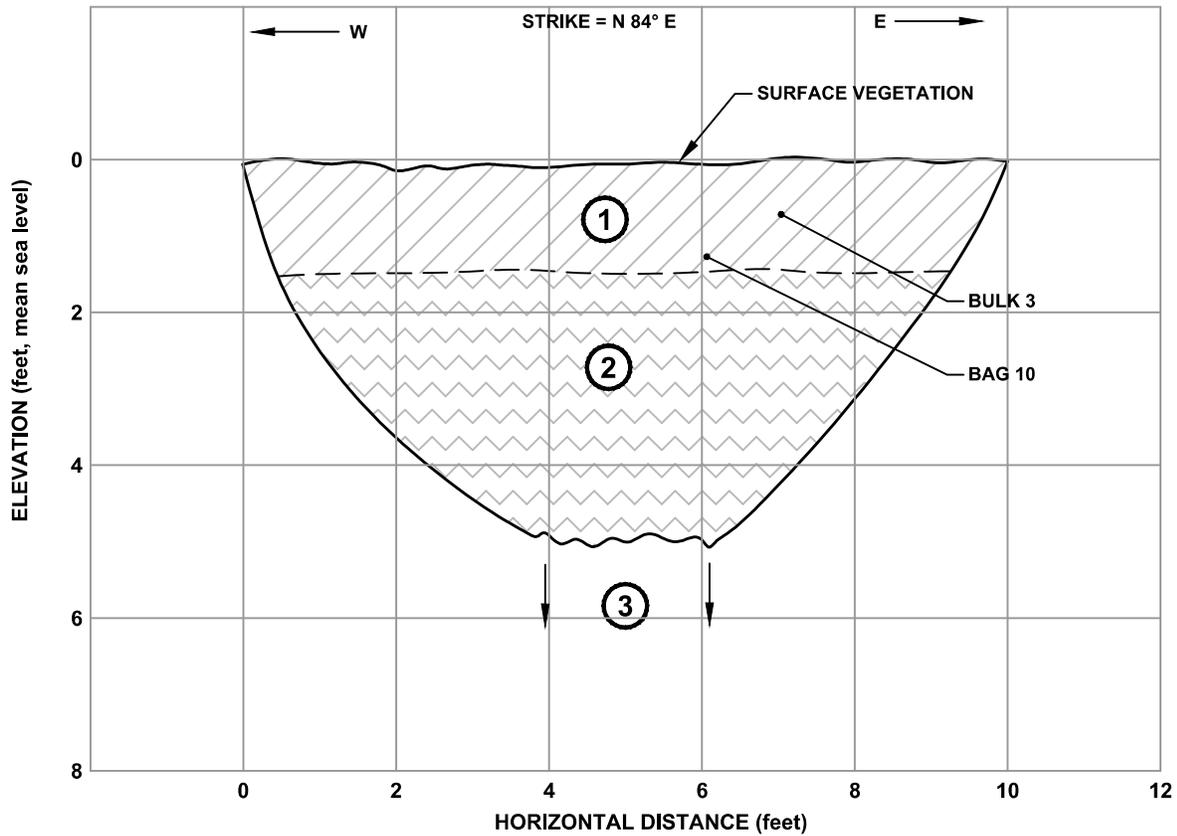
A-15

UNIT NO.	MATERIALS DESCRIPTION
①	LEAN CLAY with Sand (CL) - brownish red, dry, medium plasticity, fine to coarse sand, trace subangular fine gravel, rootlets (RESIDUAL SOIL)
②	METAVOLCANIC ROCK - bluish gray and olive, dry, highly weathered, weak, highly fractured, slight foliation, similar to CLAYEY SAND with Gravel and Cobble (SC); fine to coarse sand, subangular METAVOLCANIC ROCK fragments up to 10"
③	METAVOLCANIC ROCK - bluish gray, moderately weathered, strong, slight foliation, moderately fractured, refusal at 5' depth Latitude: 38.659963 Longitude: -121.057053

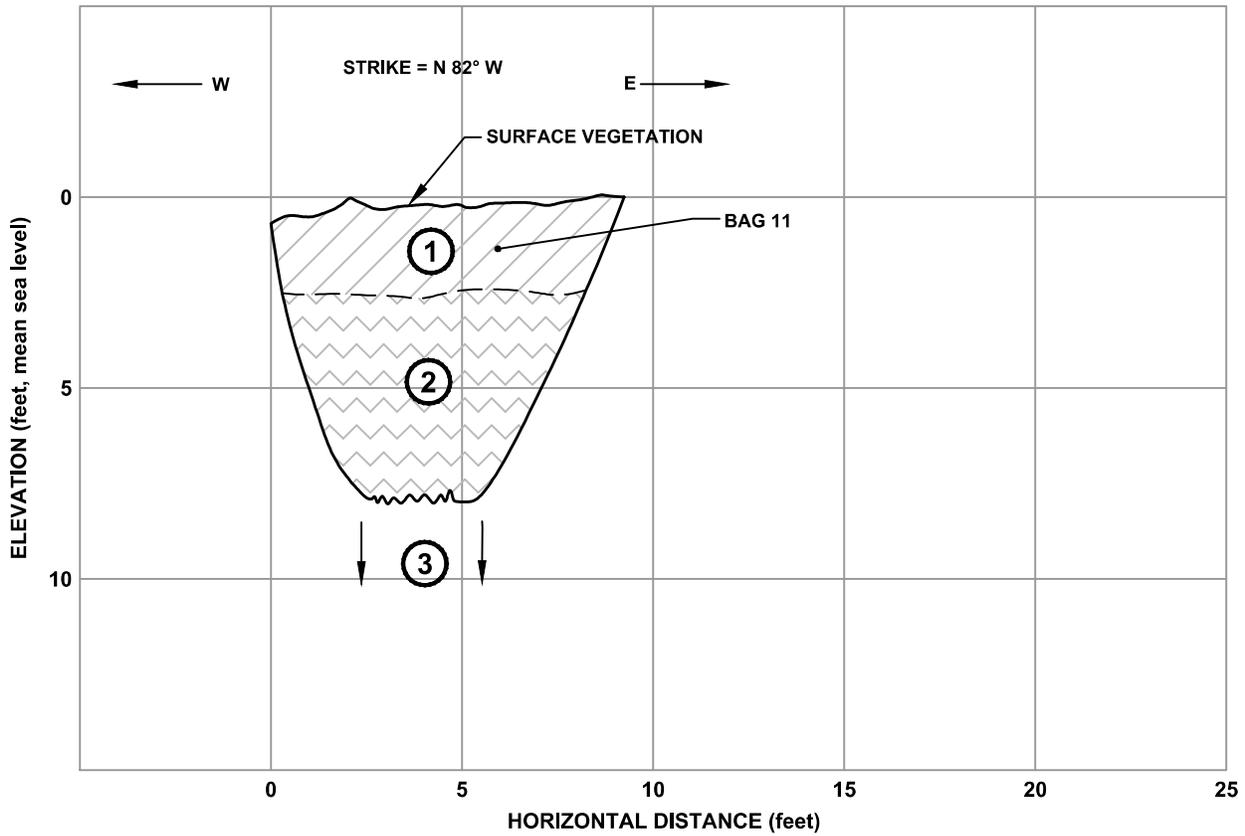
FIGURE
 A-16

TEST PIT LOG
 TP-10
 CSM COSTCO EL DORADO HILLS
 SILVA VALLEY PARKWAY
 EL DORADO HILLS, CALIFORNIA

UNIT NO.	MATERIALS DESCRIPTION
①	LEAN CLAY with Sand (CL) - brownish red, dry, medium plasticity, fine to medium sand, trace coarse sand and fine gravels, rootlets (RESIDUAL SOIL)
②	METAVOLCANIC ROCK - bluish gray and olive, dry, highly weathered, medium strong to weak, highly fractured, slight foliation, similar to CLAYEY SAND with Gravel and Cobbles (SC); fine to coarse sand, subangular METAVOLCANIC ROCK fragments up to 11"
③	METAVOLCANIC ROCK - bluish gray, moist, moderately weathered, strong, moderately fractured, refusal at 8' depth Latitude: 38.660167 Longitude: -121.056687

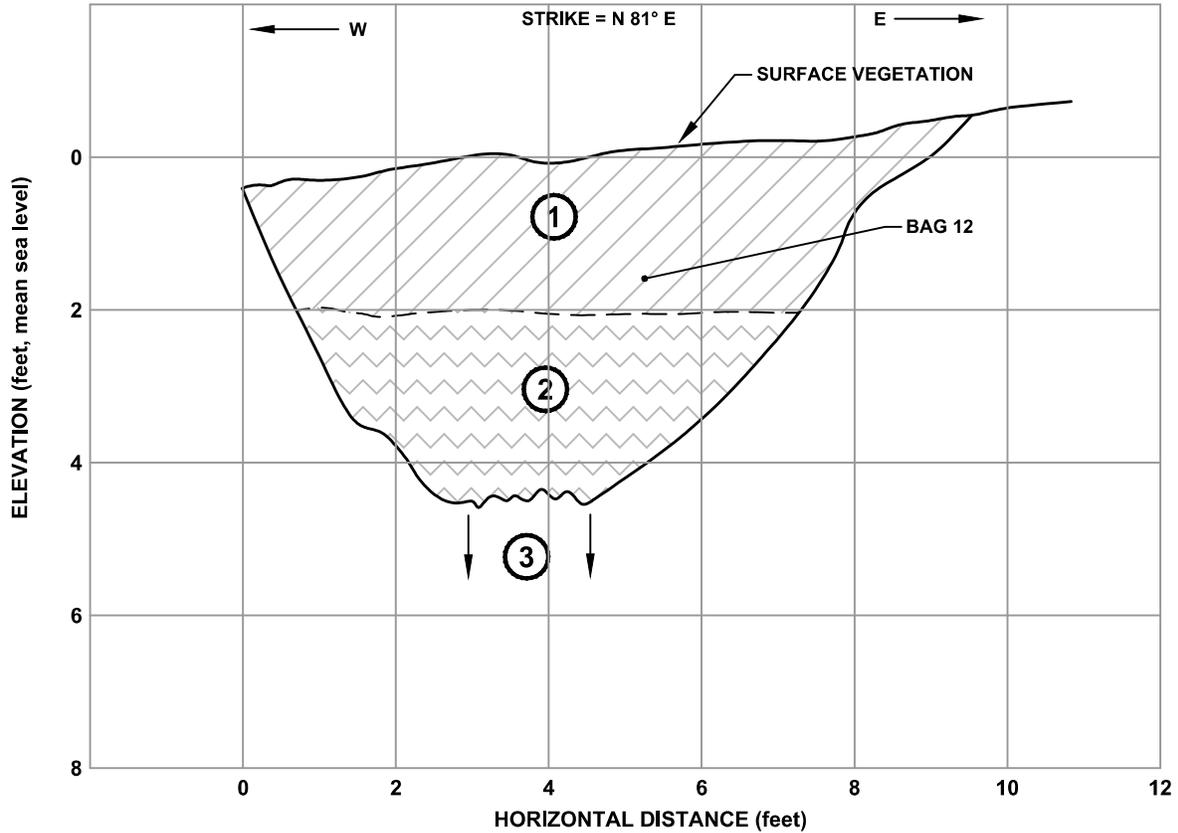
A-17

UNIT NO.	MATERIALS DESCRIPTION
①	LEAN CLAY with Sand (CL) - brownish red, dry, medium plasticity, fine to medium sand, trace coarse sand and coarse gravels up to 1.75", rootlets (RESIDUAL SOIL)
②	METAVOLCANIC ROCK - bluish gray and olive, moist, decomposed, simialr to SANDY LEAN CLAY (CL); hard, medium plasticity, fine to coarse sand, trace fine gravels (PP = 4.0 tsf)
③	METAVOLCANIC ROCK - bluish gray, moderately weathered, strong, moderately fractured, refusal at 4.5' depth Latitude: 38.660328 Longitude: -121.056397
