Geotechnical Study
(December 10, 2024)

**SUBJECT: Geotechnical Study
Proposed Costco Fuel Facility
Silva Valley Parkway
El Dorado Hills, California
CW# 18-0487**

**GEOTECHNICAL STUDY
PROPOSED COSTCO FUEL FACILITY
SILVA VALLEY PARKWAY
EL DORADO HILLS, CALIFORNIA
CW# 18-0487
KLEINFELDER PROJECT NO. 20193141.002A**

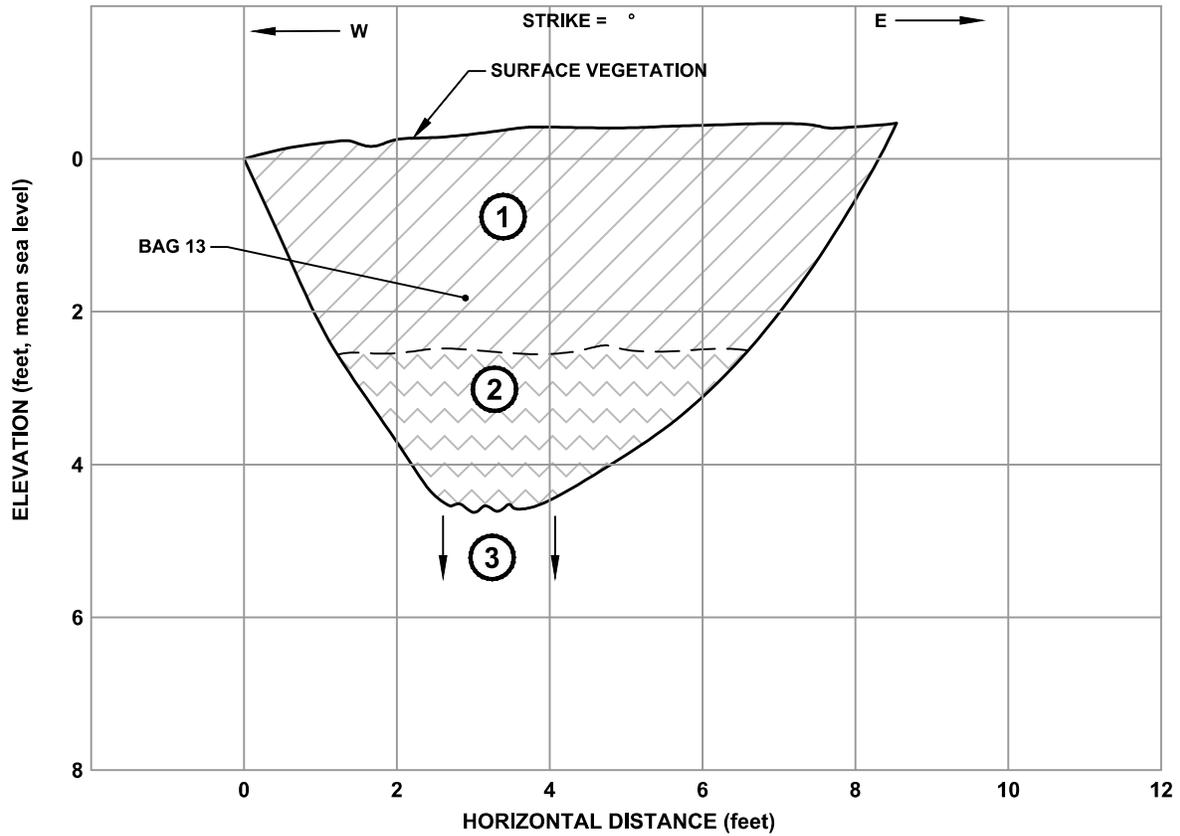
A-18

UNIT NO.	MATERIALS DESCRIPTION
①	LEAN CLAY with Sand (CL) - brownish red, dry, medium plasticity, fine to medium sand, trace coarse sand, trace subangular gravels up to 1", rootlets (RESIDUAL SOIL)
②	METAVOLCANIC ROCK - bluish gray and olive, moist, highly weathered, medium strong to weak, highly fractured, well defined foliation, similar to CLAYEY SAND with Gravel and Cobble (SC); fine to coarse sand, subangular METAVOLCANIC ROCK fragments up to 10"
③	METAVOLCANIC ROCK - bluish gray, moderately weathered, medium strong, moderately fractured, well defined foliation, refusal at 4.5' depth
Latitude: 38.660466 Longitude: -121.056072

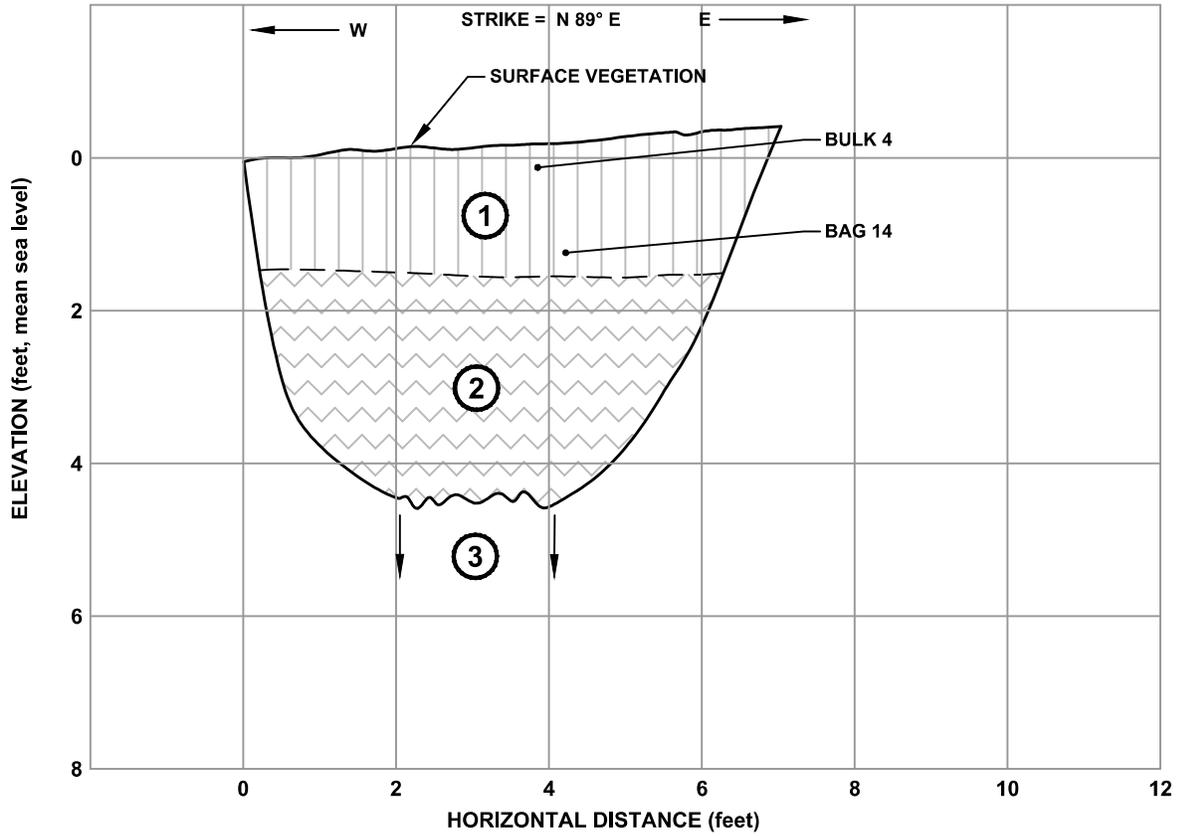
A-19

UNIT NO.	MATERIALS DESCRIPTION
①	SANDY SILT (ML) - dark brown, dry, low plasticity, fine to coarse sand, trace subangular gravels up to 1", rootlets (COLLUVIUM)
②	METAVOLCANIC ROCK - bluish gray and olive, dry, highly weathered, weak to medium strong, highly fractured, well defined foliation, similar to CLAYEY SAND with Gravel, Cobble, and Boulders (SC); fine to coarse sand, subangular METAVOLCANIC ROCK fragments up to 12"
③	METAVOLCANIC ROCK - bluish gray, moderately weathered, strong, moderately fractured, refusal at 4.5' depth Latitude: 38.659608 Longitude: -121.057533

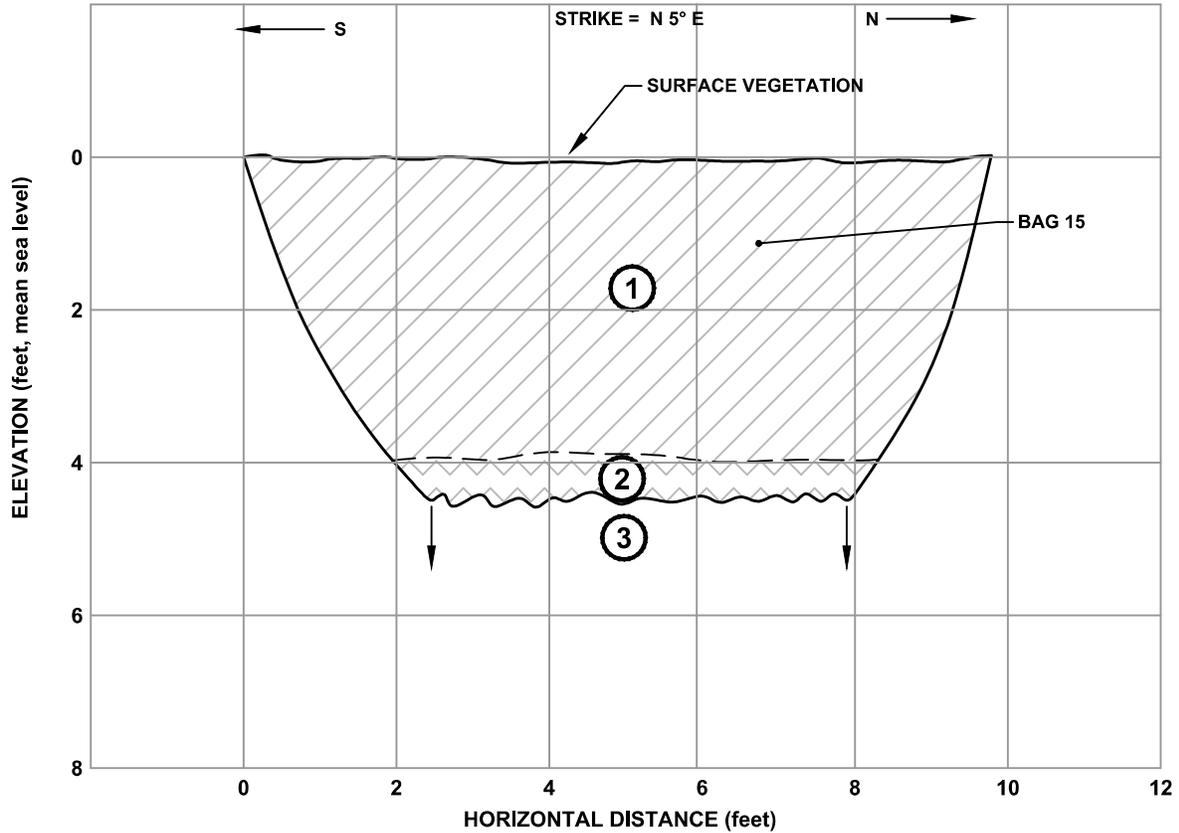
A-20

UNIT NO.	MATERIALS DESCRIPTION
①	LEAN CLAY with SAND (CL) - brownish red, dry, medium plasticity, fine to medium sand, trace coarse sand, trace subangular gravels up to 4" (RESIDUAL SOIL)
②	METAVOLCANIC ROCK - bluish gray and olive, dry to moist, highly weathered, medium strong, highly fractured, similar to CLAYEY SAND with Gravel and Cobble (SC); fine to coarse sand, subangular to angular METAVOLCANIC ROCK fragments up to 10"
③	METAVOLCANIC ROCK - bluish gray, moderately weathered, strong, moderately fractured, refusal at 4.5' depth Latitude: 38.659756 Longitude: -121.056681

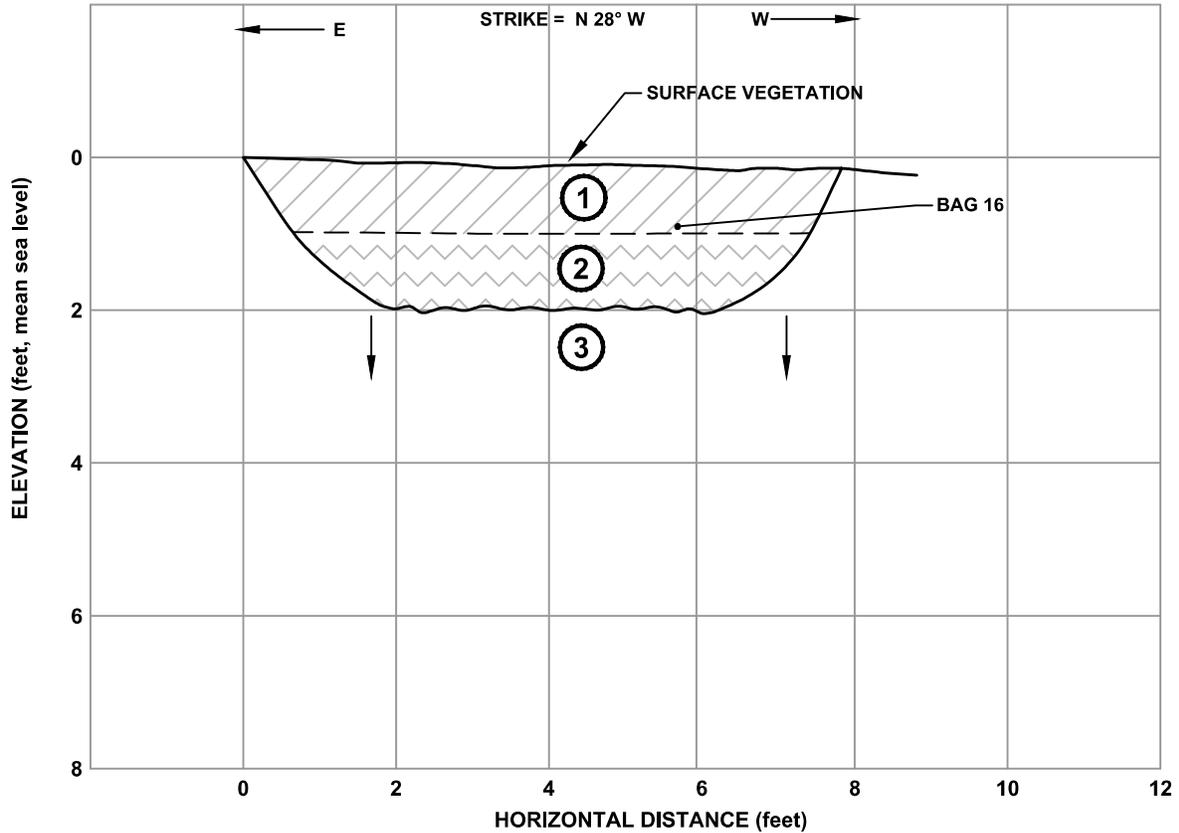
A-21

UNIT NO.	MATERIALS DESCRIPTION
①	LEAN CLAY with SAND (CL) - brownish red, dry, medium plasticity, fine to medium sand, trace coarse sand, trace coarse gravels up to 1.5", rootlets (RESIDUAL SOIL)
②	METAVOLCANIC ROCK - bluish gray and olive, dry, highly weathered, medium strong, highly fractured, slight foliation, similar to CLAYEY SAND with Gravel and Cobble (SC); fine to coarse sand, METAVOLCANIC COBBLES up to 8"
③	METAVOLCANIC ROCK - bluish gray, moderately weathered, strong, moderately fractured, refusal at 2' depth Latitude: 38.660051 Longitude: -121.055962

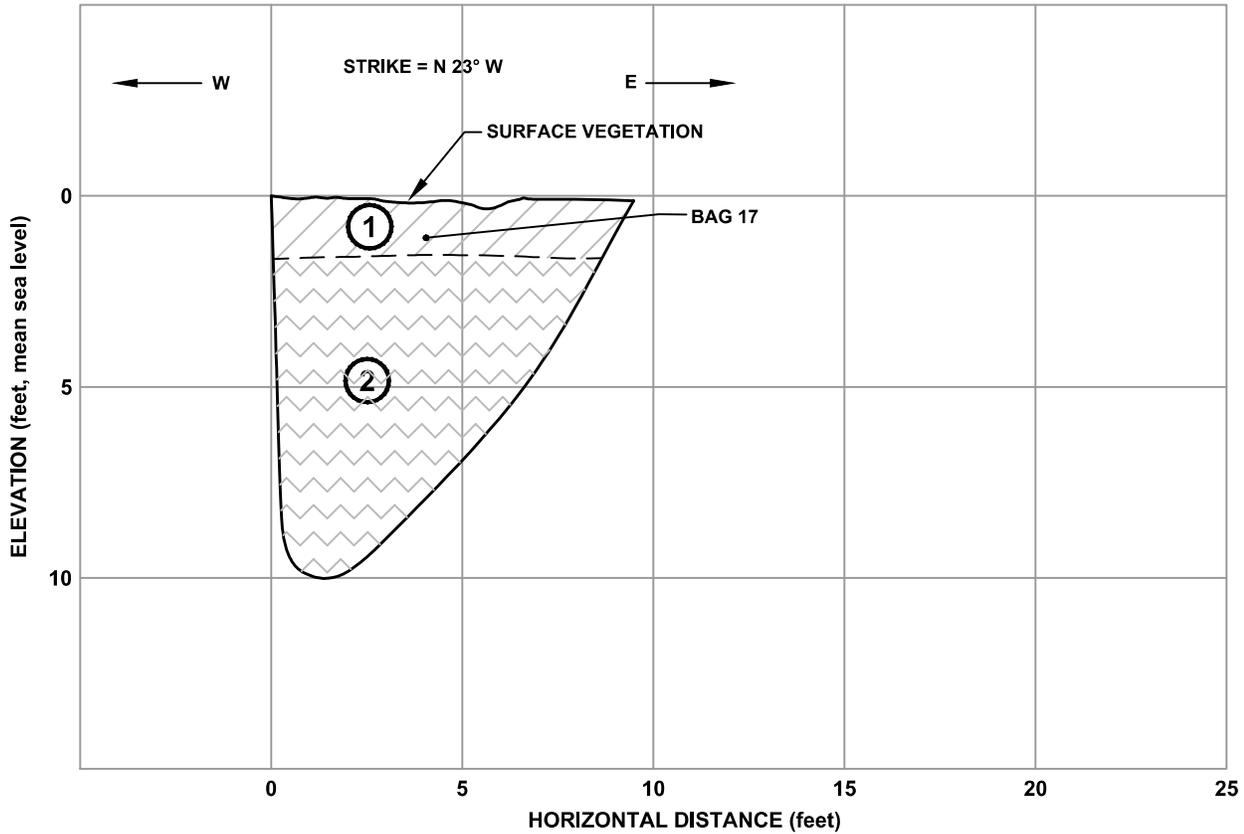
A-22

UNIT NO.	MATERIALS DESCRIPTION
①	SANDY LEAN CLAY with Gravel and Cobble (CL) - brownish red, dry, medium plasticity, fine to coarse sand, subangular gravel/cobble up to 4", rootlets (FILL)
②	METAVOLCANIC ROCK - bluish gray and olive, dry, highly weathered, medium strong, highly fractured, well defined foliation, similar to CLAYEY SAND with Gravel and Cobbles (SC); fine to coarse sand, subangular METAVOLCANIC GRAVELS and COBBLES up to 6"

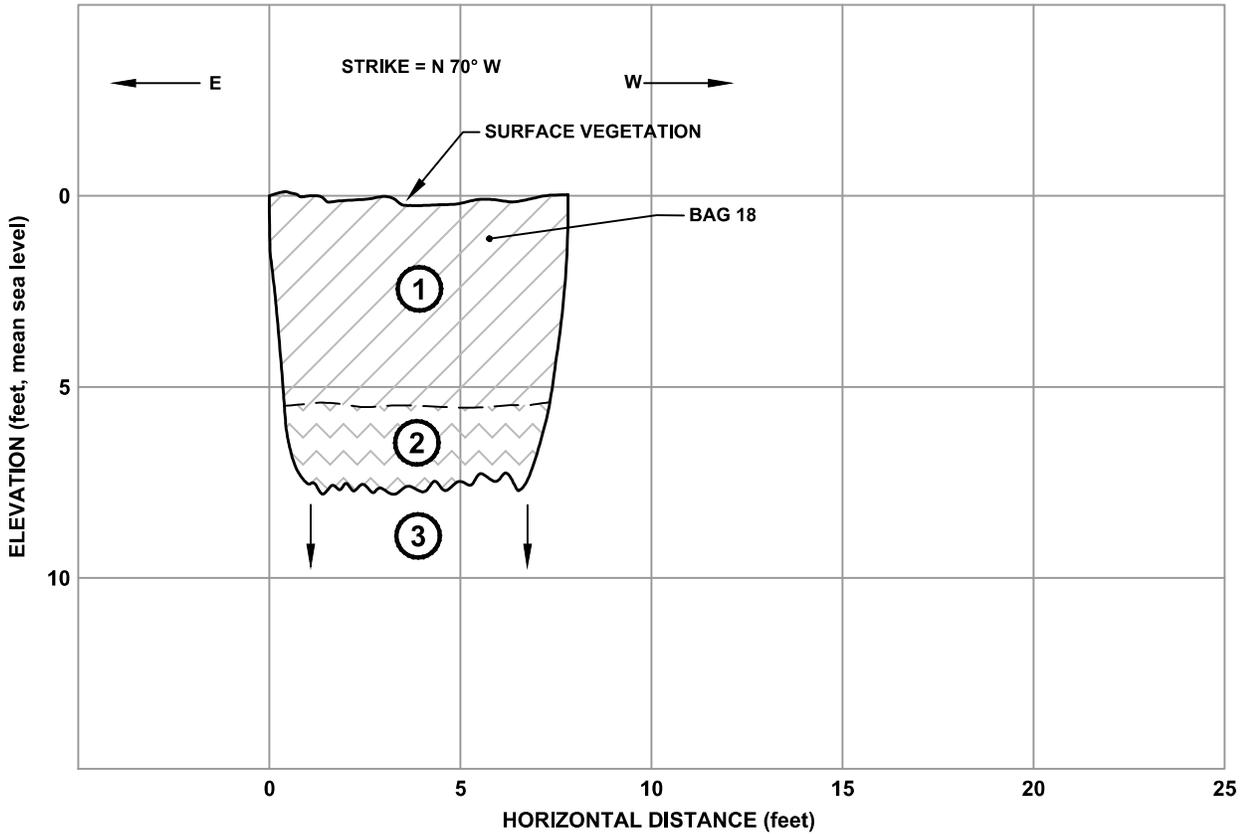
FIGURE
A-23

TEST PIT LOG
TP-17
CSM COSTCO EL DORADO HILLS
SILVA VALLEY PARKWAY
EL DORADO HILLS, CALIFORNIA

UNIT NO.	MATERIALS DESCRIPTION
①	SANDY LEAN CLAY with Gravel, Cobble, and Boulders (CL) - reddish brown, dry, medium plasticity, subangular to rounded fine sand to boulder sized particles up to 2' (FILL)
②	METAVOLCANIC ROCK - bluish gray and olive, dry, highly weathered, medium strong, highly fractured, similar to CLAYEY SAND with Gravel and Cobbles (SC); fine to coarse sand, subangular METAVOLCANIC COBBLES up to 8"
③	METAVOLCANIC ROCK - bluish gray, moderately weathered, strong, moderately fractured, well defined foliation, refusal at 7.3' depth Latitude: 38.659105 Longitude: -121.057523

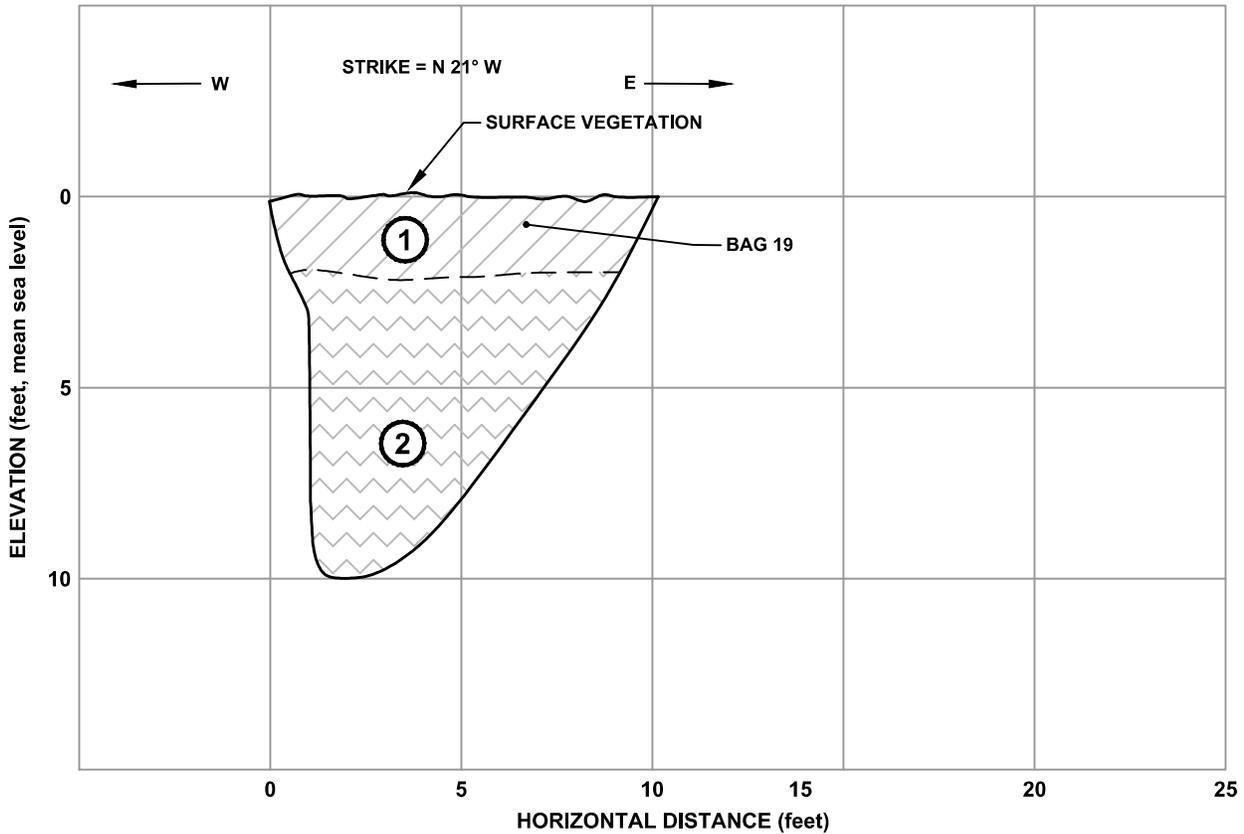
A-24

UNIT NO.	MATERIALS DESCRIPTION
①	LEAN CLAY with Sand (CL) - brownish red, dry, medium plasticity, fine to medium sand, trace subangular gravels up to 2", rootlets (RESIDUAL SOIL)
②	METAVOLCANIC ROCK - bluish gray and olive, dry to moist, highly weathered, weak to medium strong, highly fractured, slight foliation, similar to CLAYEY SAND with Gravel and Cobble(SC); fine to coarse sand, subangular METAVOLCANIC ROCK fragments up to 5"

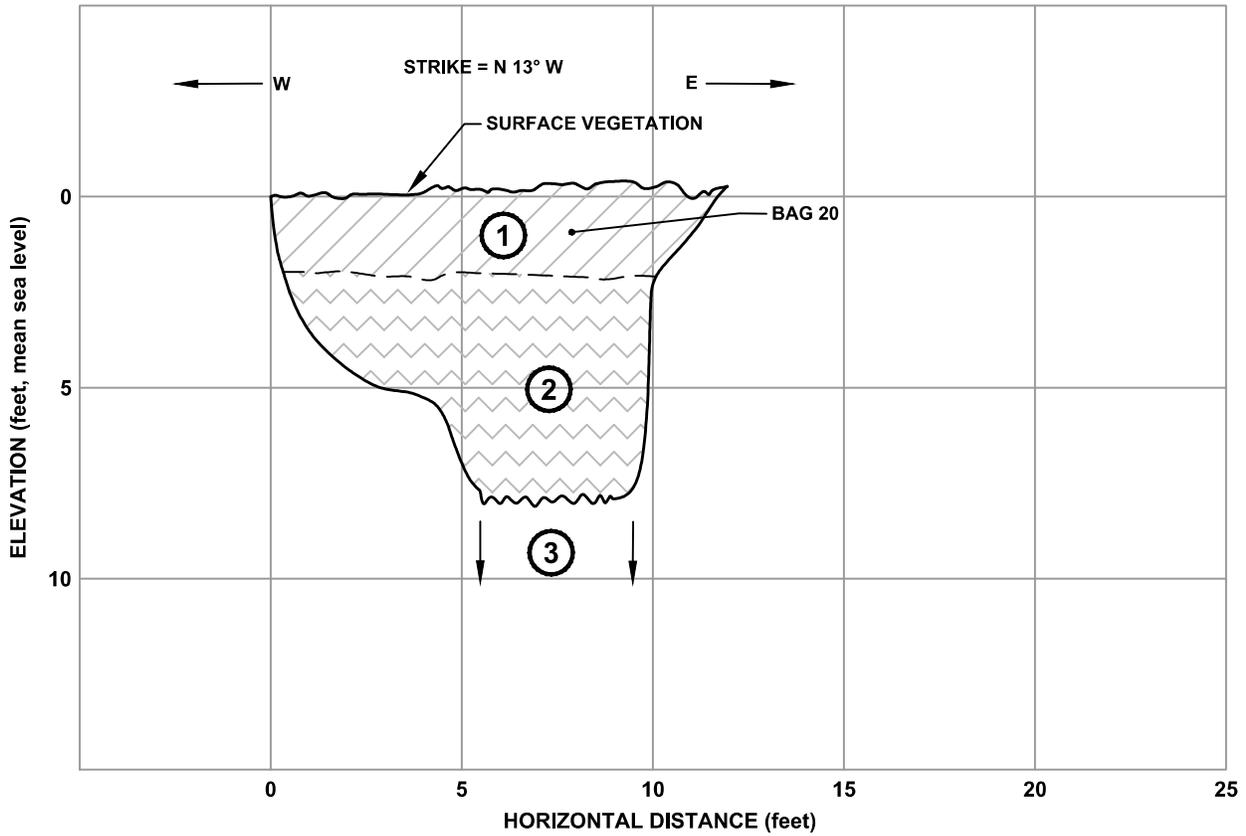
FIGURE
A-25

TEST PIT LOG
TP-19
CSM COSTCO EL DORADO HILLS
SILVA VALLEY PARKWAY
EL DORADO HILLS, CALIFORNIA

UNIT NO.	MATERIALS DESCRIPTION
①	LEAN CLAY with Sand (CL) - brownish red, dry, medium plasticity, fine to medium subangular sand, trace fine gravels, rootlets (RESIDUAL SOIL)
②	METAVOLCANIC ROCK - light bluish gray, dry, highly weathered, medium strong, highly fractured, well defined foliation, similar to CLAYEY SAND with Gravel, Cobble, and Boulders (SC); fine to coarse sand, subangular ROCK fragments up to 13"
③	METAVOLCANIC ROCK - bluish gray, moderately weathered, strong, moderately fractured, well defined foliation, refusal at 7.5' depth Latitude: 38.659582 Longitude: -121.056399

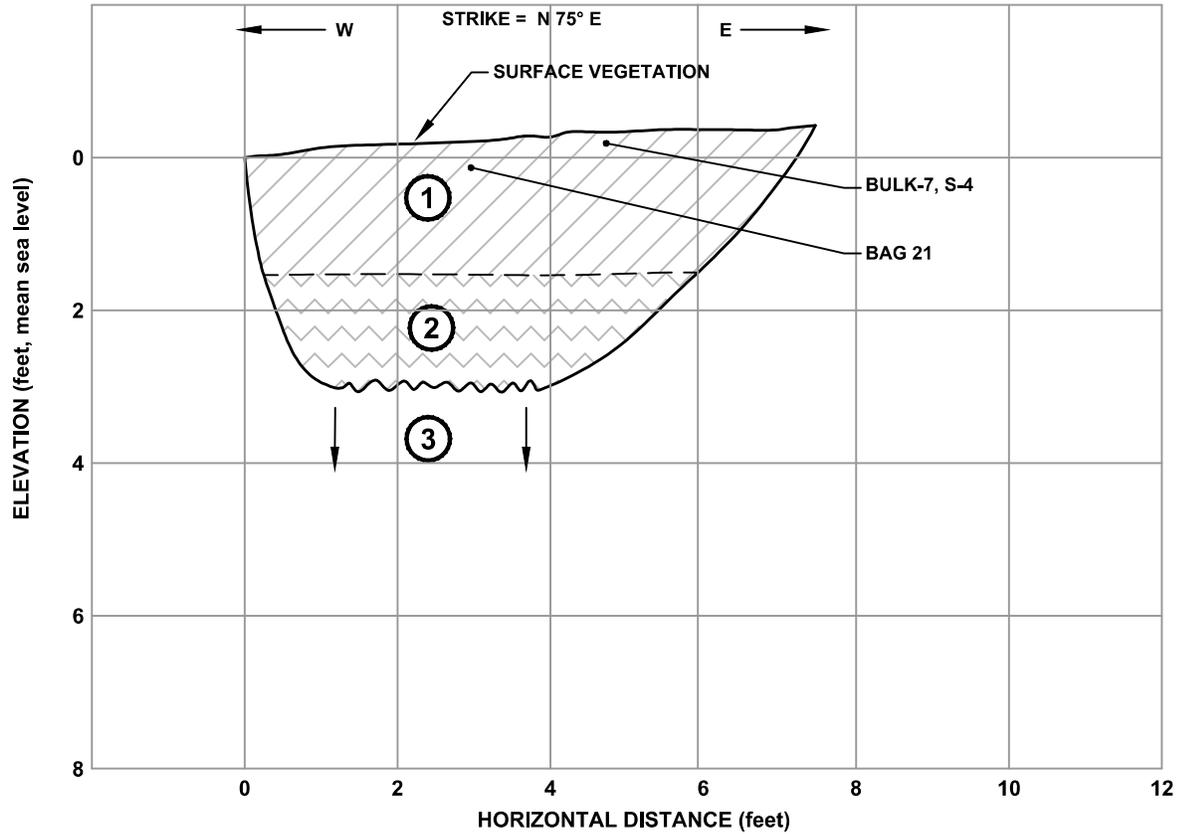
A-26

UNIT NO.	MATERIALS DESCRIPTION
①	LEAN CLAY with SAND (CL) - brownish red, dry, medium plasticity, subangular fine to medium sand, trace fine gravels, rootlets (RESIDUAL SOIL)
②	METAVOLCANIC ROCK - bluish gray and olive, dry, highly weathered, medium strong, highly fractured, similar to POORLY GRADED SAND with Clay, Gravel, and Cobble (SP-SC); fine to coarse sand and gravel subrounded cobbles up to 6"
③	METAVOLCANIC ROCK - bluish gray, moderately weathered, strong, highly fractured, slight foliation, refusal at 3' depth Latitude: 38.659766 Longitude: -121.056003

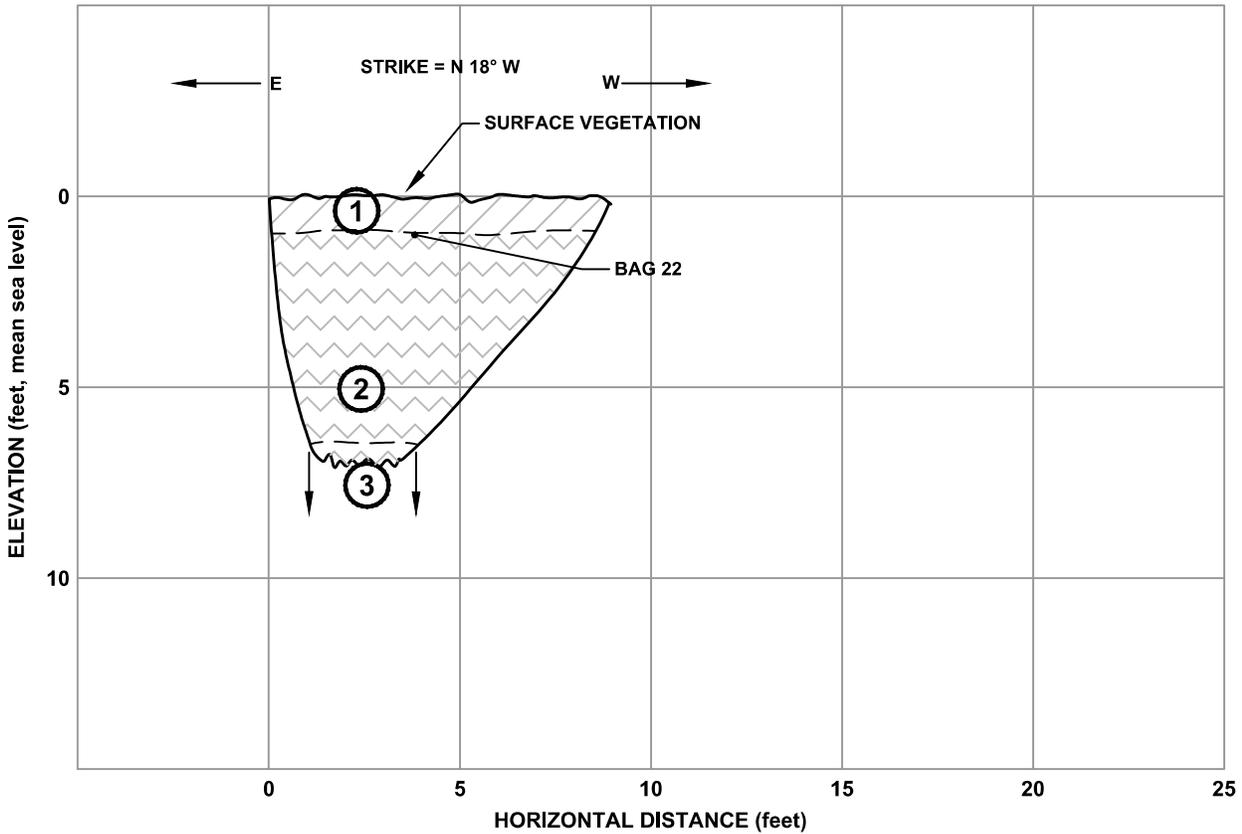
A-27

UNIT NO.	MATERIALS DESCRIPTION
①	SANDY LEAN CLAY (CL) - brownish red, dry, medium plasticity, fine to medium sand, trace subangular gravels up to 1", rootlets (RESIDUAL SOIL)
②	METAVOLCANIC ROCK - bluish gray and olive, dry to moist, highly weathered, medium strong, highly fractured, slight foliation, similar to CLAYEY SAND with Gravel, Cobble, and Boulders (SC); fine to coarse sand, subangular gravel, cobbles, and boulders up to 15"
③	METAVOLCANIC ROCK - bluish gray, moderately weathered, strong, moderately fractured, slight foliation, refusal at 7' depth Latitude: 38.659371 Longitude: -121.056358

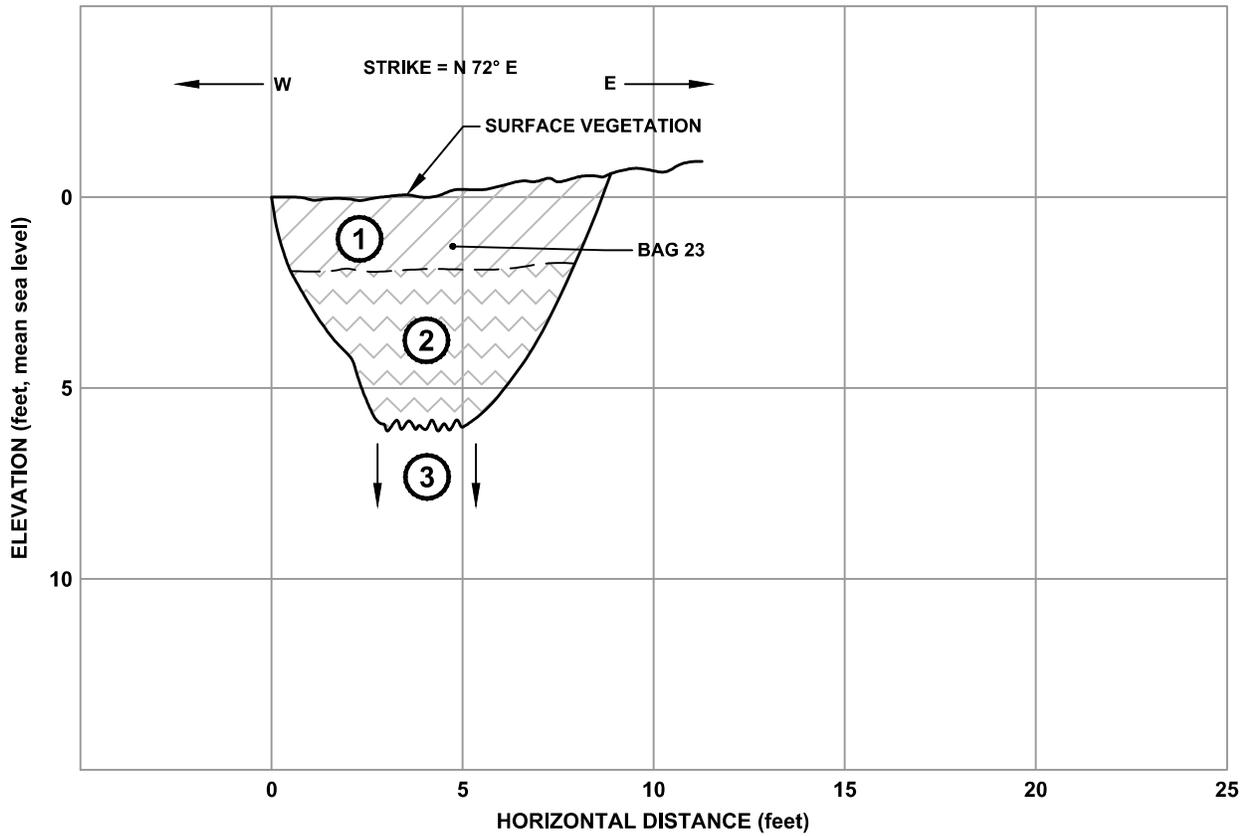
A-28

UNIT NO.	MATERIALS DESCRIPTION
①	SANDY LEAN CLAY (CL) - brownish red, dry, medium plasticity, fine to medium sand, trace subangular coarse gravels up to 1.5", rootlets (RESIDUAL SOIL)
②	METAVOLCANIC ROCK - bluish gray and olive, dry, highly weathered, weak to strong, highly fractured, slight foliation, similar to CLAYEY SAND with Gravel and Cobble, fine to coarse sand, subangular METAVOLCANIC ROCK fragments up to 10"
③	METAVOLCANIC ROCK - bluish gray, moderately weathered, strong, moderately fractured, refusal at 6' depth Latitude: 38.659276 Longitude: -121.056011

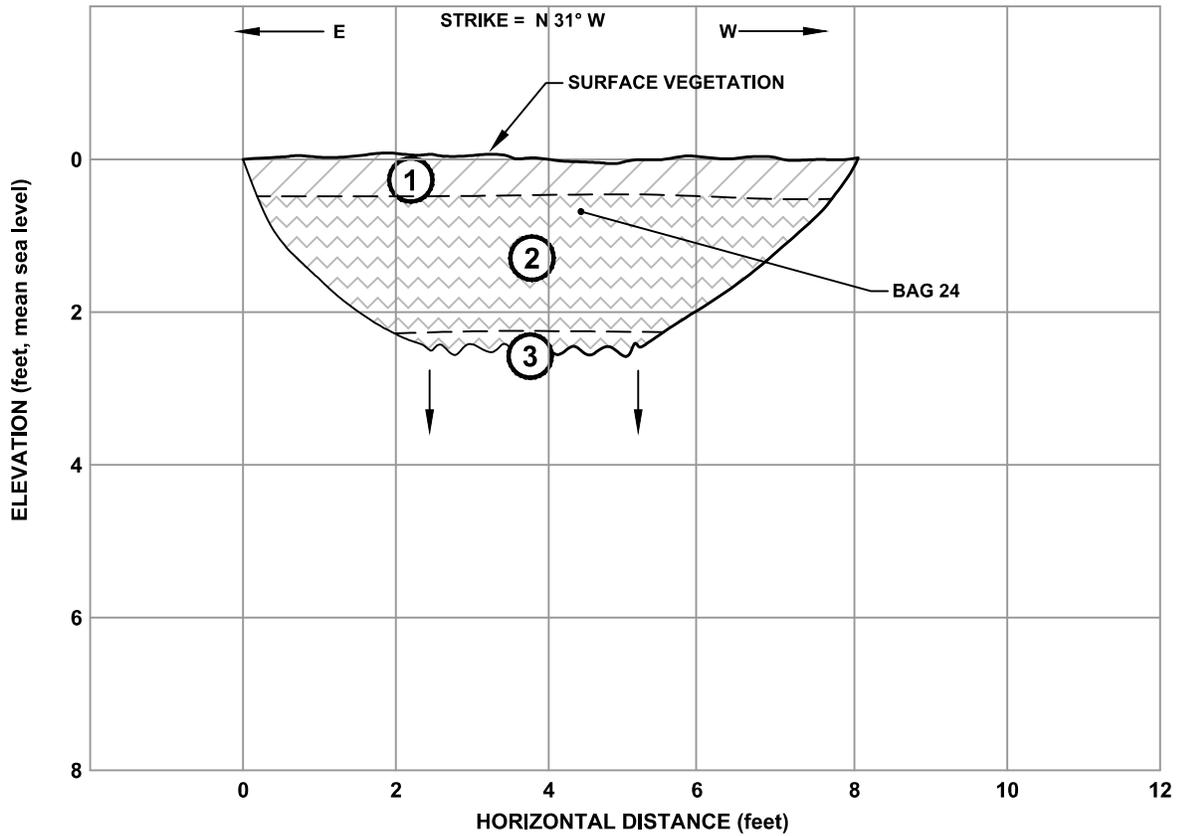
FIGURE
 A-29

TEST PIT LOG
 TP-23
 CSM COSTCO EL DORADO HILLS
 SILVA VALLEY PARKWAY
 EL DORADO HILLS, CALIFORNIA

UNIT NO.	MATERIALS DESCRIPTION
①	SANDY LEAN CLAY (CL) - brownish red, dry, medium plasticity, fine to medium sand, trace fine coarse sand, trace fine gravel, rootlets (RESIDUAL SOIL)
②	METAVOLCANIC ROCK - bluish gray and olive, dry, highly weathered, weak to medium strong, highly fractured, well defined foliation, similar to CLAYEY SAND with Gravel, Cobbles, and Boulders (SC); fine to coarse sand, subangular gravels and cobbles up to 14"
③	METAVOLCANIC ROCK - bluish gray, moderately weathered, strong, moderately fractured, well defined foliation, refusal at 2.5' depth Latitude: 38.659248 Longitude: -121.055652

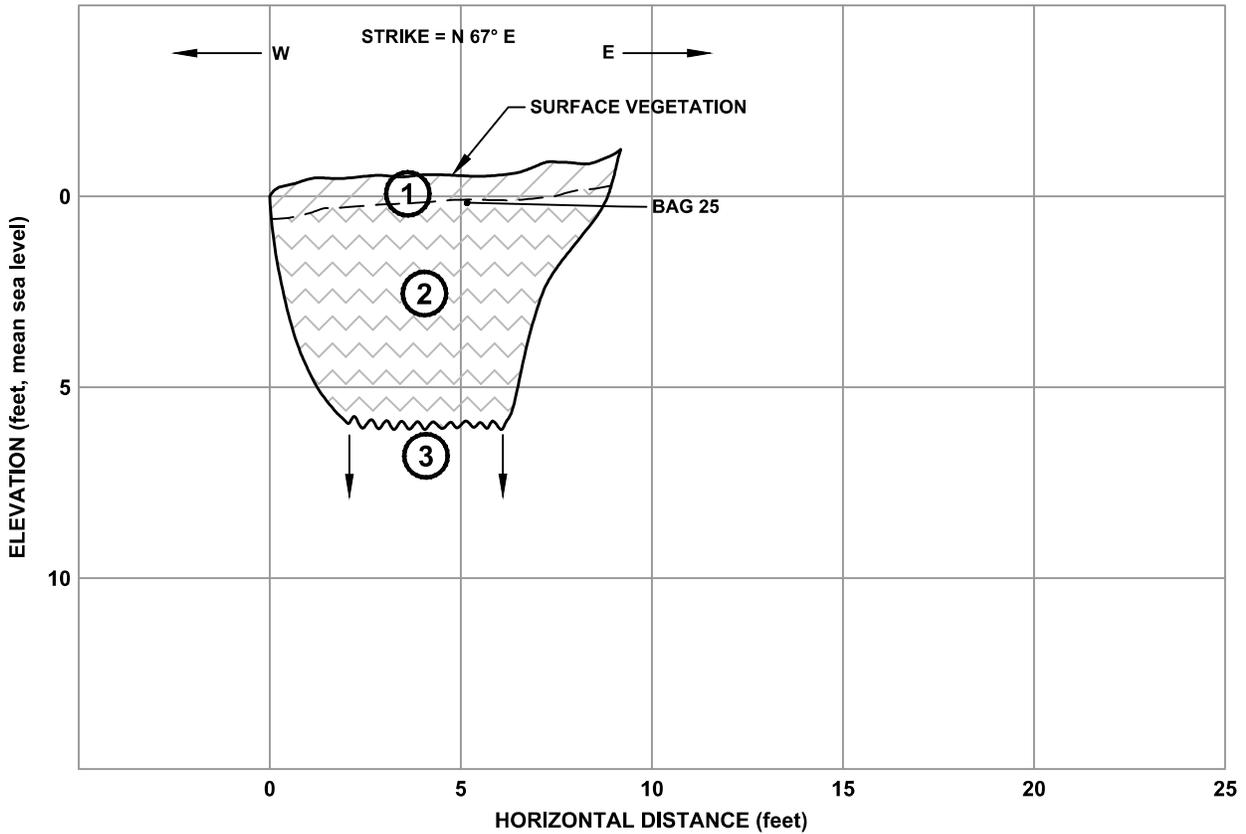
A-30

UNIT NO.	MATERIALS DESCRIPTION
①	SANDY LEAN CLAY (CL) - brownish red, dry, medium plasticity, subangular fine to medium sand, trace fine gravel, rootlets (RESIDUAL SOIL)
②	METAVOLCANIC ROCK - light bluish gray, dry, highly weathered, medium strong, highly fractured, slight foliation, similar to POORLY GRADED SAND with Clay, Gravel, Cobble, and Boulders (SP-SC); fine to coarse sand, subangular gravel, cobble, and boulders up to 14"
③	METAVOLCANIC ROCK - light bluish gray, moderately weathered, strong, highly fractured, slight foliation, refusal at 6' depth Latitude: 38.659457 Longitude: -121.055406

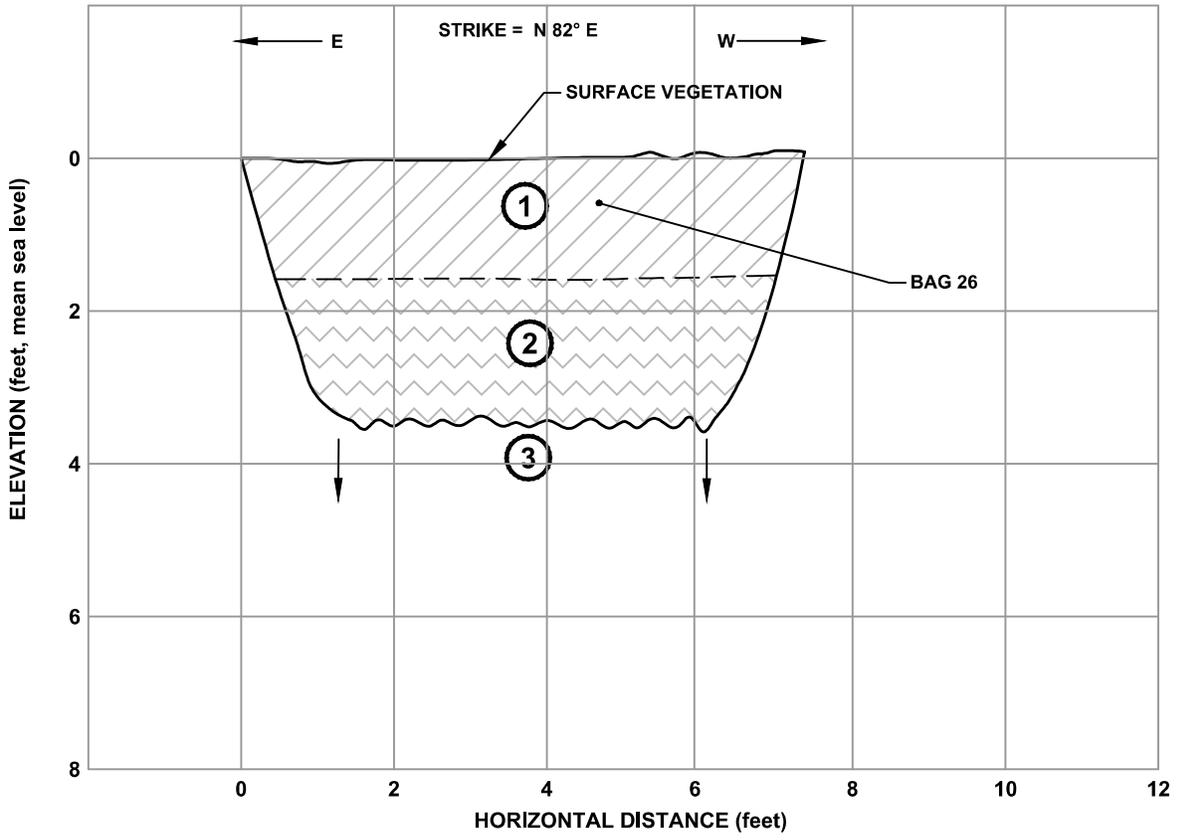
A-31

UNIT NO.	MATERIALS DESCRIPTION
①	LEAN CLAY with SAND (CL) - brownish red, dry, medium plasticity, subangular fine to medium sand, trace fine gravel, rootlets (RESIDUAL SOIL)
②	METAVOLCANIC ROCK - bluish gray and olive, dry, highly weathered, medium strong, highly fractured, well defined foliation, similar to CLAYEY SAND with Gravel and Cobble (SC); fine to coarse sand
③	METAVOLCANIC ROCK - bluish gray, moderately weathered, strong, moderately fractured, refusal at 3.5 depth Latitude: 38.659029 Longitude: -121.057009

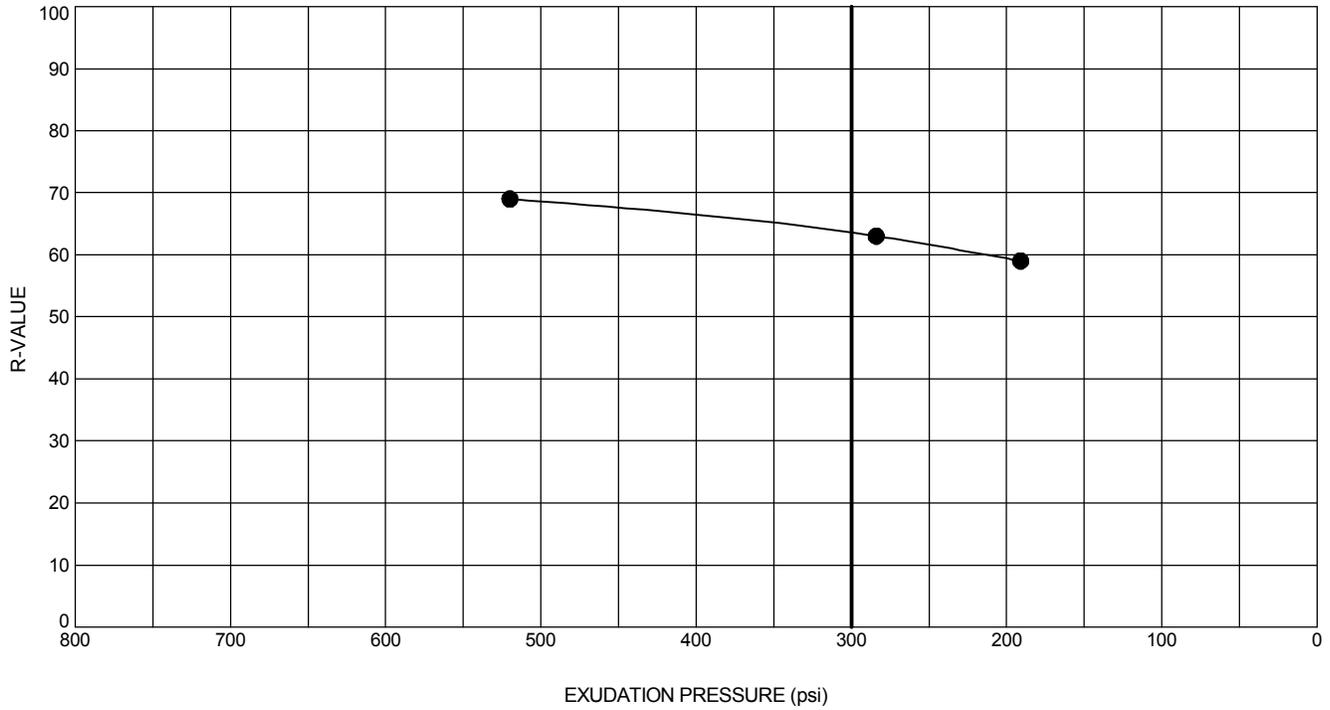
Exploration ID	Depth (ft.)	Sample Description	R-Value @ 300 psi Exudation Pressure		
TP-(1)	0 - 2	SANDY LEAN CLAY (CL)	63		
Specimen No.	Moisture at Time of Test (%)	Dry Unit Weight (pcf)	Expansion Pressure (psi)	Exudation Pressure (psi)	Corrected Resistance Value
1	16.3	108.1	286	284	63
2	15.4	110.1	450	520	69
3	17.1	108.4	268	191	59

Testing performed in general accordance with ASTM D2844.

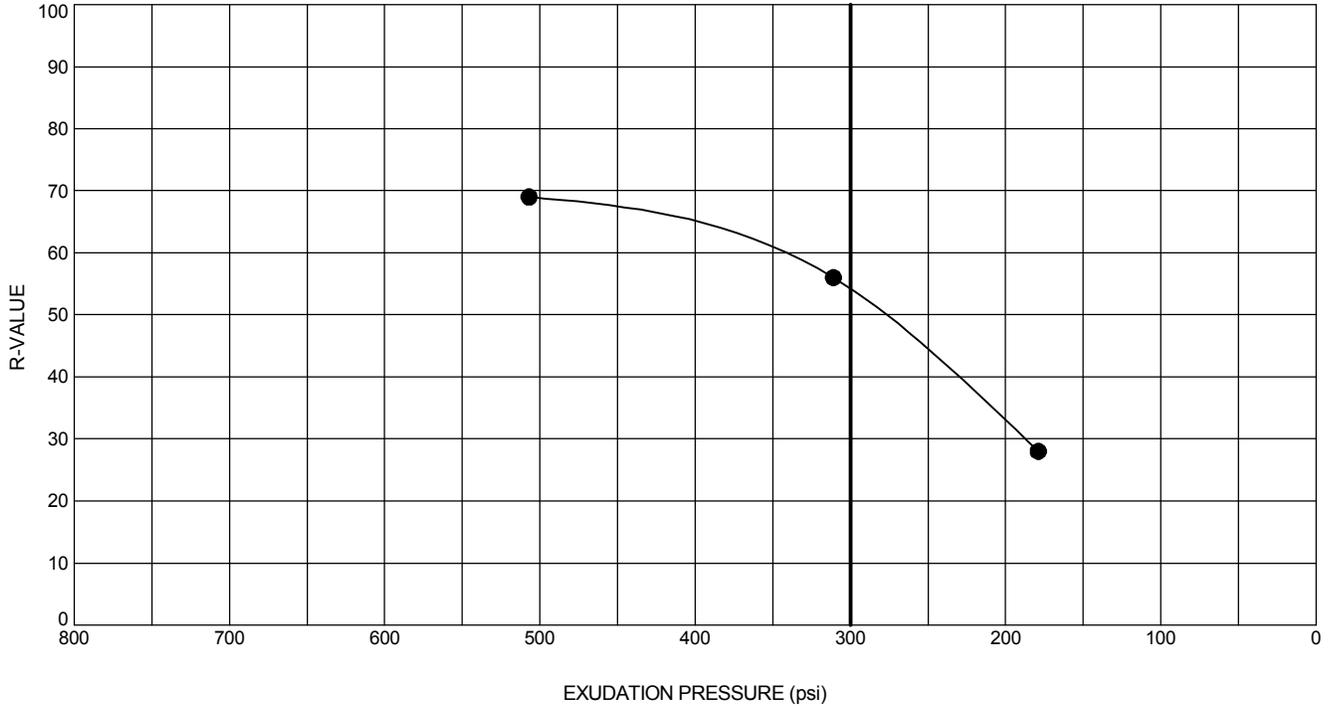
Exploration ID	Depth (ft.)	Sample Description			R-Value @ 300 psi Exudation Pressure
TP-(14)	0 - 2	SANDY SILT (ML)			54
Specimen No.	Moisture at Time of Test (%)	Dry Unit Weight (pcf)	Expansion Pressure (psi)	Exudation Pressure (psi)	Corrected Resistance Value
1	15.2	113.5	294	311	56
2	13.5	116.0	494	507	69
3	16.9	113.0	178	179	28

Testing performed in general accordance with ASTM D2844.

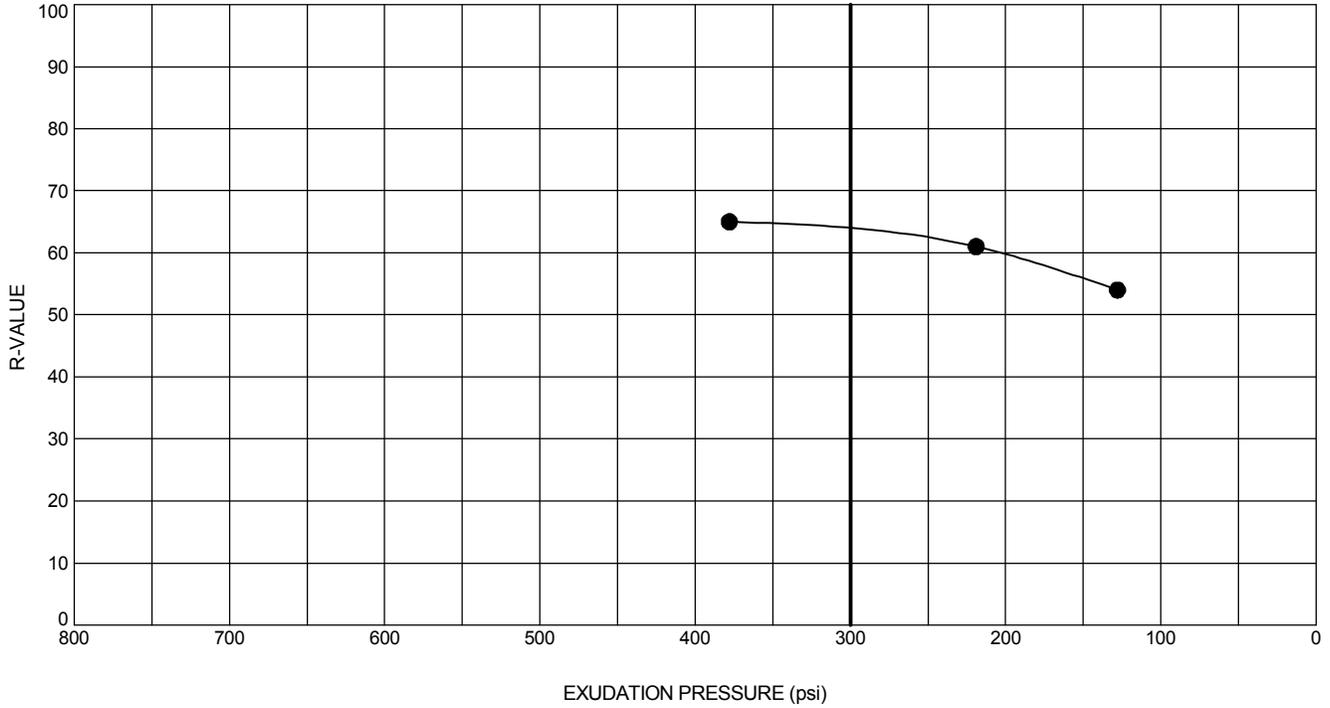
B-4

Exploration ID	Depth (ft.)	Sample Description			R-Value @ 300 psi Exudation Pressure
TP-(26)	0 - 1.5	LEAN CLAY WITH SAND (CL)			63
Specimen No.	Moisture at Time of Test (%)	Dry Unit Weight (pcf)	Expansion Pressure (psi)	Exudation Pressure (psi)	Corrected Resistance Value
1	13.8	119.1	169	128	54
2	12.9	118.9	208	378	65
3	13.3	119.5	195	219	61

Testing performed in general accordance with ASTM D2844.

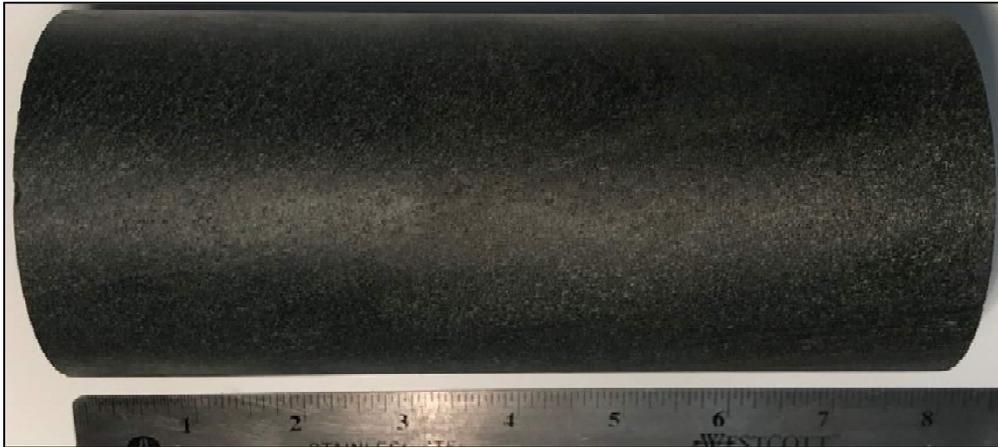
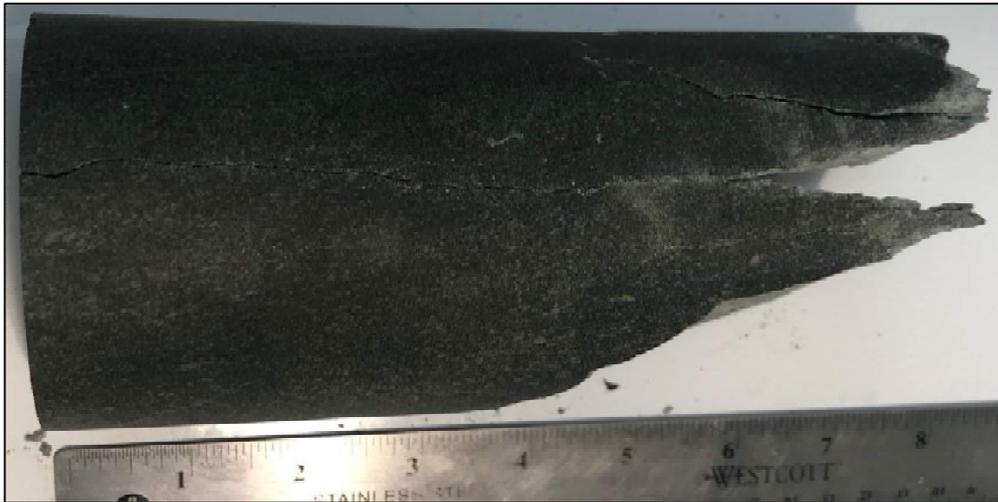
B-5

Specimen Preparation in accordance with ASTM D4543	Diameter, in	D _o	3.27
Remarks:	Height, in	H _o	6.79
	Moisture Condition		As Received
	Unit Weight, pcf	ρ _d	183
	Uniaxial Compressive Strength (psi)	σ _u	17,400
	Time to Failure, mm:ss		2:52

Description of Specimen: Metavolcanic		Test Method: ASTM D7012, Method C
Boring:	KB-4	
Run:	4	
Depth, ft:	16.6-17.6	
Test Date:	10/9/2019
