Geotechnical Study
(December 10, 2024)

**SUBJECT: Geotechnical Study
Proposed Costco Fuel Facility
Silva Valley Parkway
El Dorado Hills, California
CW# 18-0487**

**GEOTECHNICAL STUDY
PROPOSED COSTCO FUEL FACILITY
SILVA VALLEY PARKWAY
EL DORADO HILLS, CALIFORNIA
CW# 18-0487
KLEINFELDER PROJECT NO. 20193141.002A**

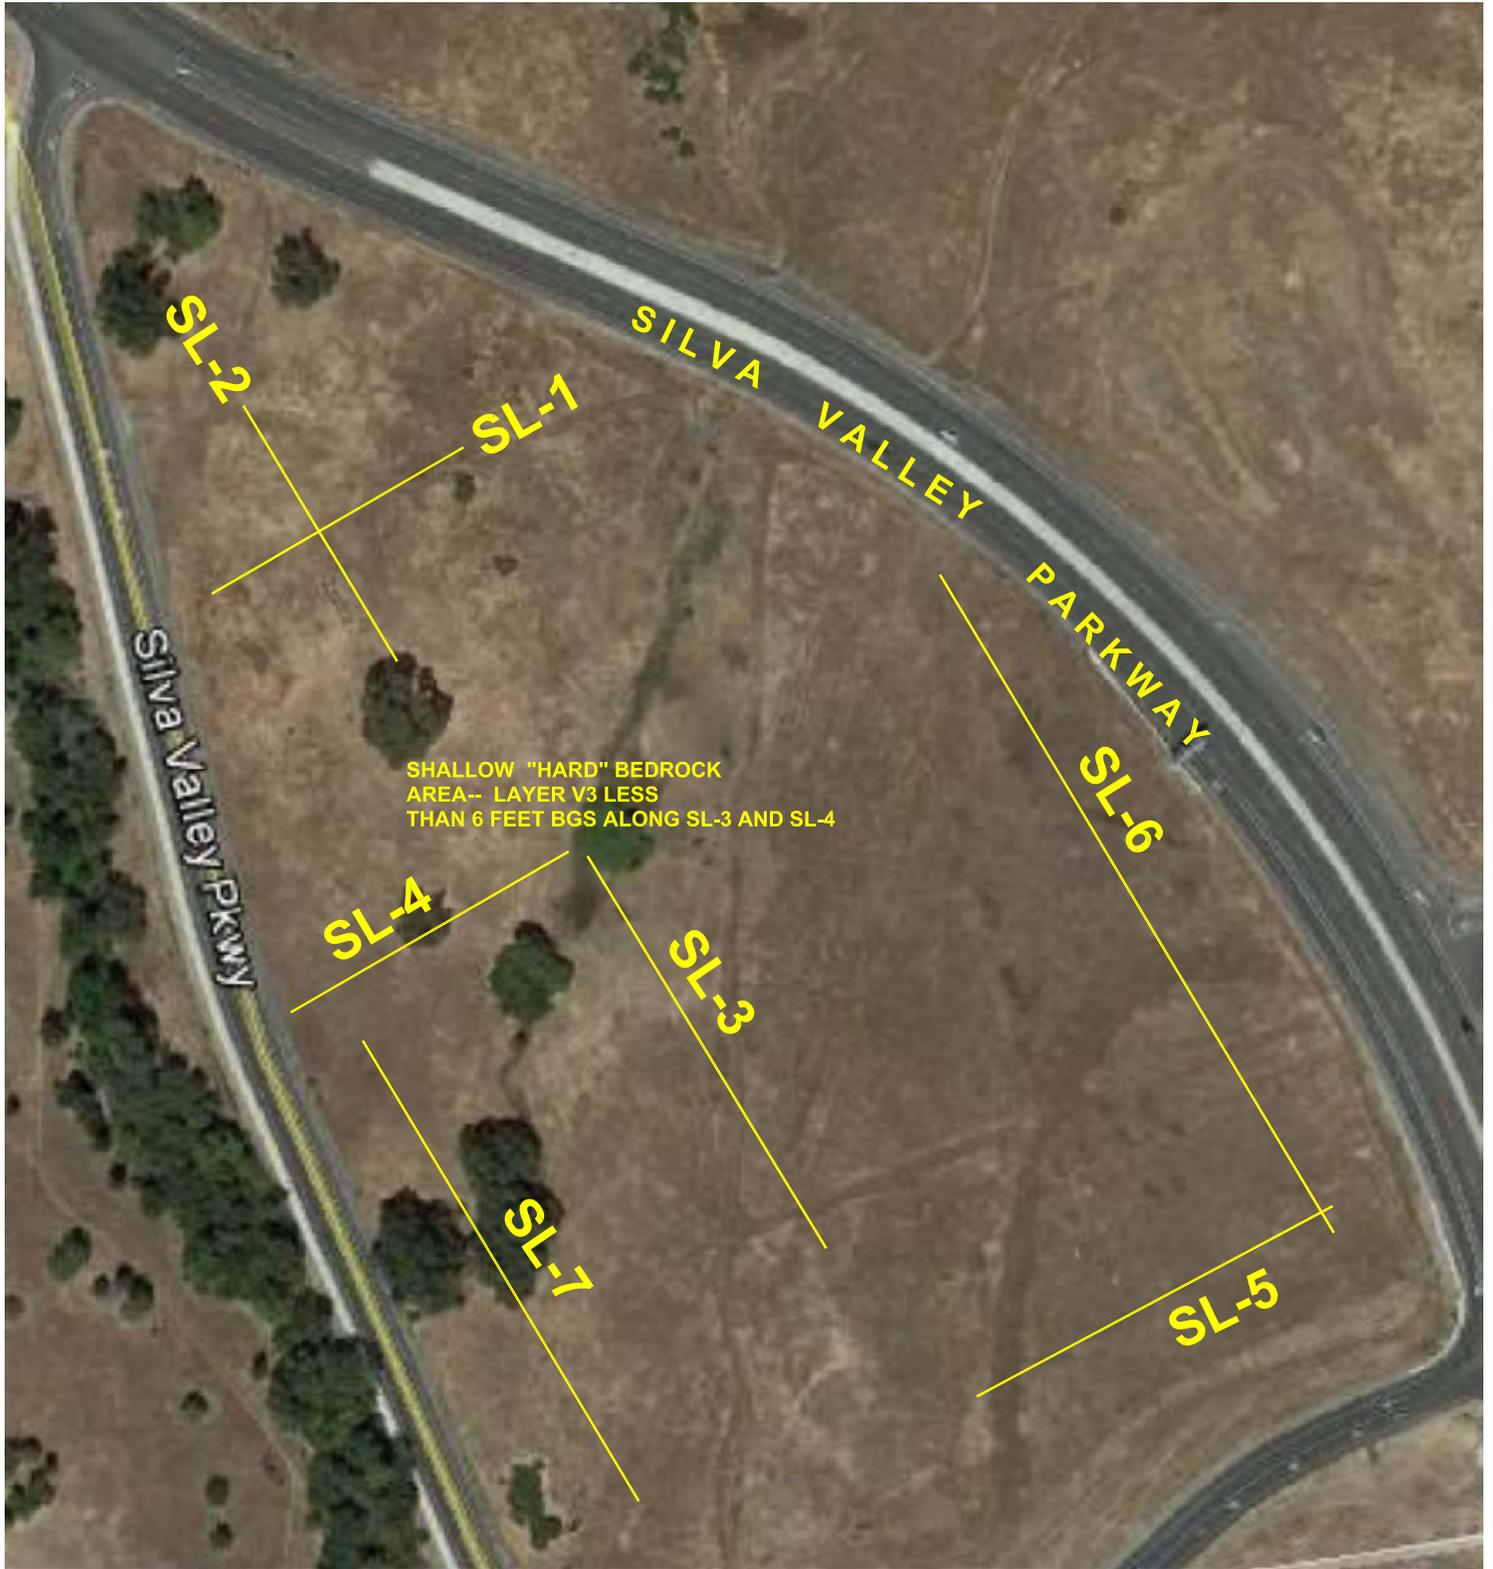
2

SHALLOW "HARD" BEDROCK
 AREA-- LAYER V3 LESS
 THAN 6 FEET BGS ALONG SL-3 AND SL-4

This letter presents the results of Advanced Geological Services, Inc. (AGS) seismic refraction survey in support of grading work at a 16-acre site north of Tong Road and west of Silva Valley Parkway in El Dorado Hills, California (Figure 1). The survey objective was to assess the depth and excavation characteristics (rippability) of bedrock. The survey was performed on August 7 and 8, 2019 by AGS senior geophysicist Roark W. Smith and his assistant. Field oversight was provided by Mr. Jordan Annand of Kleinfelder, who showed AGS the seismic line locations, which were marked in the field with wood stakes labeled with the seismic line number. The survey comprised seven seismic lines of varying lengths and orientations distributed across the site (Figure 2).

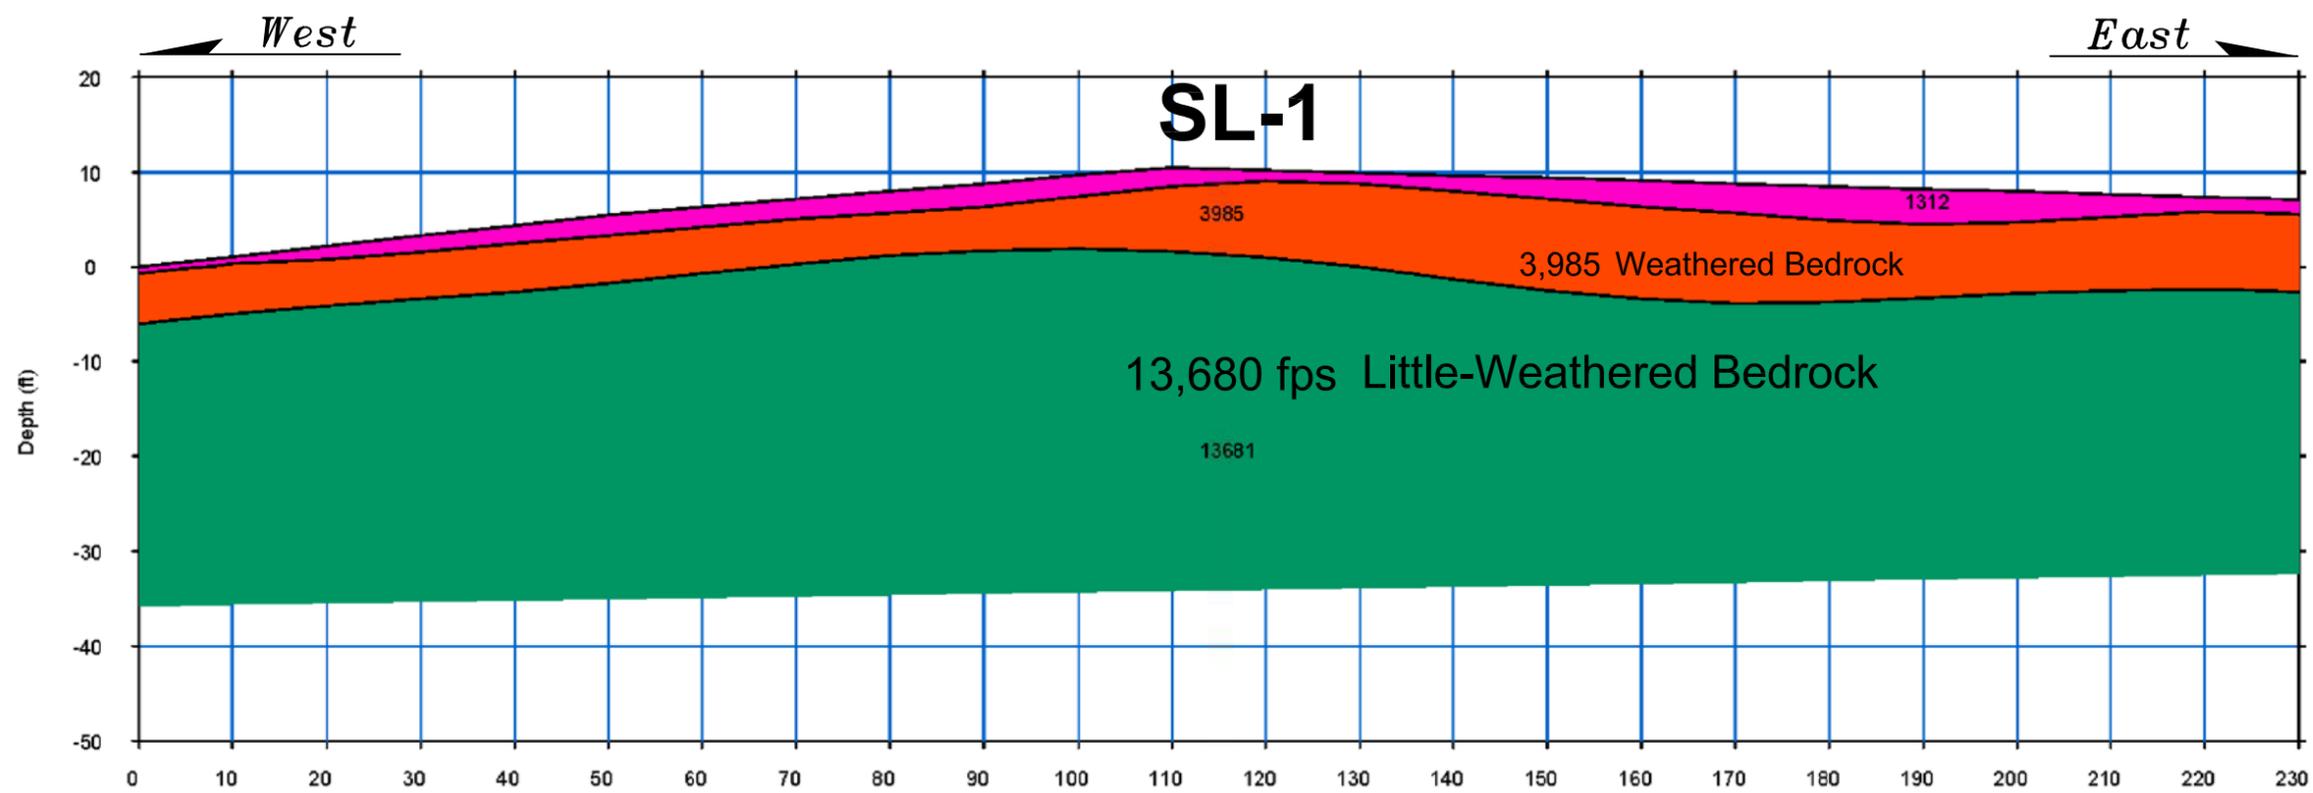
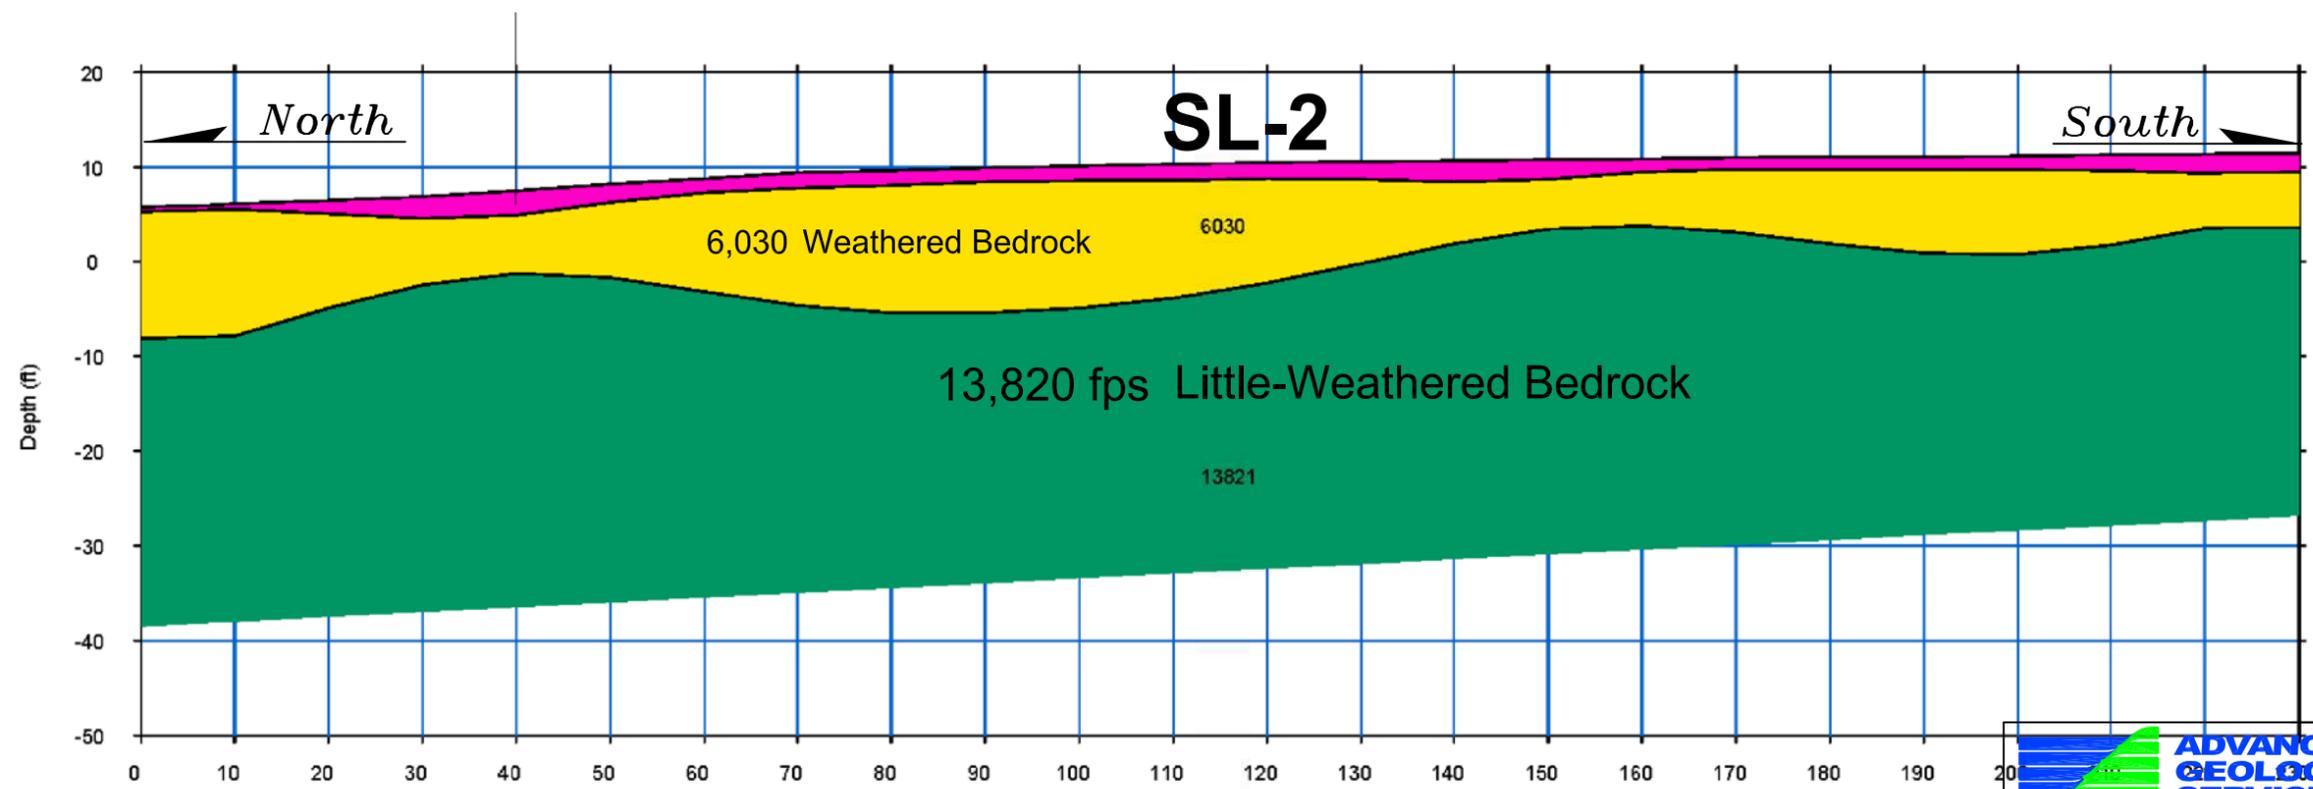
SL-1, SL-2 SEISMIC LINE LOCATIONS

Figures: Figure 1 Seismic Refraction Survey Area (imbedded in Report text, above)
 Figure 2 Seismic Refraction Line Locations
 Figure 3 P-wave Velocity Layer Models, SL-1 & SL-2
 Figure 4 P-wave Velocity Layer Models, SL-3 & SL-4
 Figure 5 P-wave Velocity Layer Model, SL-5
 Figure 6 P-wave Velocity Layer Model, SL-6
 Figure 7 P-wave Velocity Layer Model, SL-7

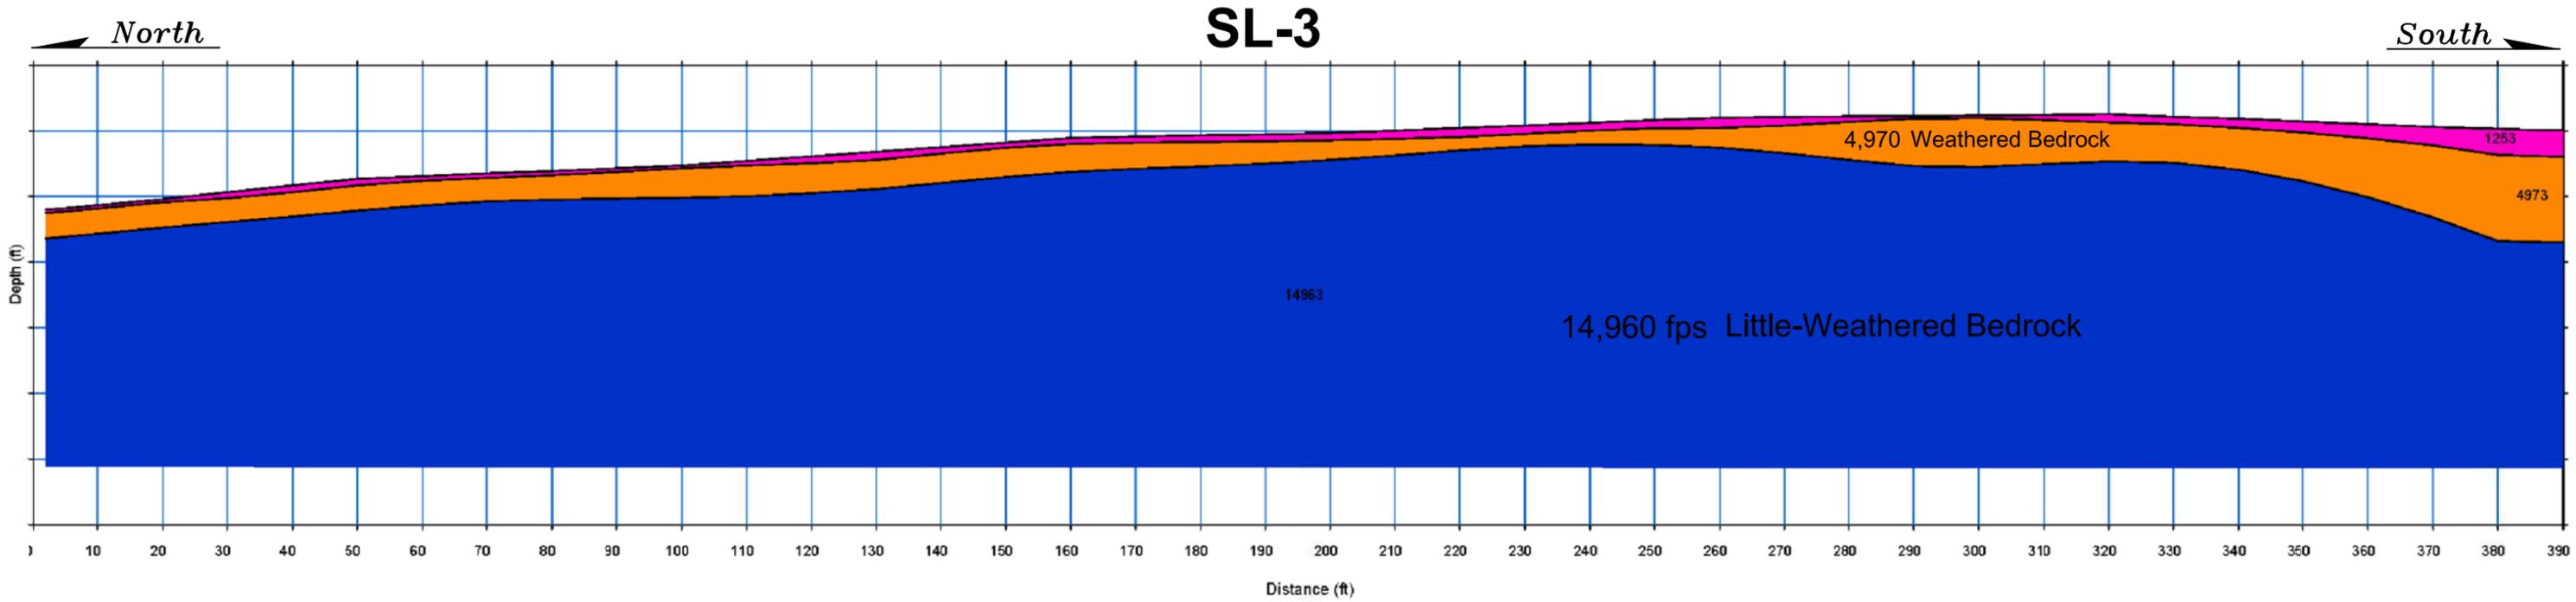
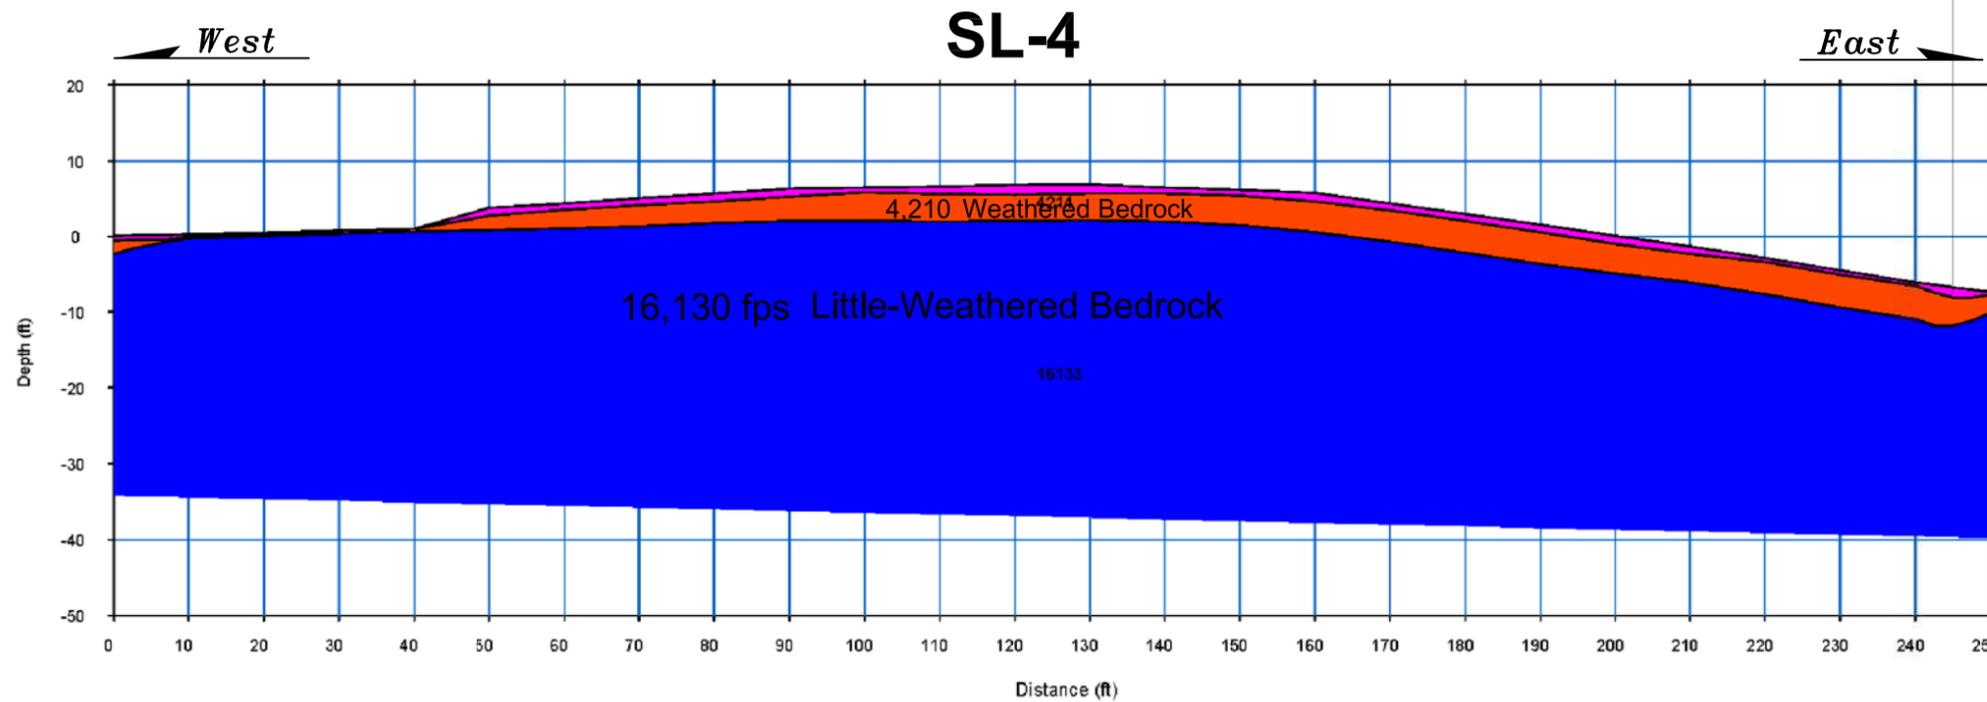
SL-3 & SL-4 SEISMIC LINE LOCATIONS

<p>ADVANCED GEOLOGICAL SERVICES</p>	<p>SL-3 & SL-4 P-Wave Velocity Layer Models Silva Valley Parkway, Phase II Seismic Refraction Investigation</p>	
	<p>1605 School Street Suite 4 Moraga, CA 94556 (925) 808-8965</p>	
<p>LOCATION: El Dorado Hills, California</p>		<p>FIGURE 4</p>
<p>CLIENT: Kleinfelder, Inc.</p>		
<p>PROJECT #: 19-093-1CA</p>		
<p>DATE: Aug 19, 2019</p>	<p>DRAWN BY: R. SMITH</p>

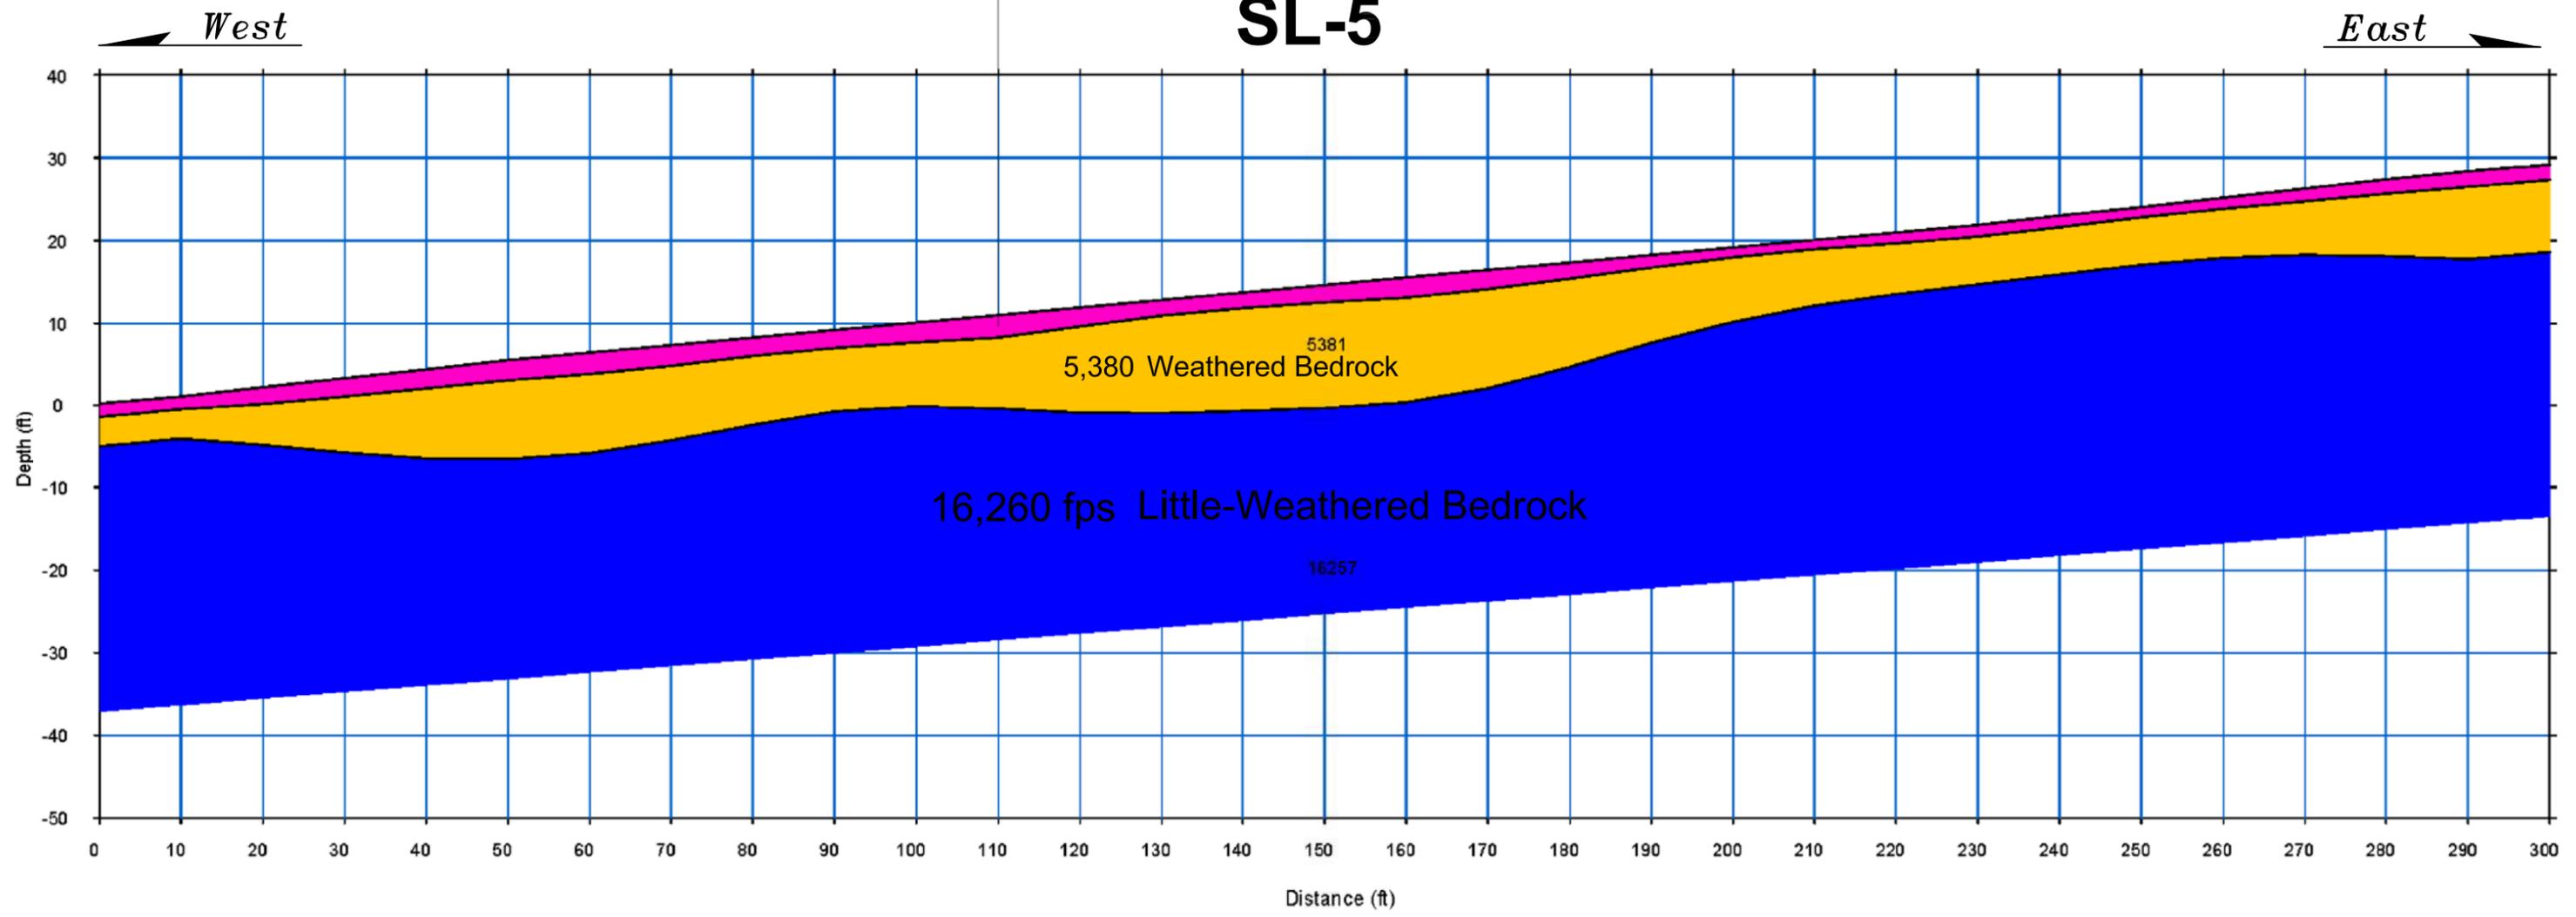
SL-5 SEISMIC LINE LOCATION

<p>ADVANCED GEOLOGICAL SERVICES</p>	SL-5 P-Wave Velocity Layer Model Silva Valley Parkway, Phase II Seismic Refraction Investigation	
	1605 School Street Suite 4 Moraga, CA 94556 (925) 808-8965	LOCATION: El Dorado Hills, California CLIENT: Kleinfelder, Inc. PROJECT #: 19-093-1CA DATE: Aug 19, 2019 DRAWN BY: R. SMITH

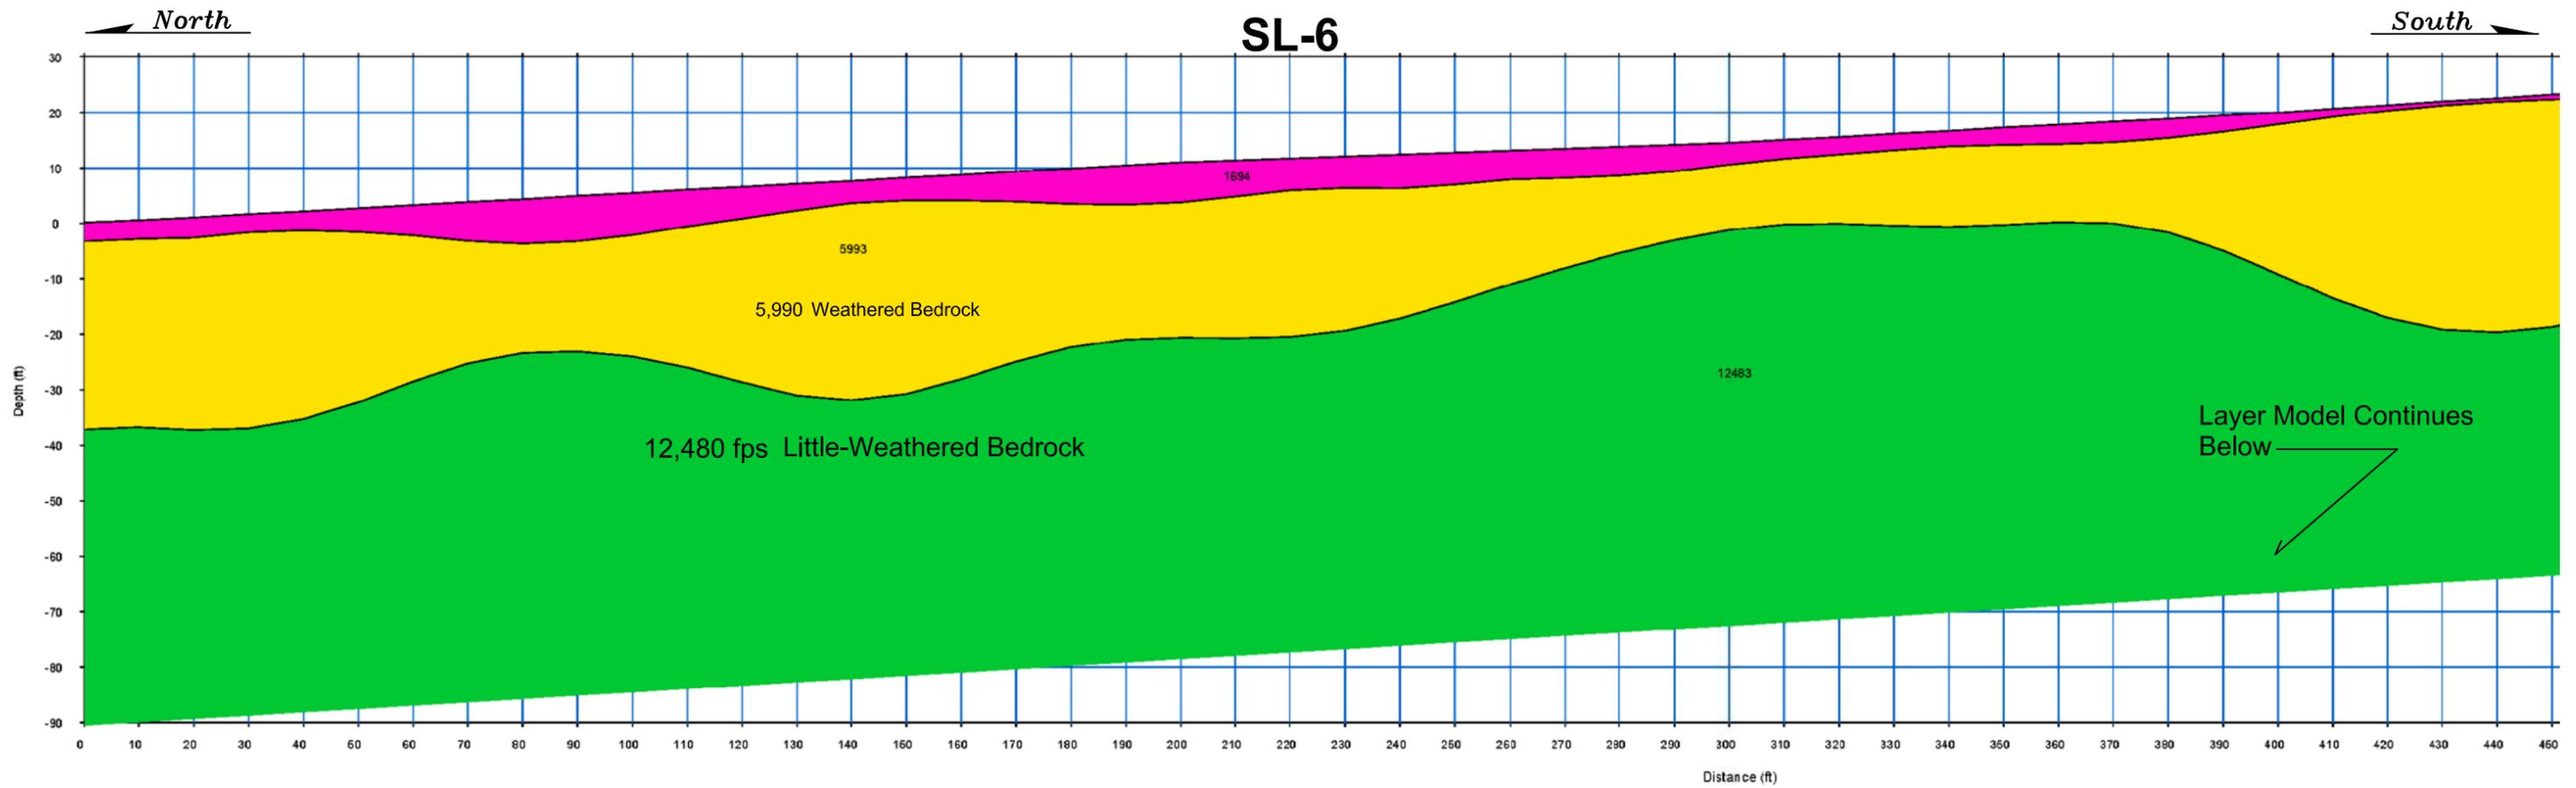
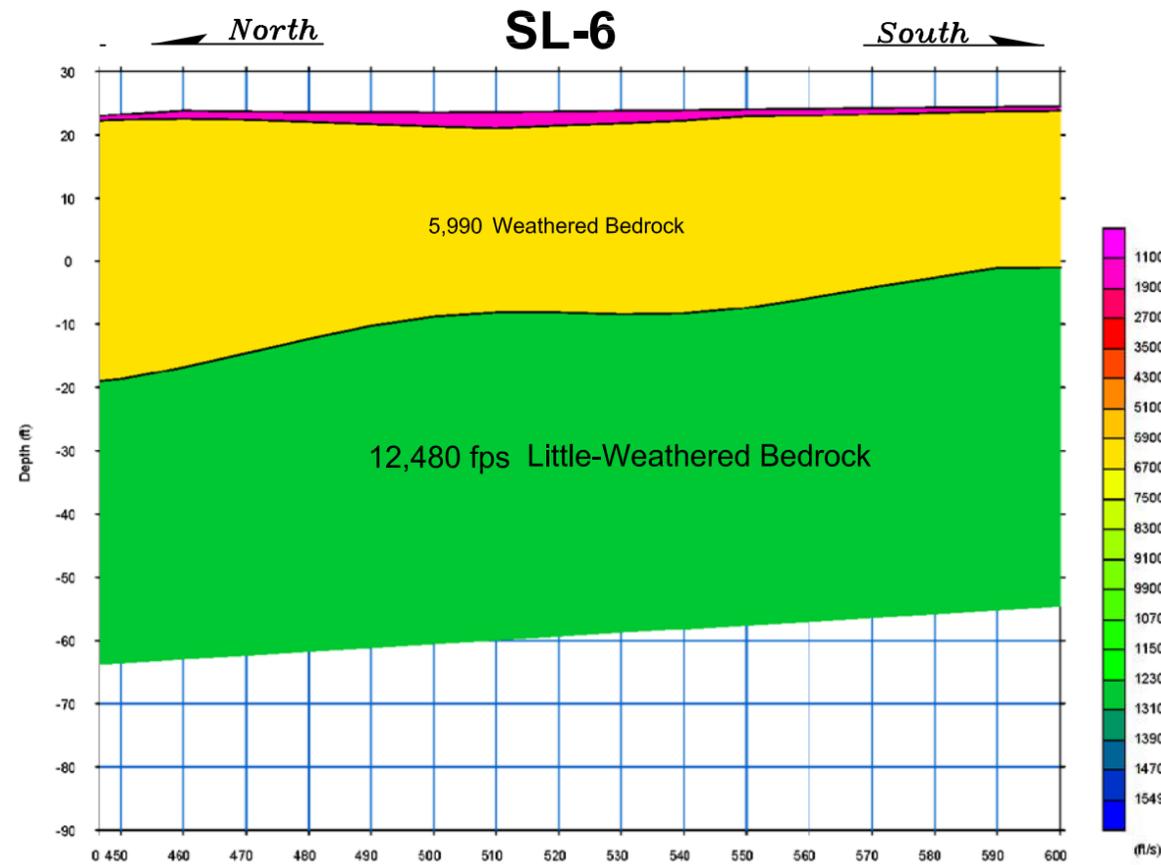
6

SL-6 SEISMIC LINE LOCATION

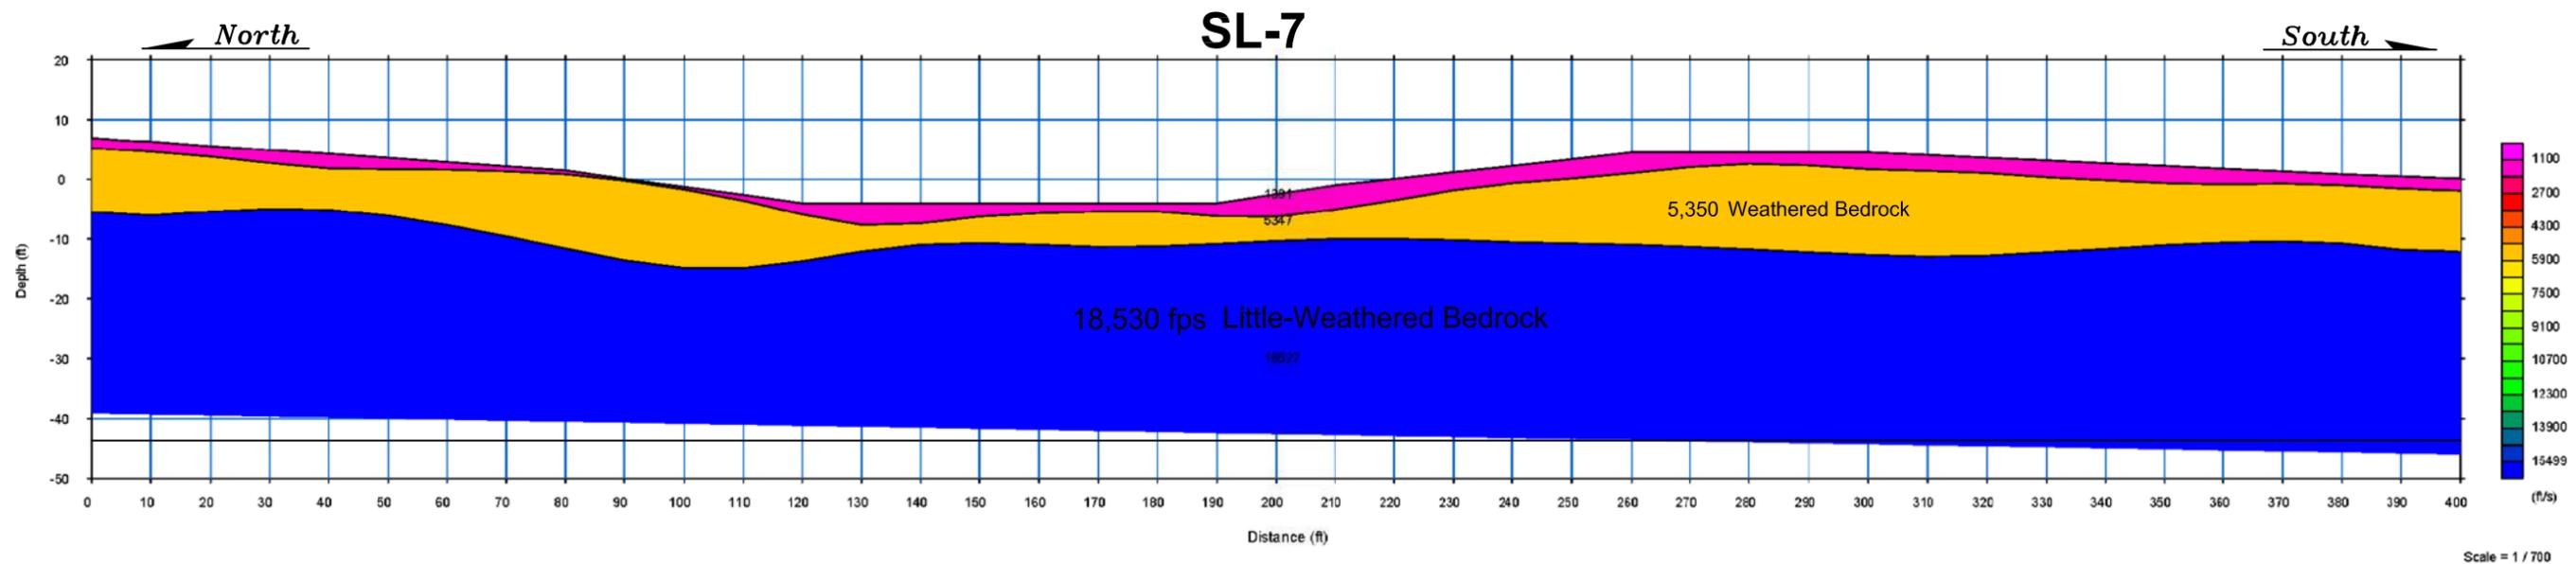
SL-7 SEISMIC LINE LOCATION
