FINAL FOUNDATION REPORT

Silva Valley Eastbound
Off-Ramp Undercrossing
El Dorado County, California
Bridge No. 25-0128S
03-ED-50
PM R1.65
EA 03-1E2901

Subject: **FINAL FOUNDATION REPORT**
Silva Valley Eastbound Off-Ramp UC
Bridge No. 25-0128S
03-ED-50; PM R1.65; EA 03-1E2901

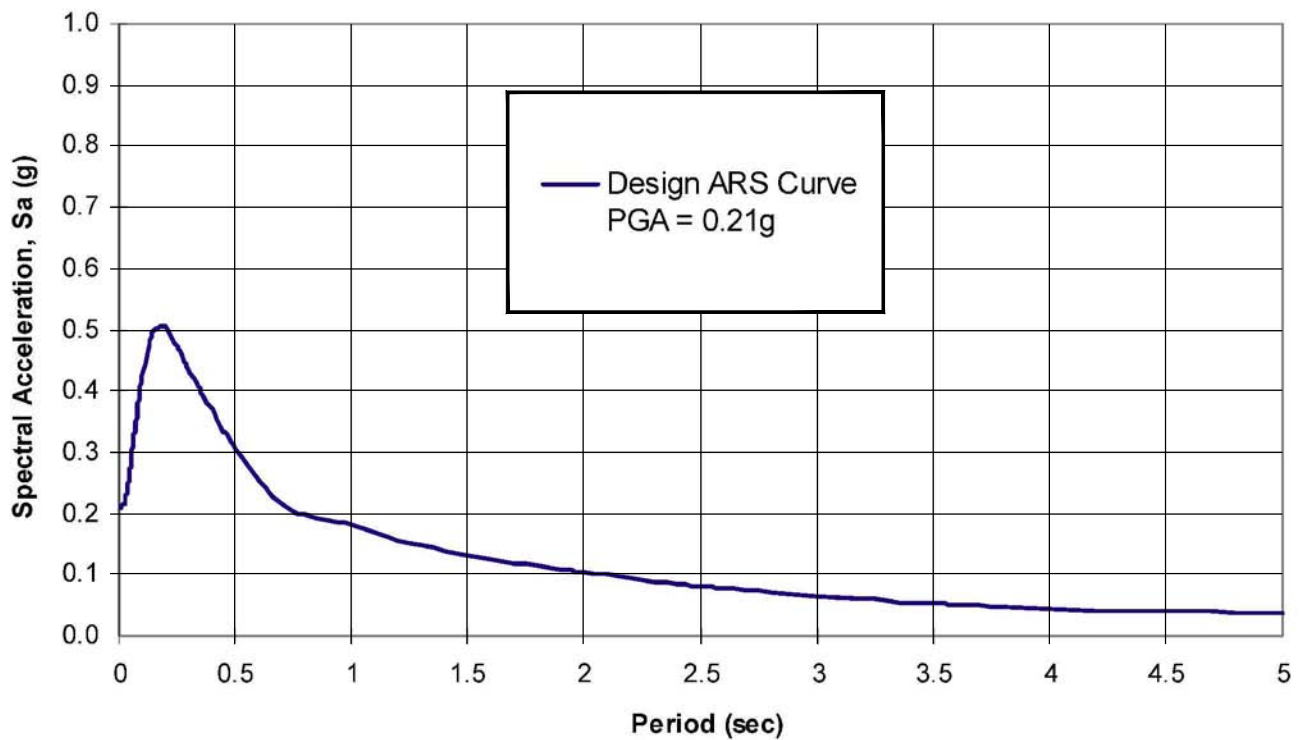
5/11/2012 556.2 Silva Valley EB Off-Ramp UC Figure 4.dwg

Design ARS Curve (5% Damping)

Reference: Geotechnical Services Design Manual (Version 1.0, August 2009) and Caltrans Seismic Design Criteria, Appendix B, Revised 9/11/2009.

We recommend the design spectrum based on the upper envelope spectral values of the combined minimum deterministic and probabilistic response spectra across the period spectrum from 0 to 5 seconds. BCI assigns the site a MMax of 6.5 with a Peak Ground Acceleration (PGA) of 0.21g. We present data points for site spectra in Table 4 and graphed site spectra on Figure 4.

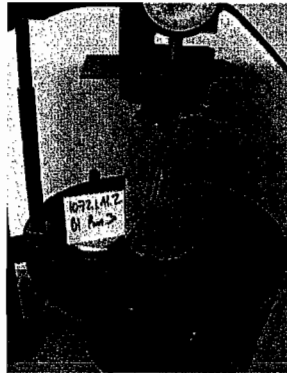
Sample ID	Description	Length (inches) ³	Dia. (inches)	Area (in ²)	Moisture (%)	Temp. (°f)	Max Load (psf) ²	Strength (tsf)
R-07-B1/Run 3 (12.3-15.6)	Metavolcanic Rock, gray green, slightly weathered, very hard, very intensely fractured	5.07	2.38	4.45	n/a	75	35704	575.9

Before Test

After Test

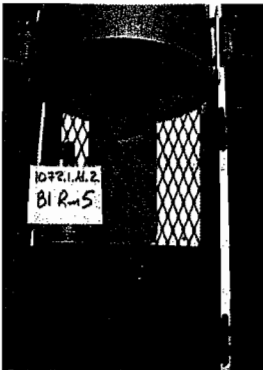
Sample ID	Description	Length (inches) ³	Dia. (inches)	Area (in ²)	Moisture (%)	Temp. (°f)	Max Load (psf) ²	Strength (tsf)
R-07-B1/Run 5 (18.1-20.6)	Metavolcanic Rock, gray green, slightly weathered to fresh, very hard, very intensely fractured	5.00	2.38	4.45	n/a	75	8251	133.1

Before Test

After Test

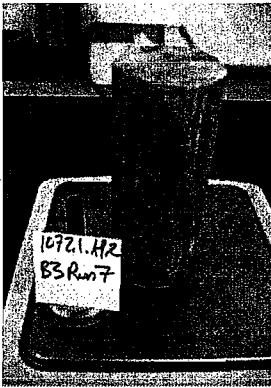
Sample ID	Description	Length (inches) ³	Dia. (inches)	Area (in ²)	Moisture (%)	Temp. (°f)	Max Load (psf) ¹	Strength (tsf)
R-07-B3A/Run 7 (28.0-30.0)	Metavolcanic Rock, gray green, slightly weathered, hard, very intensely fractured	5.34	2.39	4.49	n/a	75	1531	24.7

Before Test

After Test

Sample sheared on fracture plane
